Reliability Study of Grid Connected PV Systems

Field Experience and
Recommended Design Practice

Report IEA-PVPS T7-08: 2002

March 2002

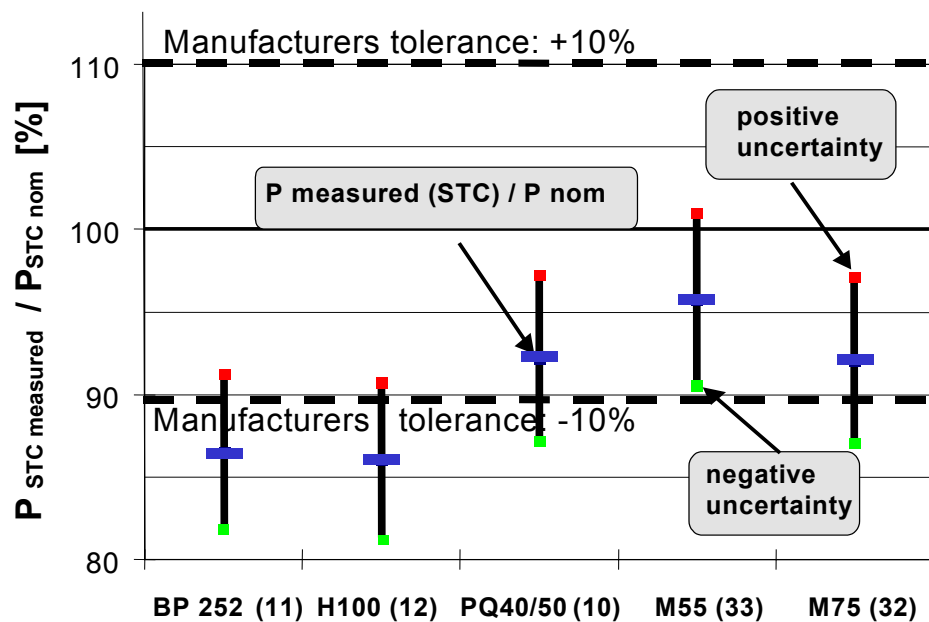
The determination of generator power at STC frequently revealed power deficits of 10 % to 20 % compared with the datasheet values given by the module manufacturers. Nominal STC power was reached only by two module manufacturers: Siemens and GPV (Hoffmann et al., 1998), see figure 6.

Fig. 6: Some manufacturers power ratings cannot be confirmed in field operation .

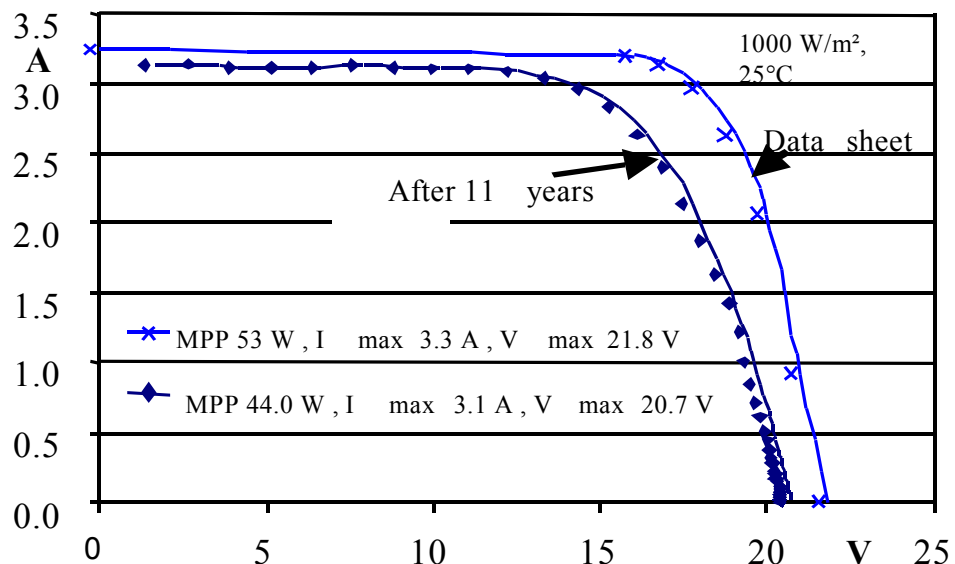
Rasmussen et al. (1999) report an interesting interaction of degradation or wrong manufacturer's data of modules, poor inverter behaviour and system design. An eleven years old system consisting of several strings of six modules ARCO M55 in series was retrofitted with a new inverter. The modules showed poor I-V curves compared to the data sheet (fig. 7).

Fig. 7: I-V curve of a module after 11 years (Rasmussen et al. (1999))

When the system was started with the new inverter, a power drop at higher irradiance levels was noted. The analysis revealed that the inverter did not reach its specified minimum MPP input voltage of 72 V, but limited the input voltage at 85 V. Thus the inverter was not able to track the MPP under the conditions of elevated module temperature and degraded V_{oc} .

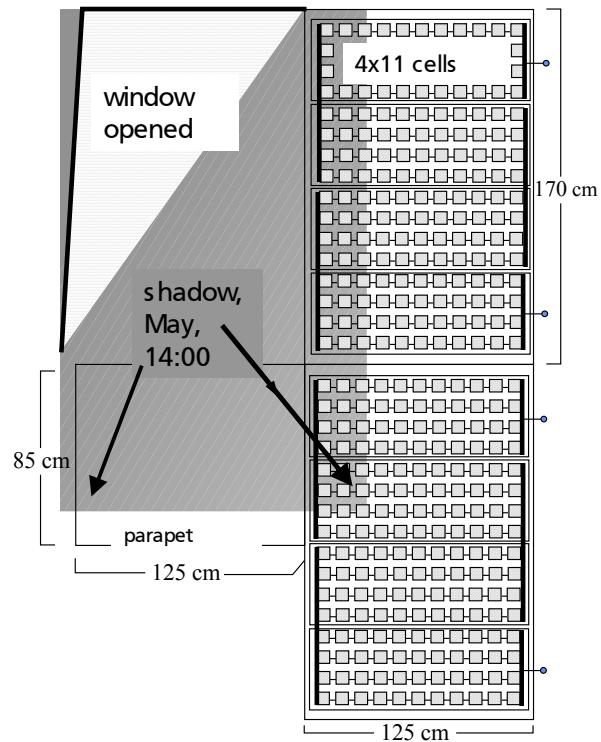
Experience shows that this is a risky path. Paralleling several cell strings within a module does not protect the modules, if partial shading from nearby objects occurs regularly.

A field experiment using the shadow of an open window demonstrated the occurrence of hot-spots (Laukamp H. et al. 1998), see figure 8 for the situation.

Fig. 8: An open window casts its shade on the adjacent modules. Modules are constructed from submodules using 11x 4 cells. String wiring is horizontal.

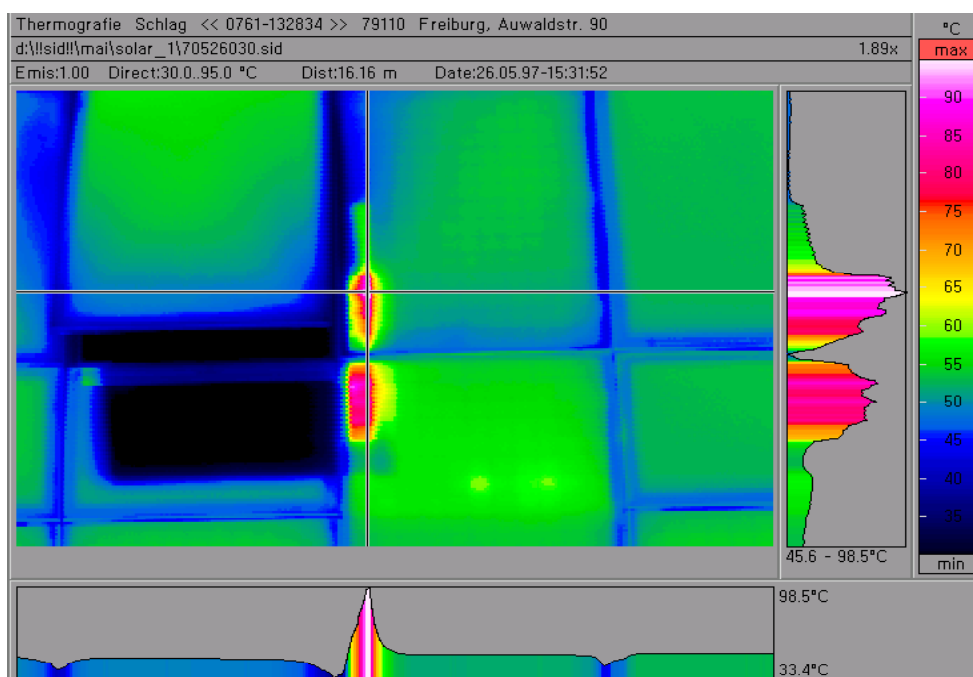
An infrared image clearly shows local heating of the modules – the beginning of a hot-spot (fig. 9). The maximum surface temperature measured during the experiment was 98 °C. Though no module damage was visible after the experiment, a year later we found several modules with cell and glass damage from hot-spots. These modules were shaded by a street lamp in the winter.

Fig. 9: Infrared image of the situation from figure 8. On the left side the open window is visible. The glass facade section shaded by the window appears dark, i.e. cool. Two modules in the centre of the image are partially shaded. They show local high temperatures up to 98 °C. The cross lines mark the cuts for the temperature distributions shown at the bottom and the right side of the image.

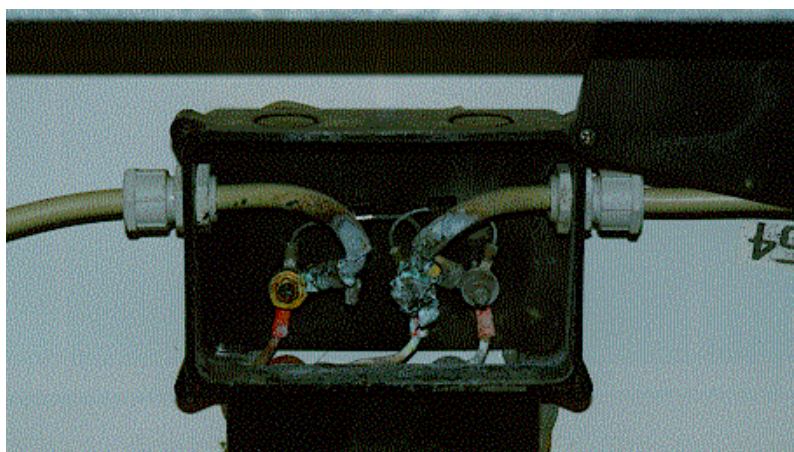
Loose or broken connections can be caused by poor workmanship during installation. However, these defects can also be caused by thermal cycling, which works the screwed connections loose with time. Sometimes terminals were found corroded after only 2 years (figure 10). Presumably, condensing moisture could not drain and accumulated in the junction box (j-box).

In a few cases broken printed circuit boards (PCB) in junction boxes were reported, which caused arcing across the fissures. Possibly, the cracks were caused by too much torque or pressure. Depending mainly on the operating voltage, these faults can lead to an electric arc and subsequently to destruction of the module junction box.

Fig. 10: Corroded contacts probably due to lack of water drainage. This connection will not last 20 years (Laukamp, Häberlin et. al.)

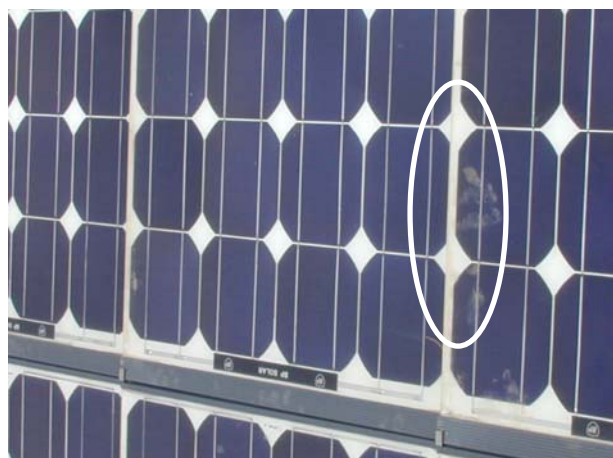
The study concludes that rain provides a good degree of cleaning. Dust, pollen and the like are washed away. However, sticky dirt like bird droppings may stay even during severe rainstorms (Fig. 12).

Fig. 12: Some dirt stays after a heavy rainfall (ewz)

Häberlin recommends a regular annual cleaning.

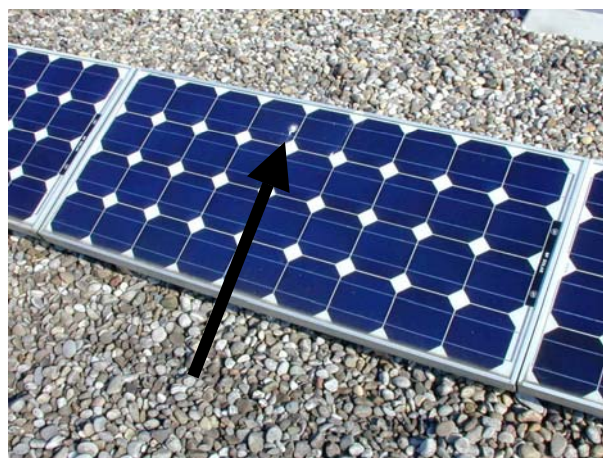
Fig. 13: Bird dropping stays after a heavy rainfall (ewz)

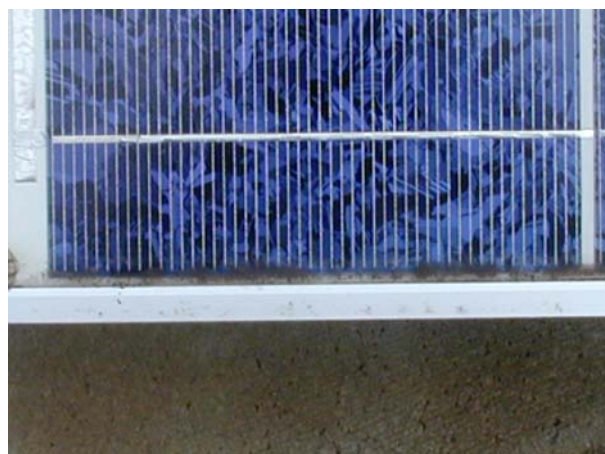
The most critical part of a module is the lower edge. Especially with rather low inclinations, soiling at the edge of the frame occurs. By often repeated water collection in the shallow puddle between frame and glass and consecutive evaporation dirt accumulates (Fig 13). Once it causes shading of the cells, this dirt reduces the available power from a module. Densely packed modules with little distance between cells and frame are especially concerned. Laminates allow free run-off of the water. Therefore, they are less prone to this effect (Fig. 14).

Fig. 14: Dirt accumulation above the frame (ewz).

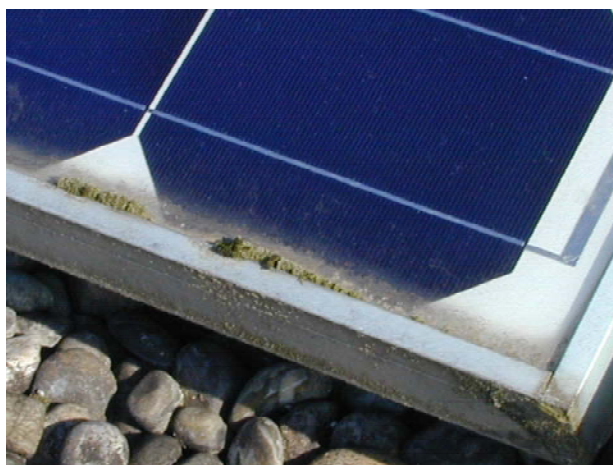
Fig. 16 Three years after installation moss has grown.(ewz).

Over time dirt accumulation may collect enough soil to allow plant growth (Fig. 16). This effect can be resolved only by yearly manual cleaning, by using laminates or by using a new development – a $\frac{3}{4}$ frame (Fig. 17).

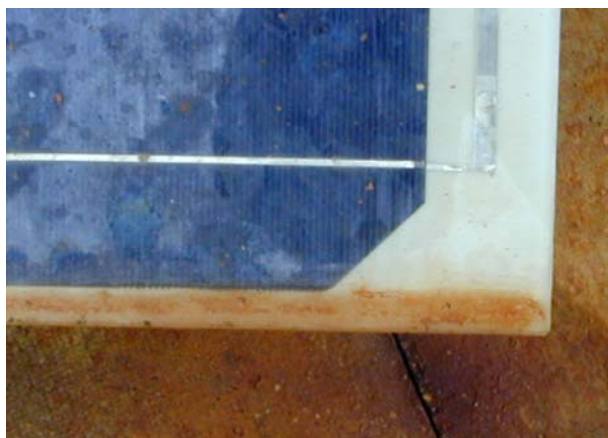
Generally, soiling is a reversible effect. However, there are some situations, where corrosive or sticky dirt is very hard to remove. One example is exhaust fumes from a heating system (ewz). Acidic and sulphuric fumes create a dirt layer, which reportedly is very difficult to remove (Fig. 18 and 19).

Fig. 18: Dirt from exhaust fumes (ewz).

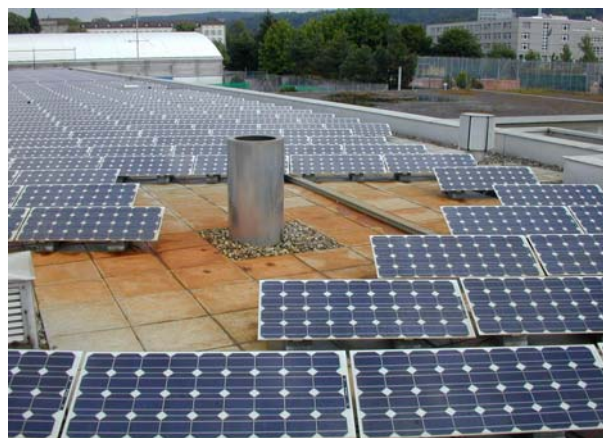
Fig. 19: Detail of a module edge close to a chimney.
