# Case Studies of Accidents and Their Causes in PV Systems

Structural Performance Evaluation Institute (SPEI)

Researcher Kota Sato

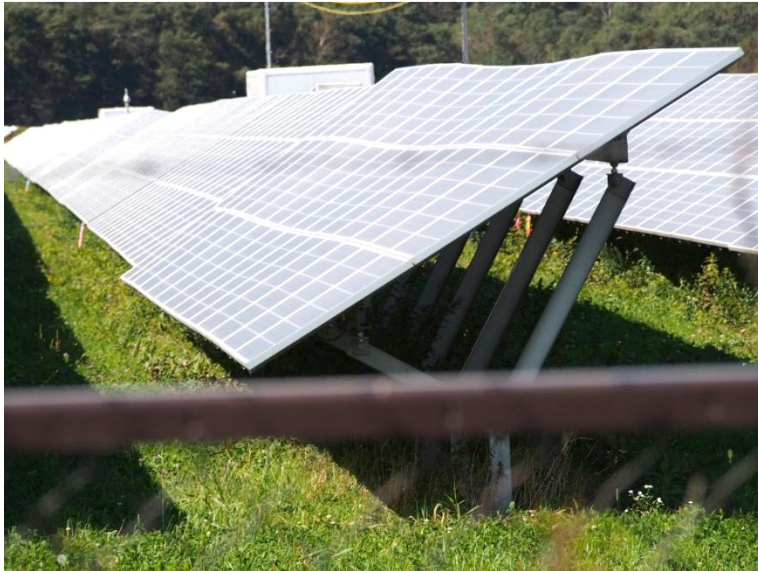
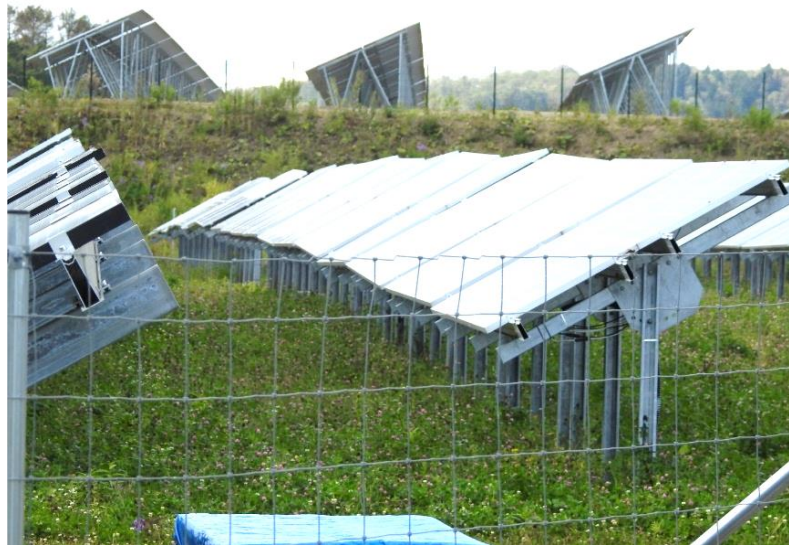
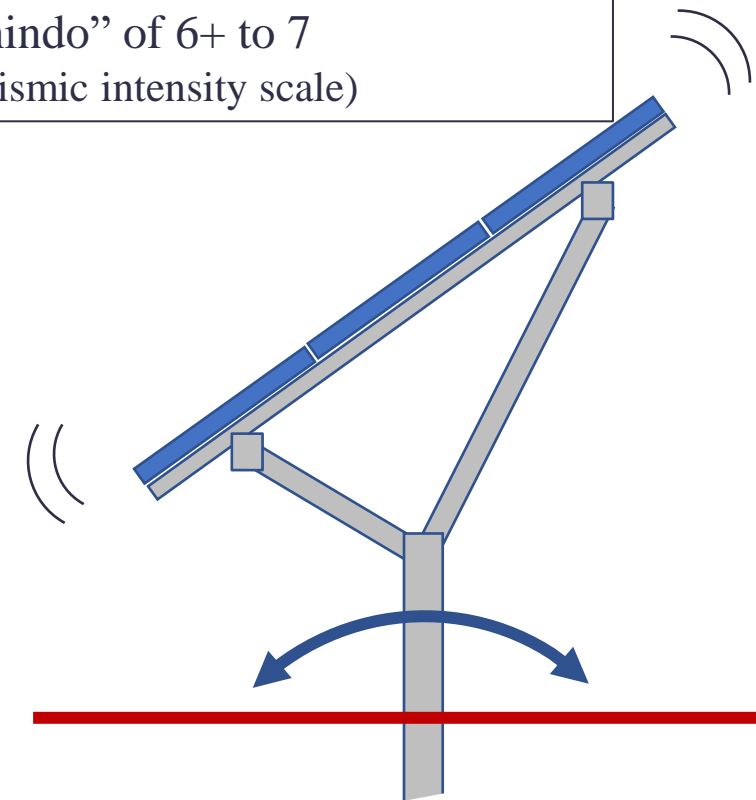
## In Hokkaido Iburi Earthquake (September 2018)

- The single-legged frame type was tilted due to the horizontal forces from the earthquake.
- The single-legged frame type tends to have larger amplitude, which increases the load on the pile foundation.

In the case of a single-legged frame, the oscillation tends to become larger

**Cause of damage: Insufficient horizontal resistance of the pile foundation**

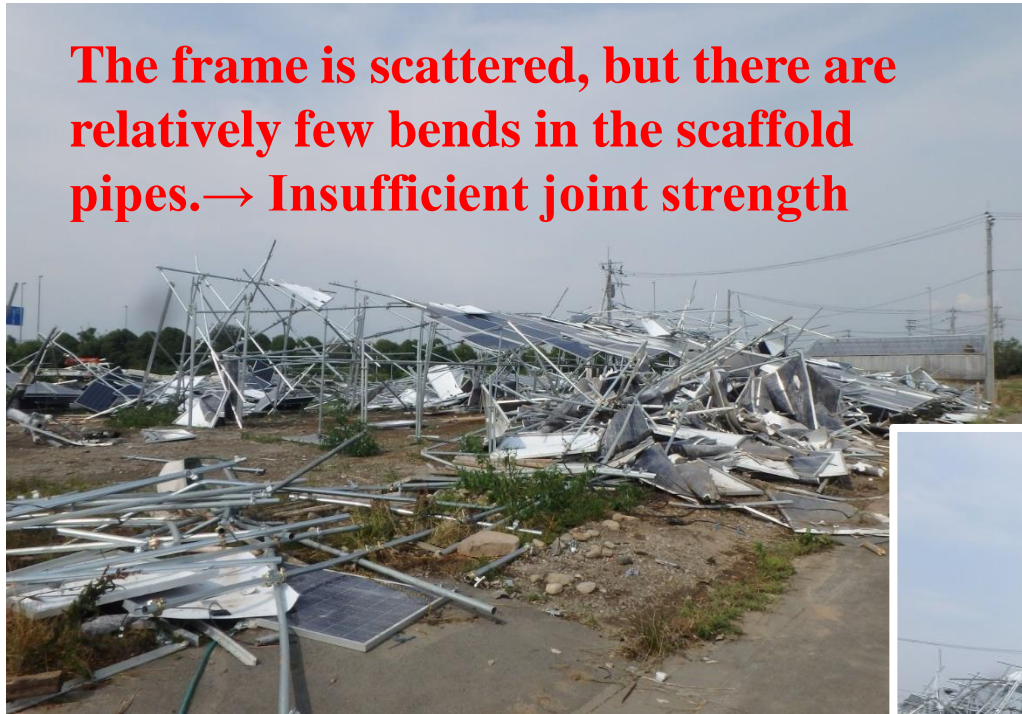
## In Gunma Prefecture (June 2015)

**The frame is scattered, but there are relatively few bends in the scaffold pipes. → Insufficient joint strength**

The frame collapsed and scattered due to a gust of wind, which is believed to have been a downburst. The frame and foundation were constructed using materials from temporary scaffolding used in construction.

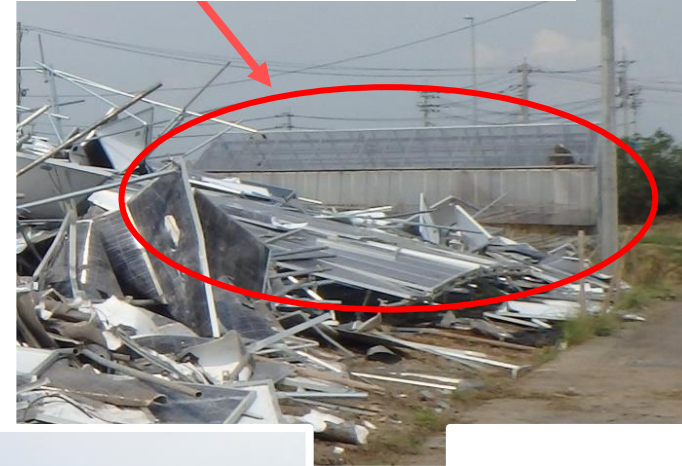
The adjacent agricultural greenhouse sustained no damage

It is highly probable that the design wind speed was not reached. (It is also important to observe the surrounding conditions)

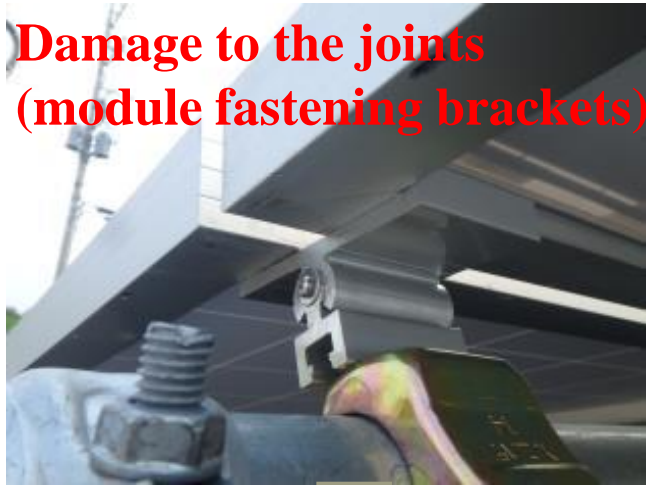
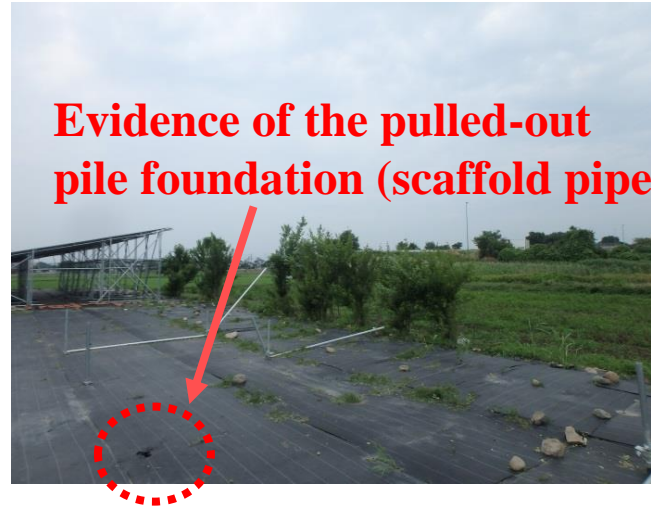
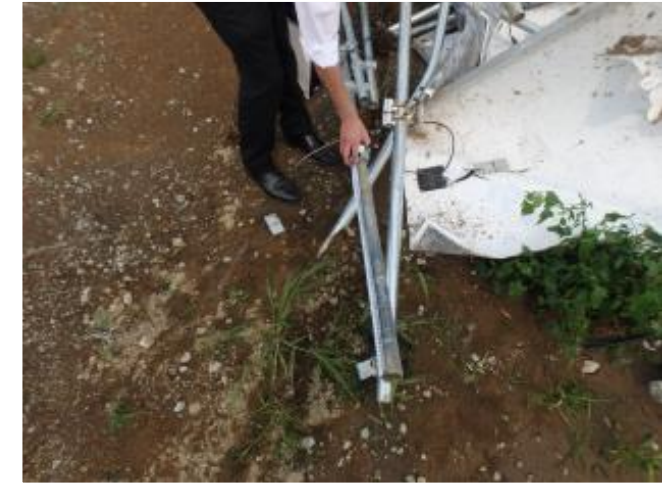
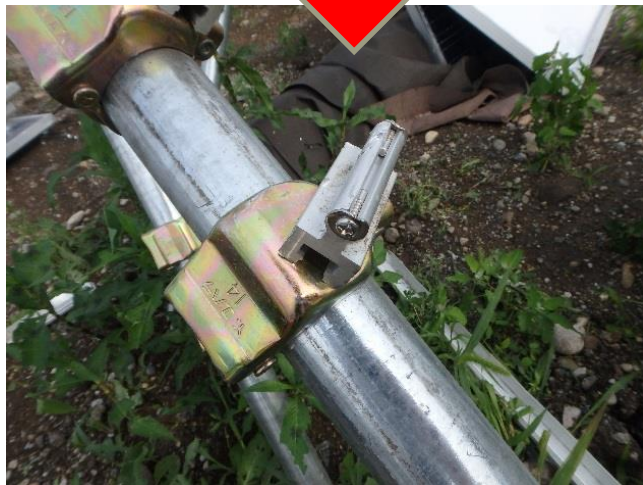
## In Gunma Prefecture (June 2015)

**The penetration depth of the pile foundation is approximately 800 mm**

**Cause of damage: Insufficient strength of the frame joints / Insufficient pull-out resistance of the pile foundation**

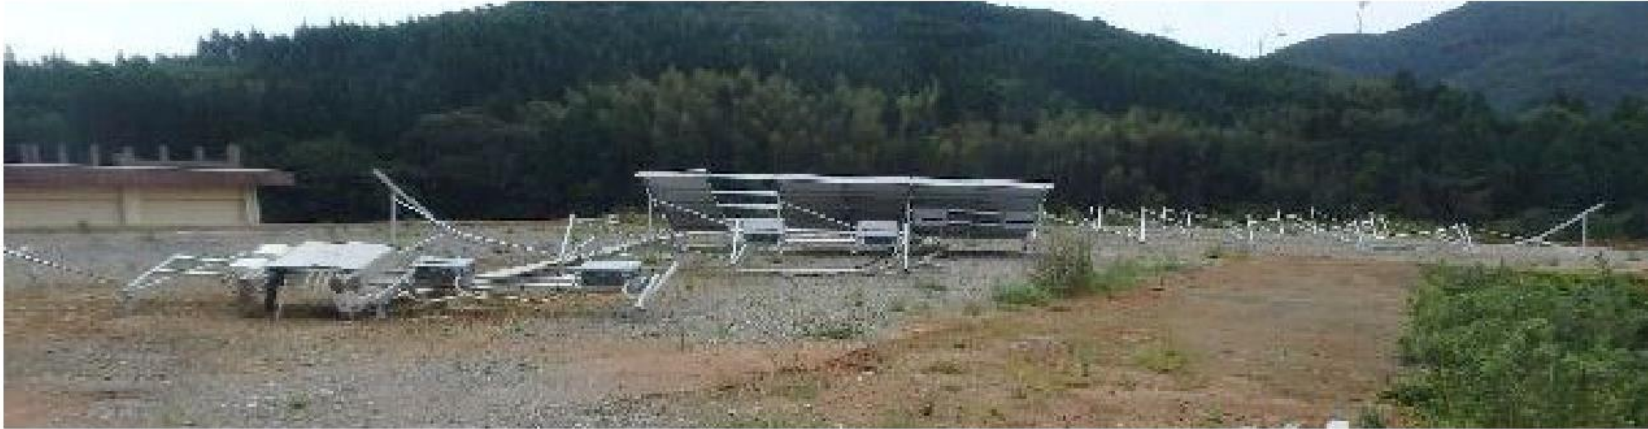
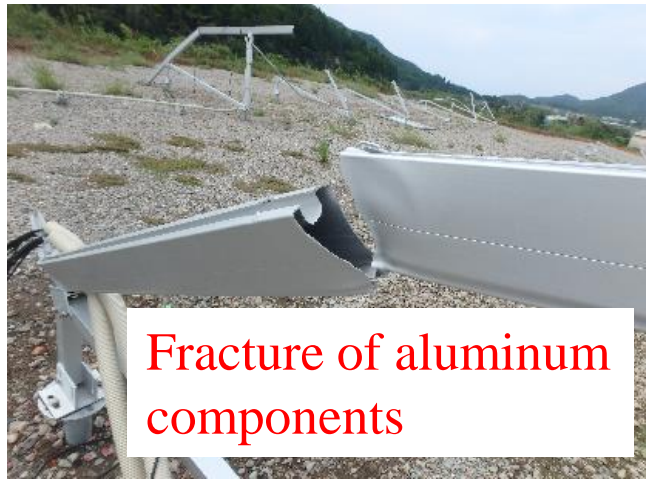
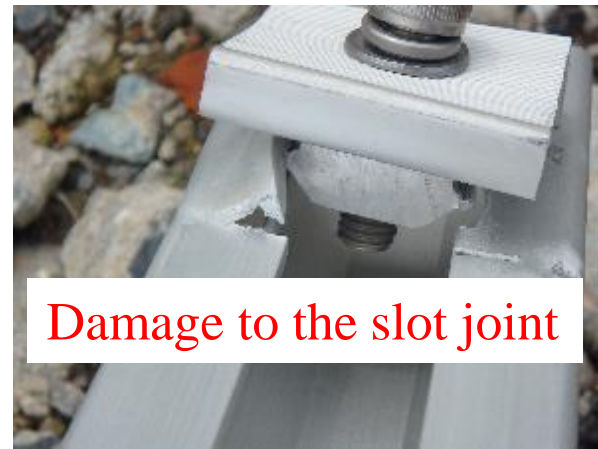
## In Kagoshima Prefecture (September 2016)

- Aluminum components can have their strength increased through **heat treatment**, but this results in **a decrease in toughness**.
- **If the thickness of the component is reduced, it may fail in a brittle manner.**

**Cause of damage: Insufficient strength of the components and joints**

The array was damaged and scattered by the strong winds of Typhoon No.16 in 2016.

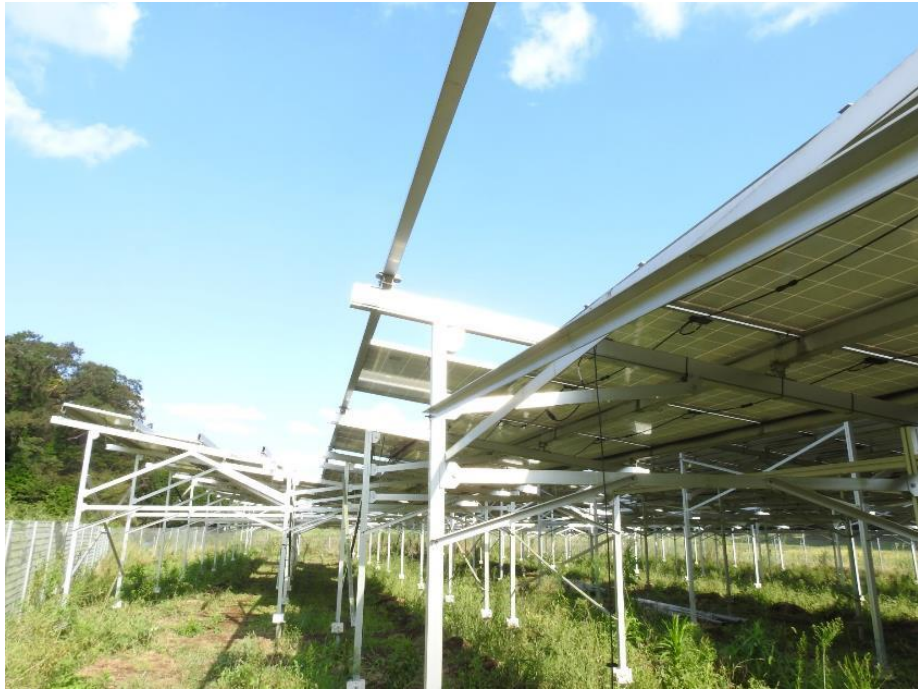
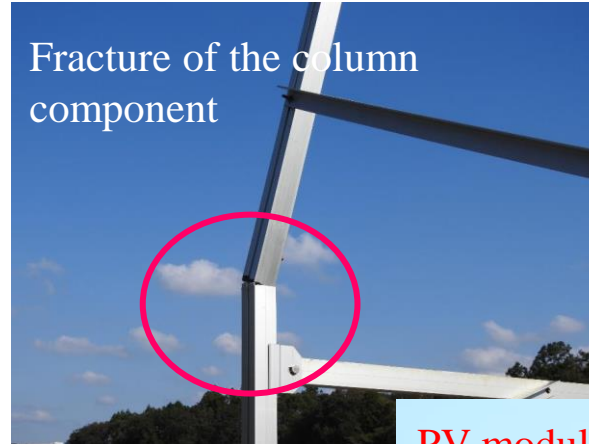
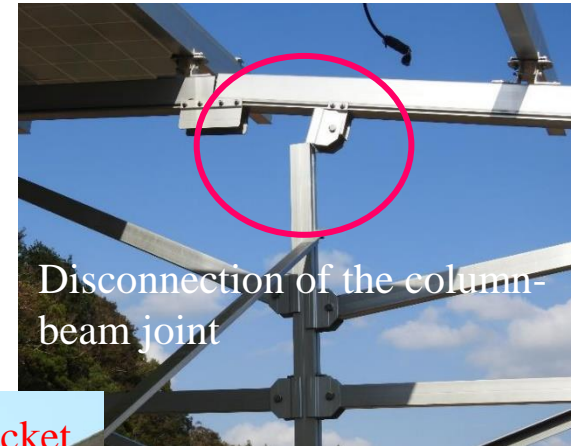
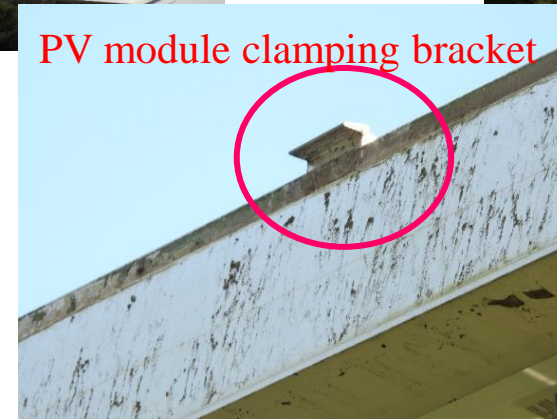
## In Chiba Prefecture (September 2019)

Damage to the agrivoltaic PV system caused by the strong winds of Typhoon No.19 in 2019. The aluminum frame fractured, and damage at the joints led to the scattering of some PV modules and parts of the frame.

**Cause of damage: Insufficient strength of the components and joints.**

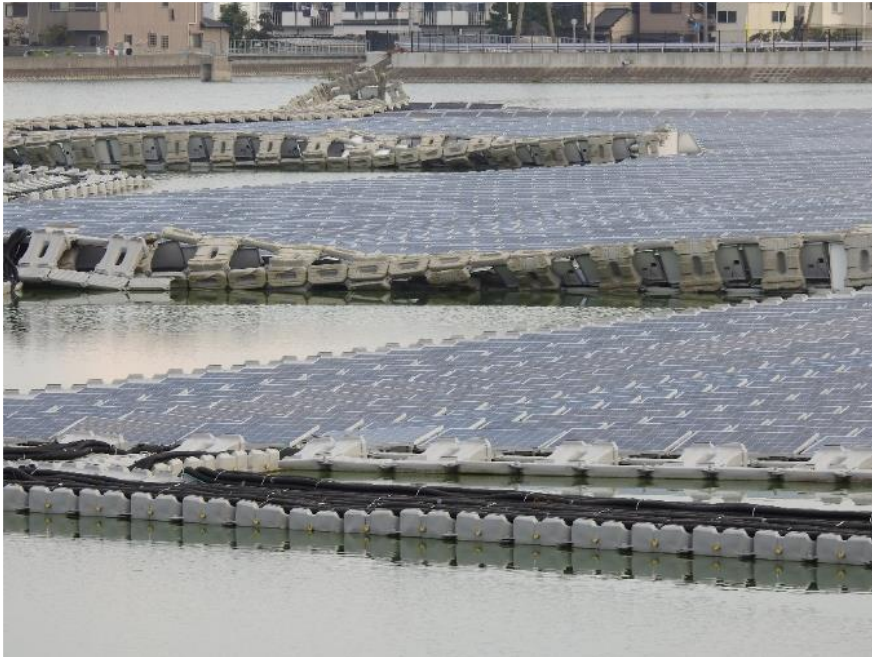
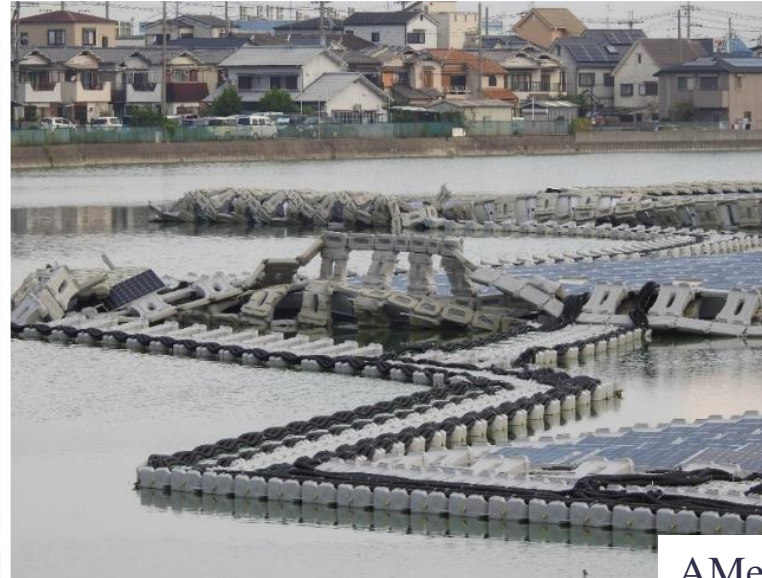
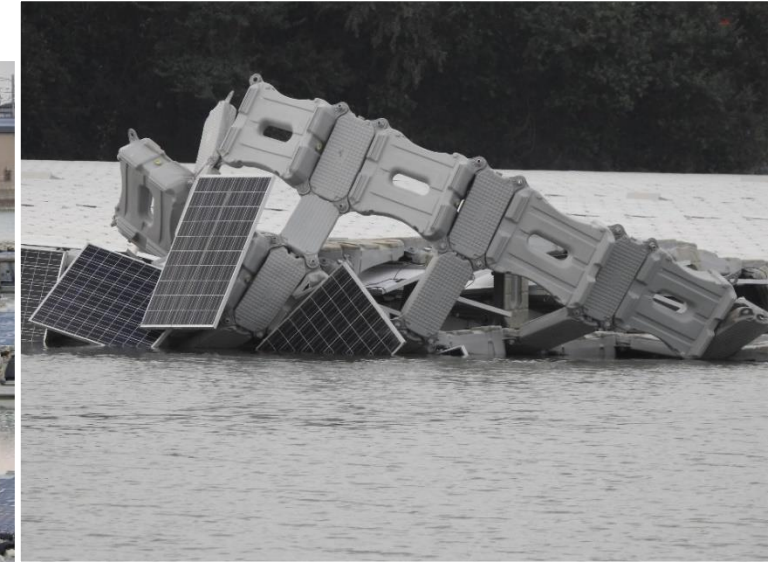
## In Osaka Prefecture (September 2018)

Damage to the Floatvoltaics caused by the strong winds of Typhoon 1821. The Floatvoltaics are anchored by multiple mooring lines arranged around a group of floats. The cause of the damage is believed to be the failure of the connection between the windward mooring lines and the floats. The windward float, with its mooring lines severed, was lifted and twisted by the strong winds.

**Cause of damage: Insufficient joint strength  
between the mooring lines and the floats**

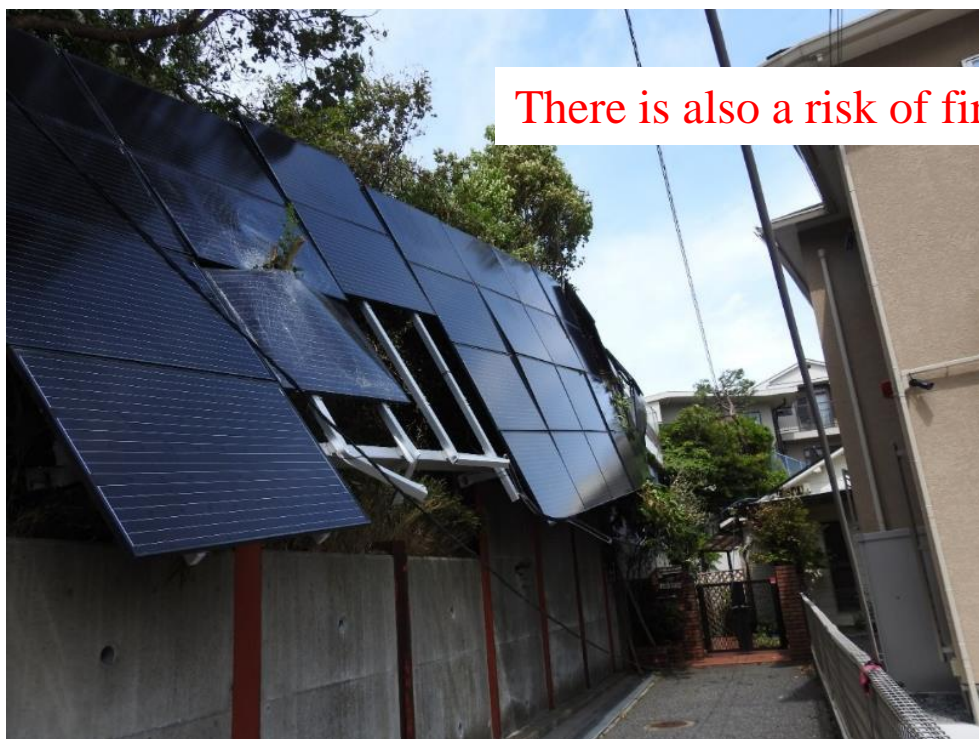
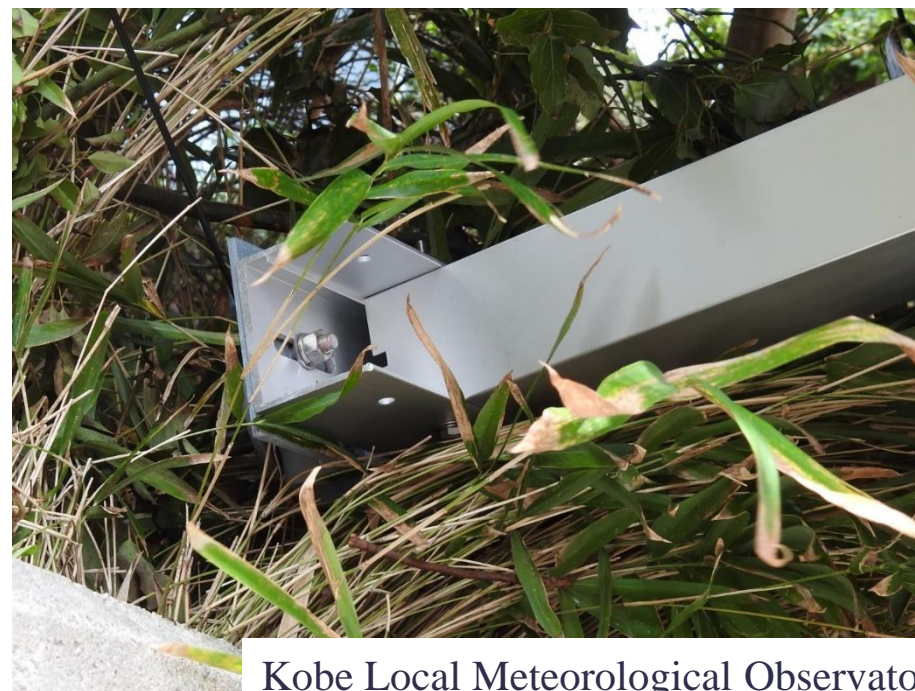
## In Hyogo Prefecture (September 2018)

There is also a risk of fire

Damage to the rooftop PV system caused by the strong winds of Typhoon No.18 in 2021. The joint between the rooftop surface of the apartment building and the frame was damaged, causing the entire array to be blown 20 m/s and fall.

**Cause of damage: Insufficient joint strength between the building rooftop and the frame**

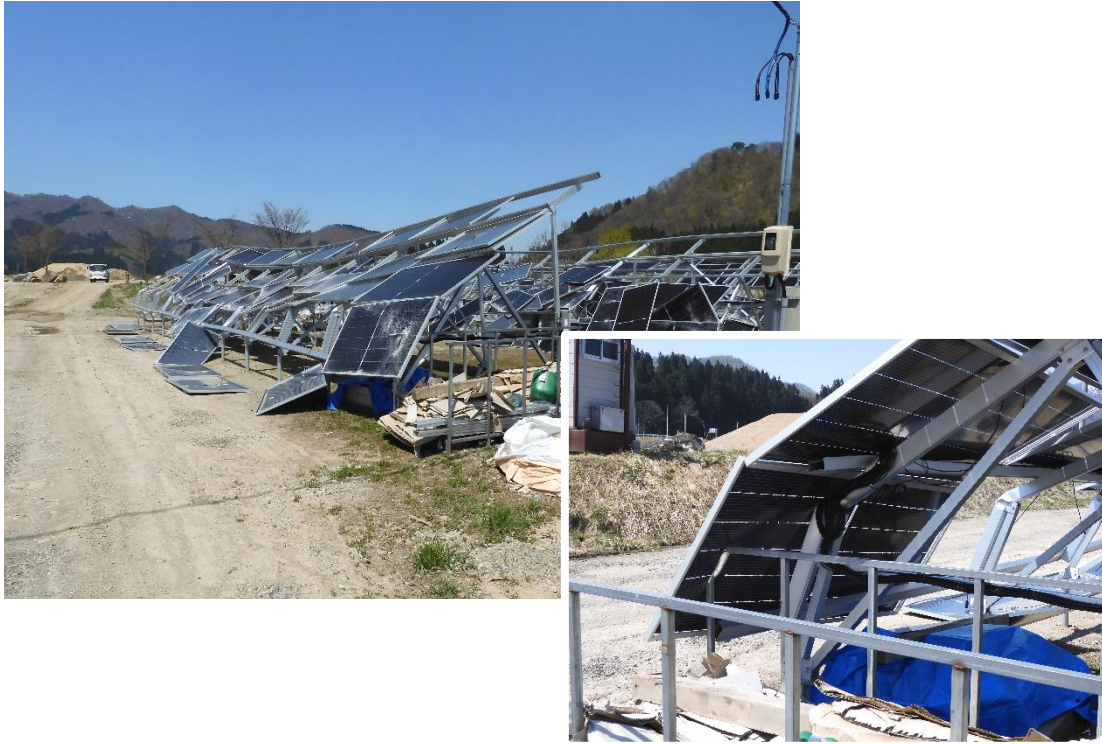
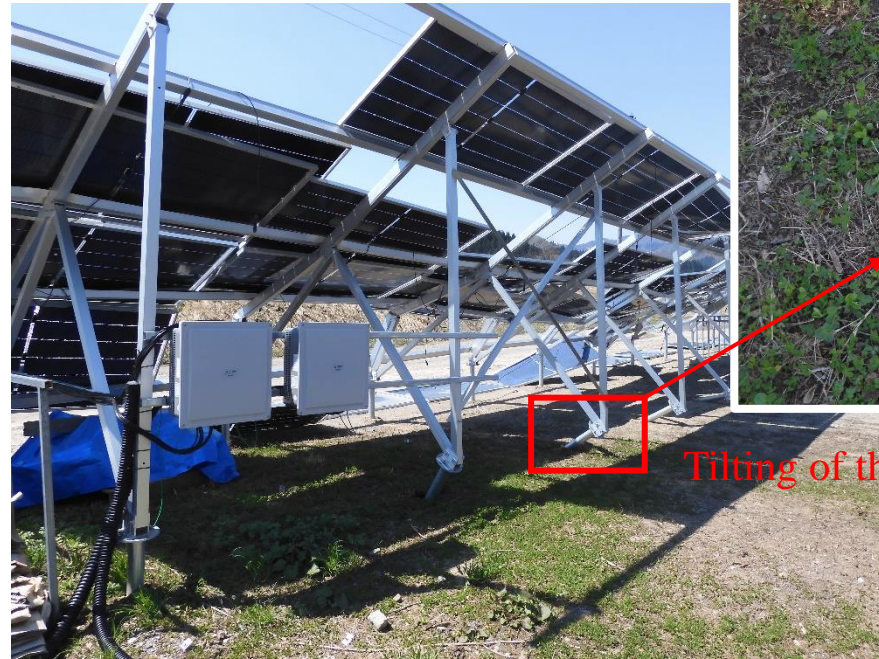
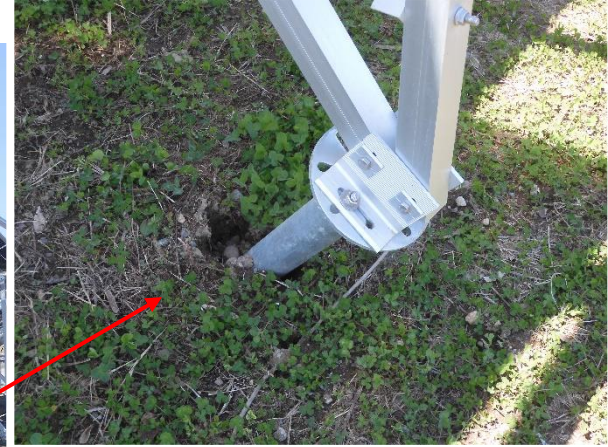
## In Yuzawa City, Akita Prefecture (Winter 2020-2021)

Tilting of the piles was also observed.

**Cause of damage: Inadequate setting of eaves load, insufficient horizontal resistance of the piles**

Deformation (fracture) of the aluminum frame, detachment of the PV modules, and tilting of the pile foundation were observed. It is presumed that the primary cause of the damage was the load acting on the eaves.

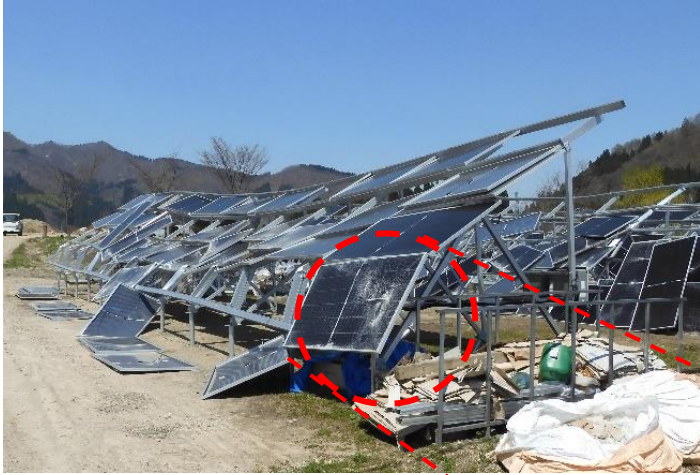
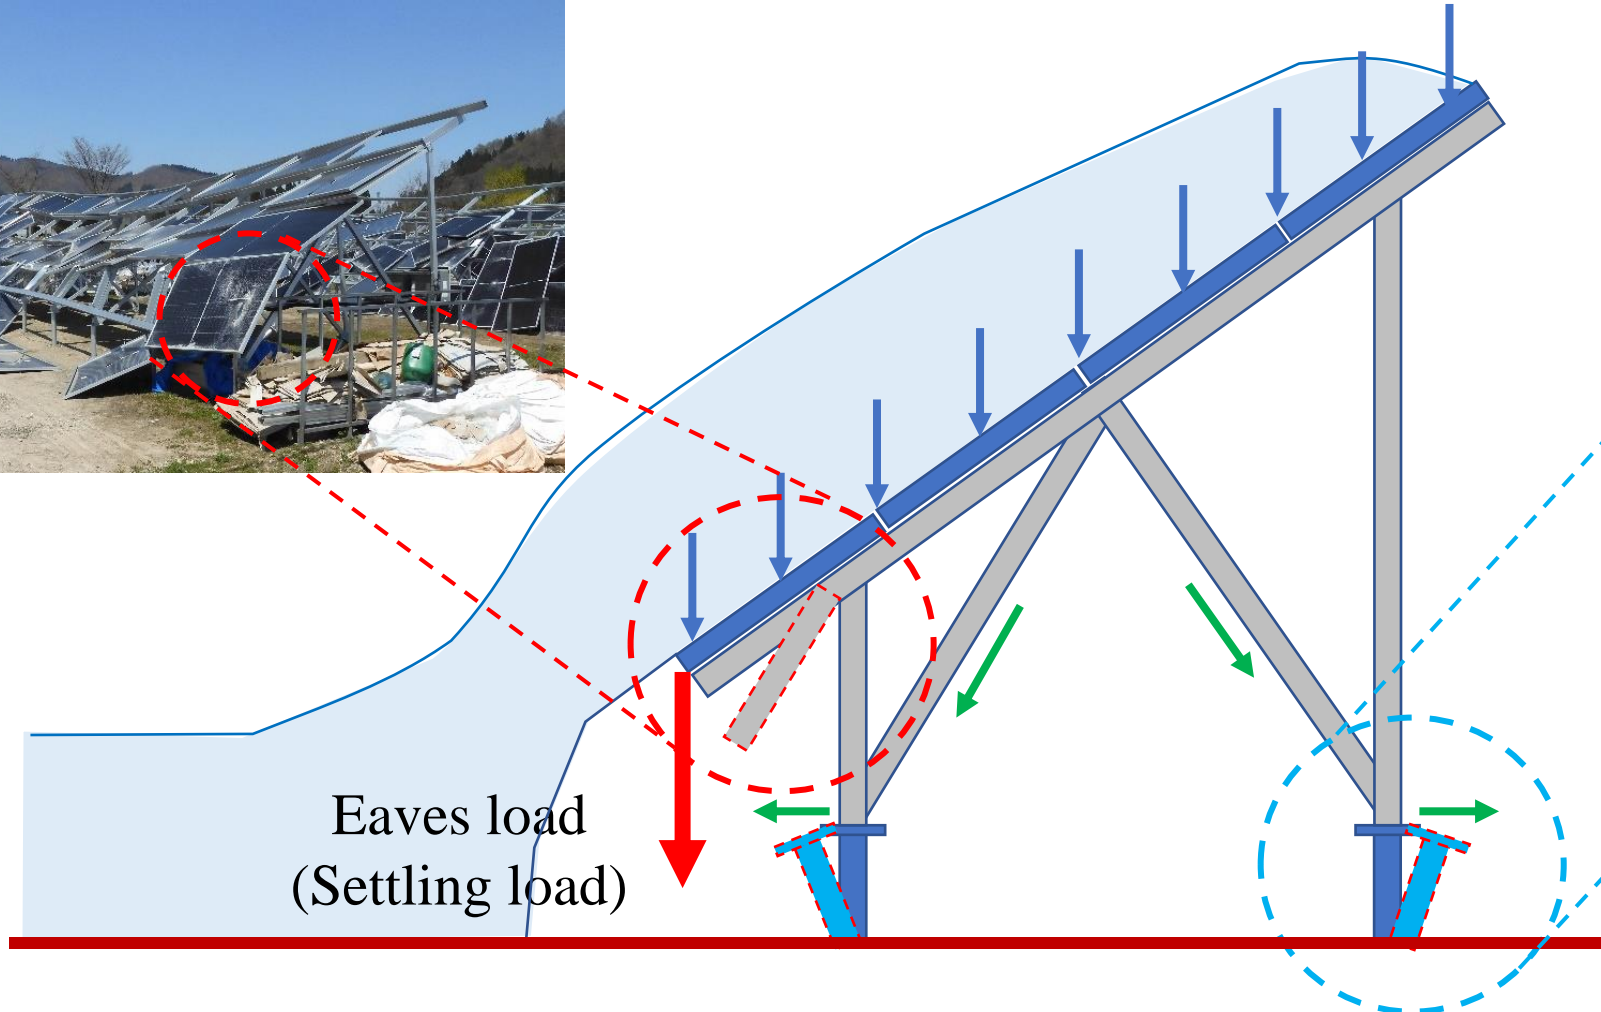
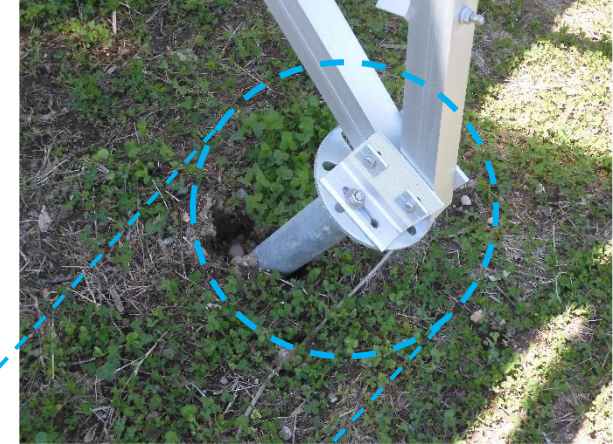
## In Yuzawa City, Akita Prefecture (Winter 2020-2021)

Tilt of the piles

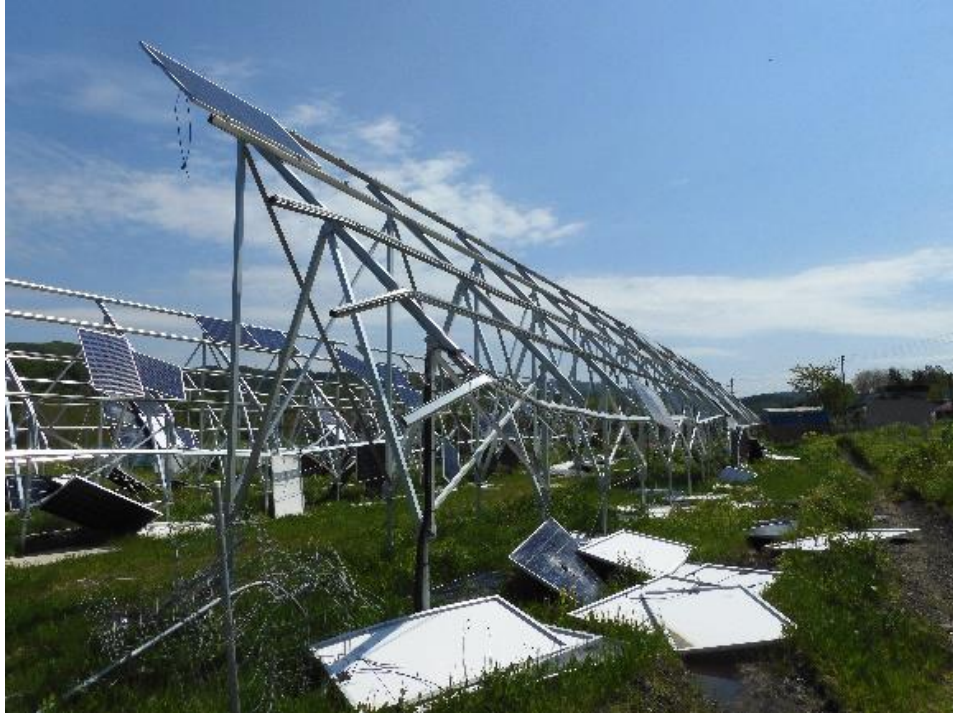
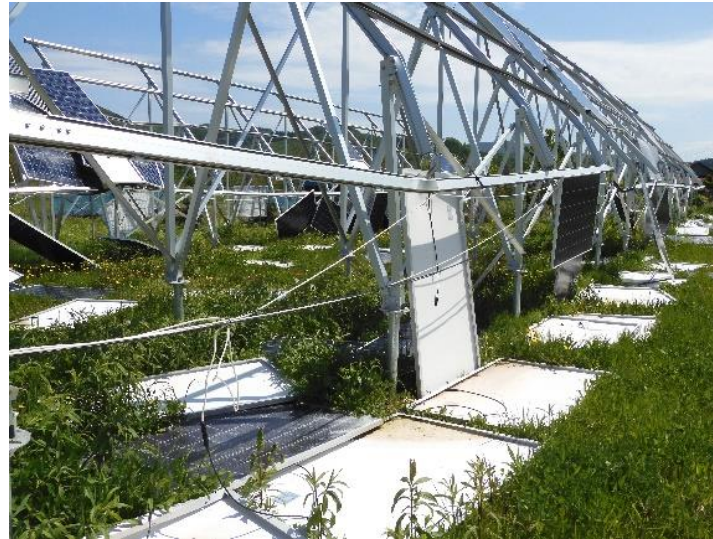
Deformation (tilting) of the horizontal rail

Detachment of PV modules was observed due to the deformation of the horizontal rails of the aluminum frame. It is presumed that the primary cause of the damage was insufficient joint strength between the vertical and horizontal rails. Tilting of the pile foundation was also observed.

**Cause of damage: Inadequate setting of eaves load, possible insufficient strength of the components.**

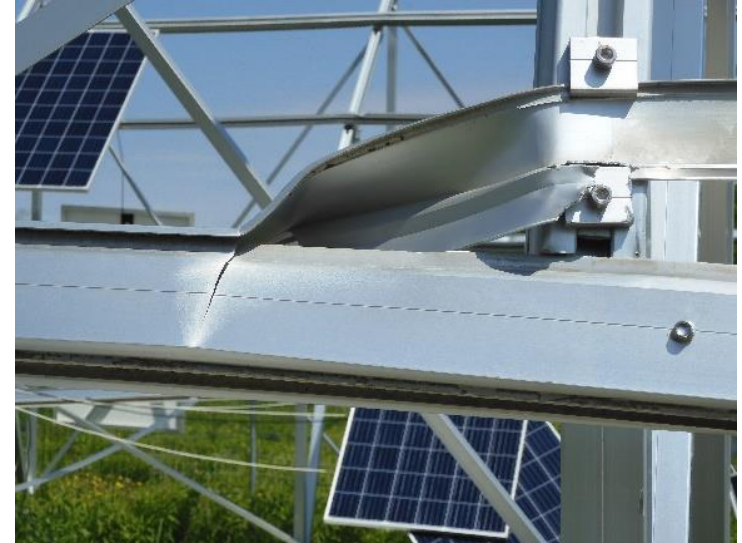
Tear at the joint of the horizontal rail

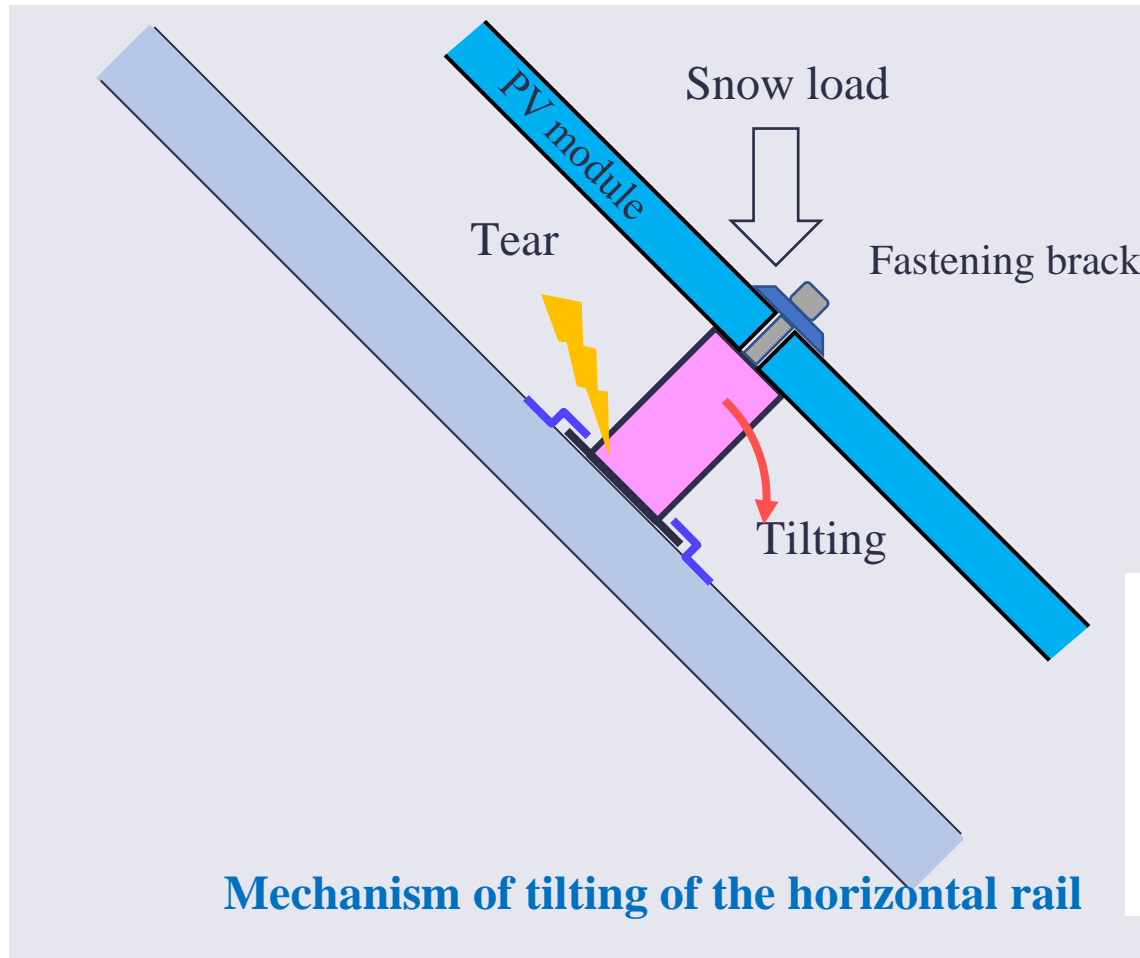
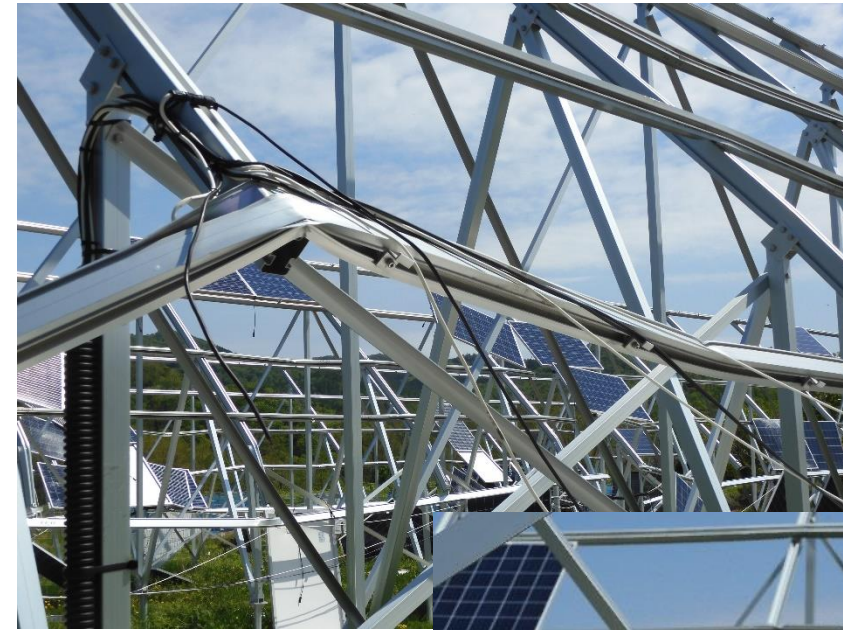
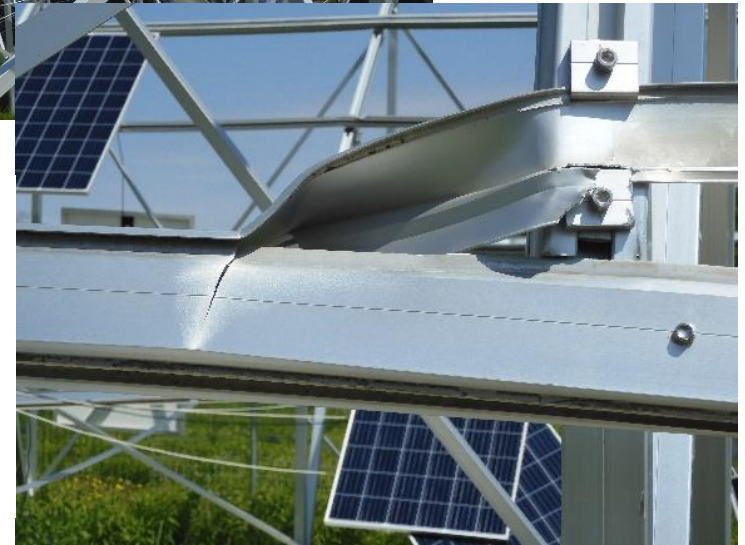
## In Iwamizawa City, Hokkaido (Winter 2020-2021)

When the horizontally fixed rail is pushed downward, a moment is applied in the direction of tilting of the component.

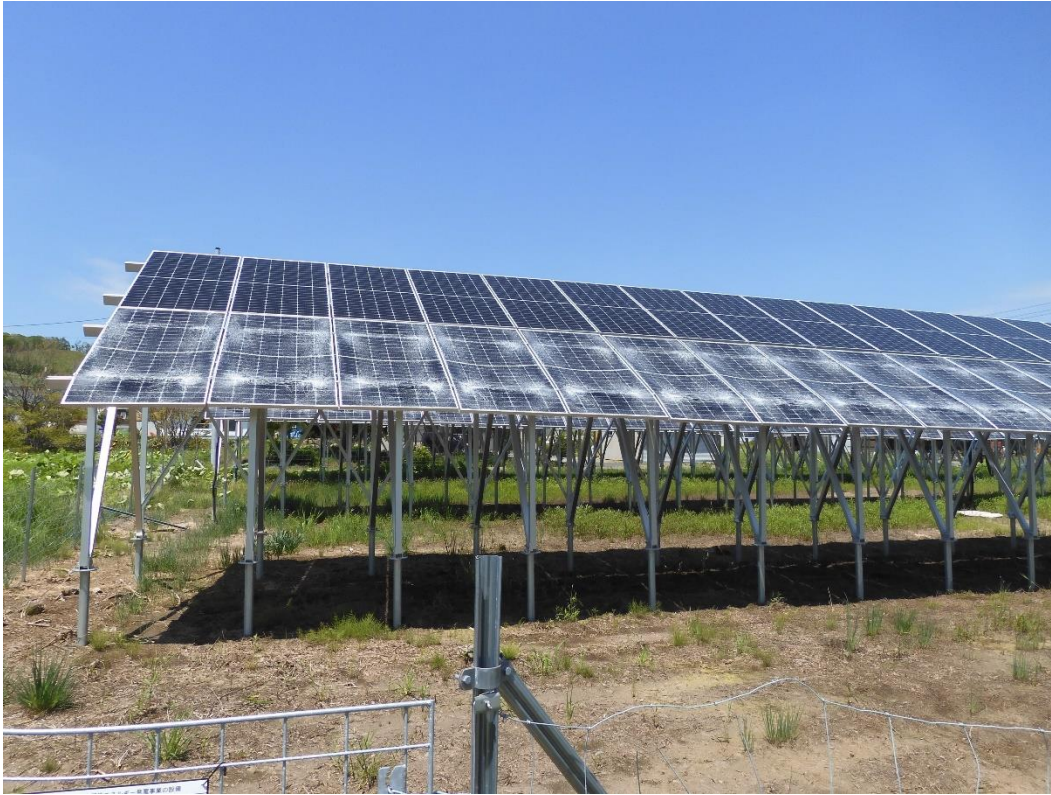
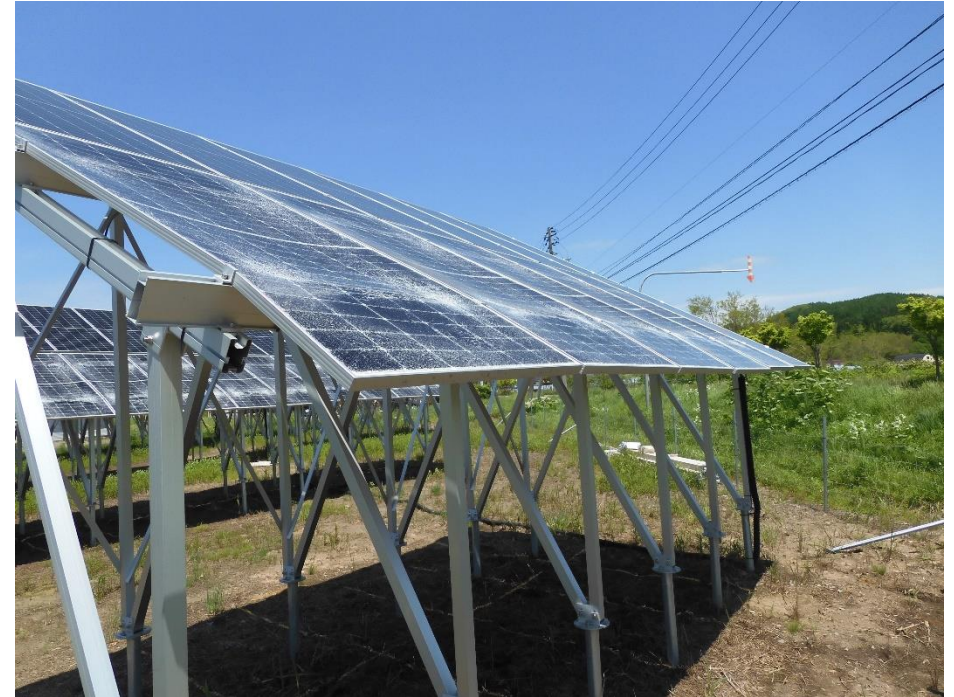
## In Iwamizawa City, Hokkaido (Winter 2020-2021)

Only the PV modules have been damaged. It is important to select modules that are compatible with the local snow load (design snow load).

The glass surface of the PV modules bends significantly under snow load (or wind pressure load), leaving marks where it has contacted the horizontal rails.

**Cause of damage: Incorrect selection of PV modules (insufficient strength)**

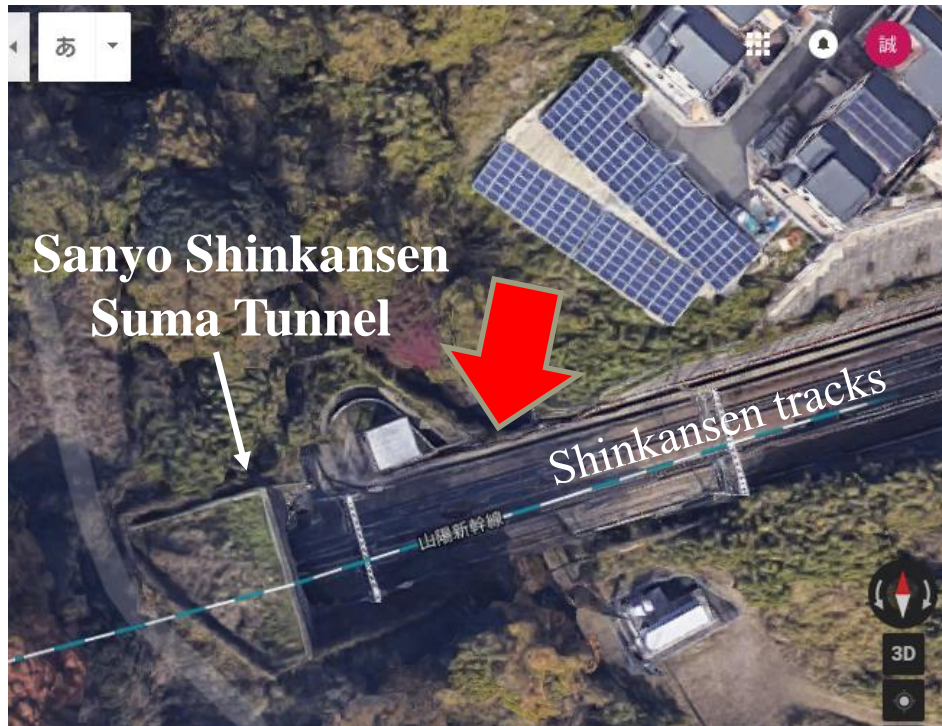
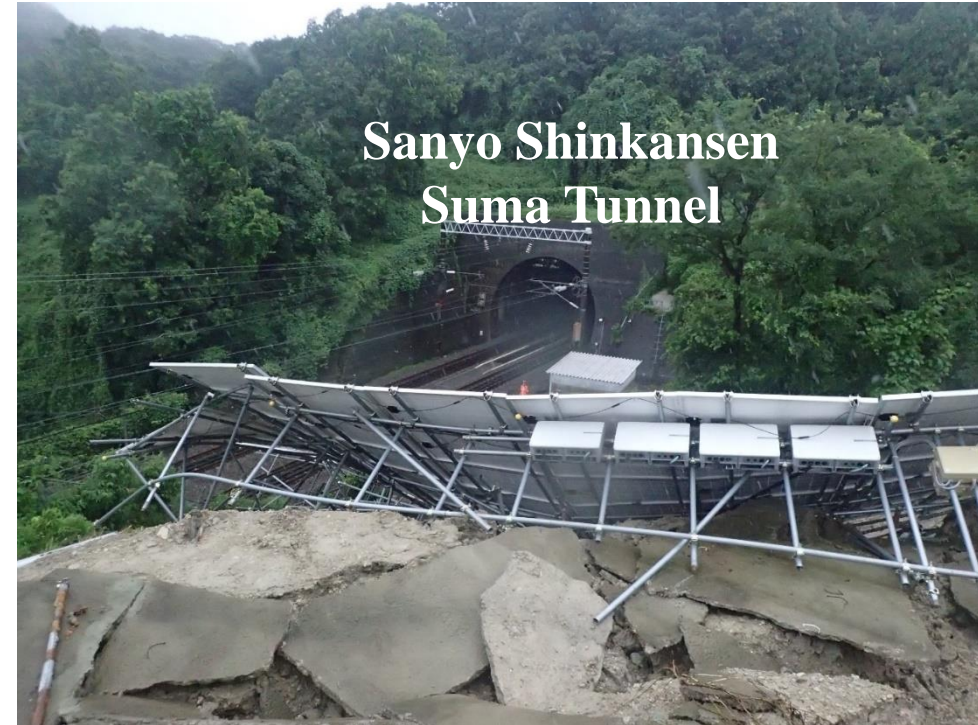
## In Hyogo Prefecture (July 2018)

Damage from the Western Japan Heavy Rain Event of July 2018 : The ground at Slope-mounted PV Systems along the Sanyo Shinkansen line collapsed, and debris threatened the Shinkansen tracks, leading to partial suspension of service.

**Cause of damage: Insufficient ground construction (poor drainage ditches and retaining walls)**

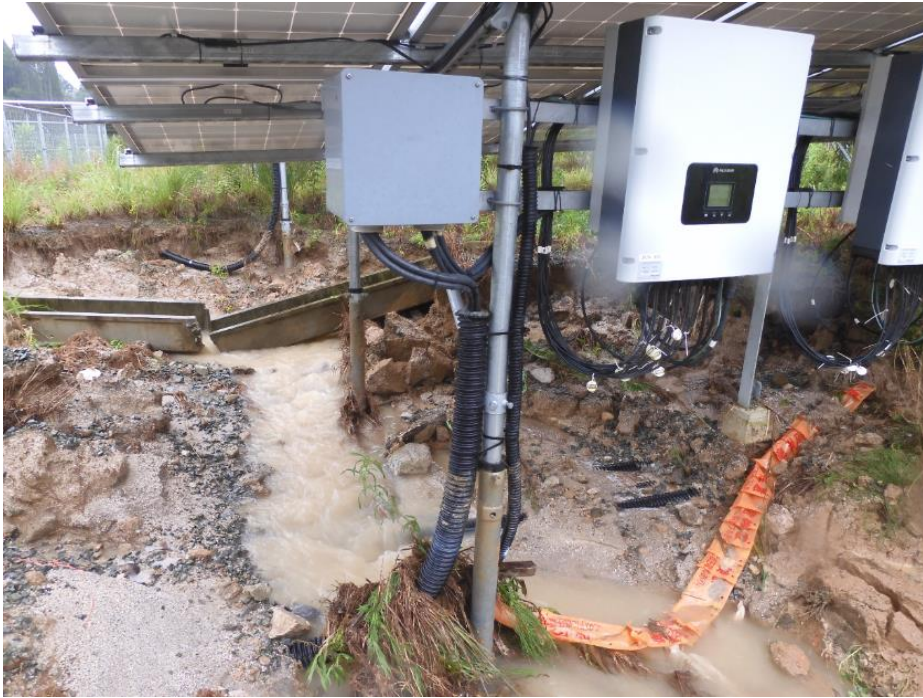
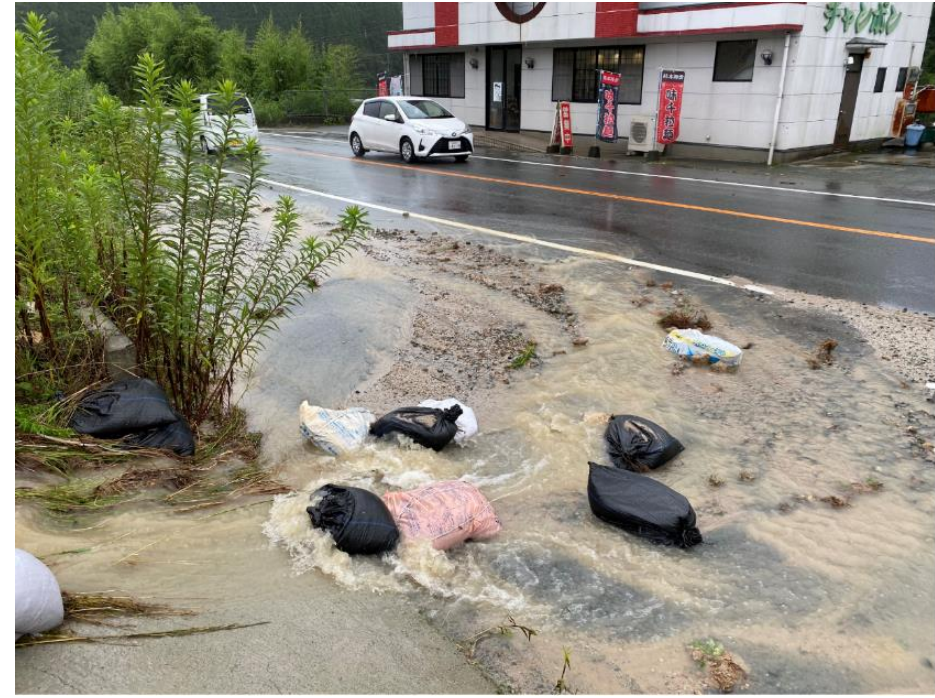
## In Kumamoto Prefecture (July 2020 Kyushu Torrential rain )

Damage to the drainage ditch due to soil erosion, exposure of pile foundations.

**Cause of damage: Inadequate drainage system**

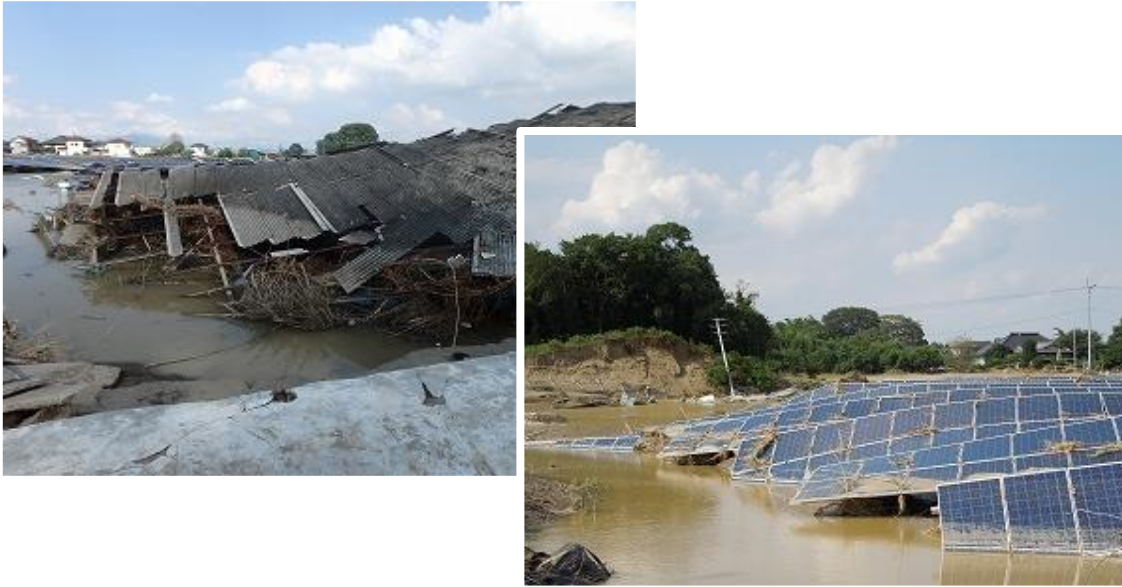
## In Joso City, Ibaraki Prefecture (September 2015)

Due to the heavy rainfall from Typhoon No.15 in 2018, the levee of the Kinugawa River collapsed, and the PV system was submerged. Because of the high flow velocity, many PV systems were damaged.

**Cause of damage: Location of the PV systems**
