# Case Studies of Accidents and Their Causes in PV Systems

Structural Performance Evaluation Institute (SPEI)

Researcher Kota Sato

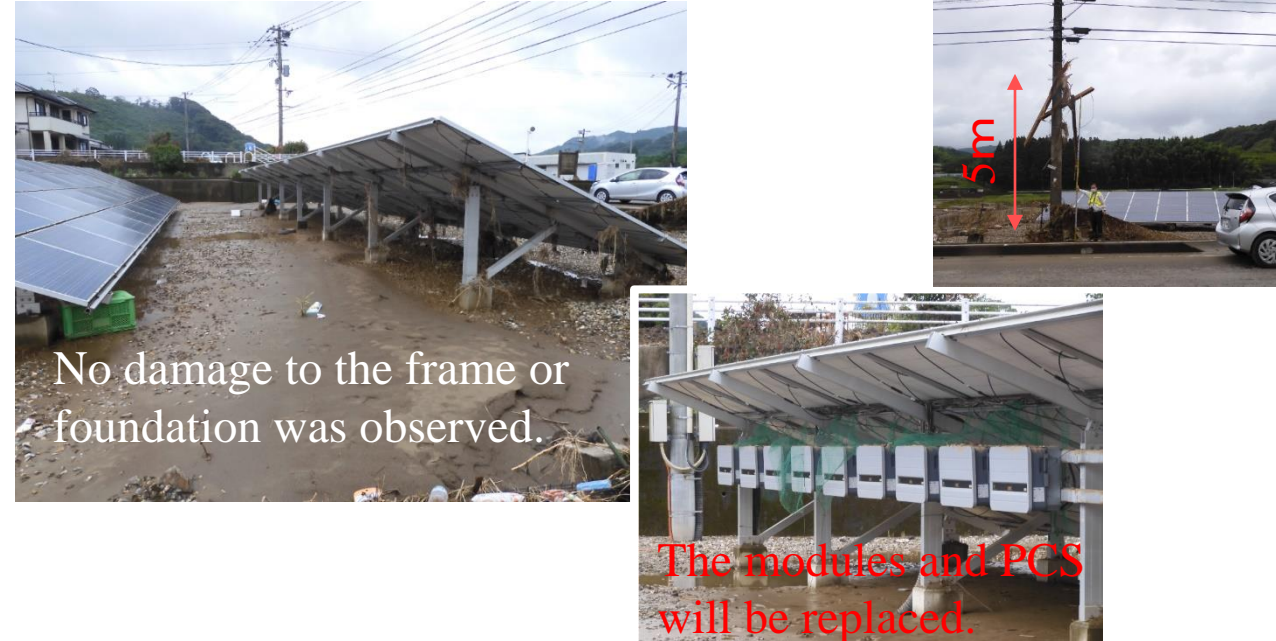
## In Kuma District, Kumamoto Prefecture (July 2020)

Due to the heavy rainfall from the July 2020 Kyushu floods, the Kuma River flooded, submerging the PV systems. However, because the flow velocity at the location of PV system was slow and the water level gradually rose (by approximately 5 meters), no damage to the frame was observed.
