Safety category	Performance category

Task 13 Reliability and Performance of Photovoltaic Systems

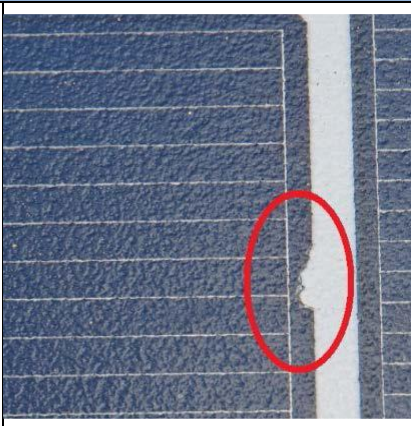
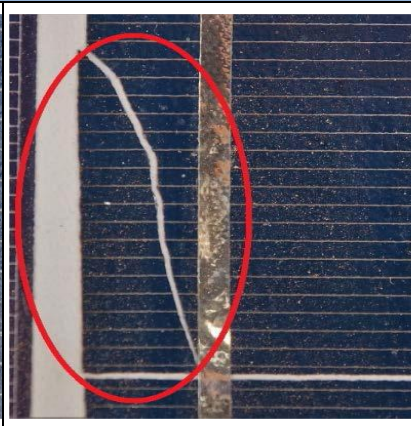
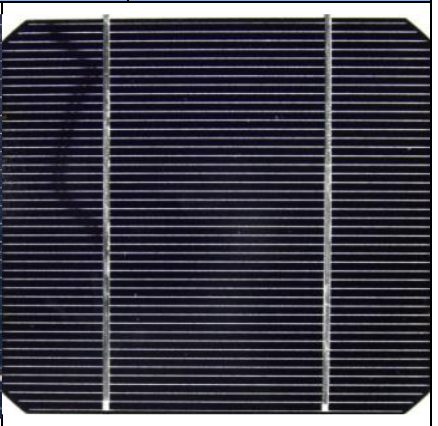
<p>Cell chipping. A very small region is missing from the edge of the cell, but does not enter metalized region [Köntges14].</p>	<p>Large crack at cell corner visible by eye - small portion of the cell (<10%) is no longer electrically connected [Köntges14].</p>	<p>Cell crack with snail track. No isolation of any cell part. The propagation could isolate a cell area >10% [Köntges14].</p>
<p>Severity</p>

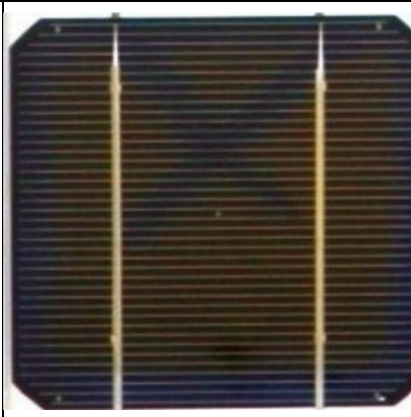
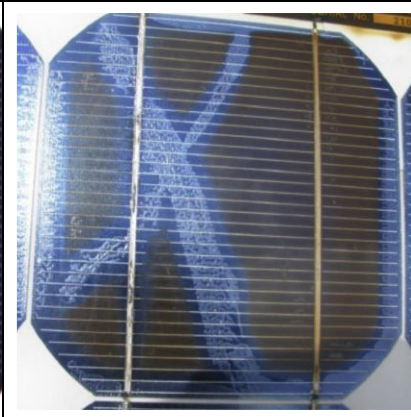
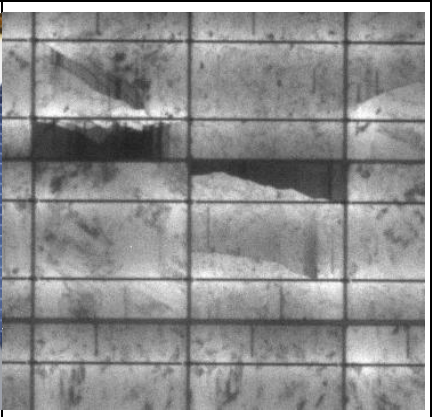
<p>Cell cracks visible by the photo-bleaching effect. This may not be mistaken for snail tracks [Köntges14].</p>	<p>Two cell cracks with extensive delamination, EVA browning and photo bleaching [Yang19].</p>	<p>EL image of 2 cell cracks which isolates more than 10% of the cell area [By the courtesy of TUV Rheinland].</p>
<p>Severity</p>

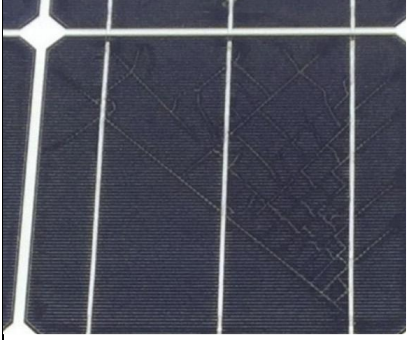
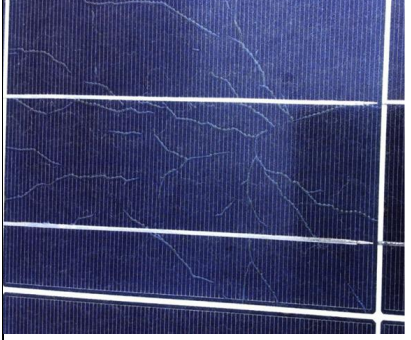
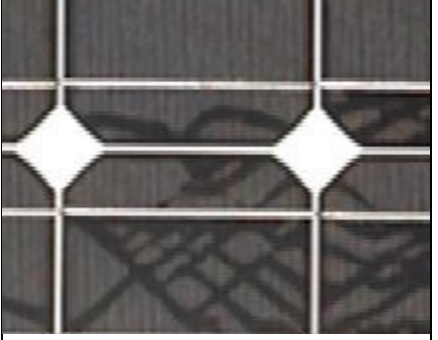
<p>Snail track example [Yang19].</p>	<p>Snail track example [Yang19].</p>	<p>EL of cell cracks with snail tracks [Köntges14].</p>

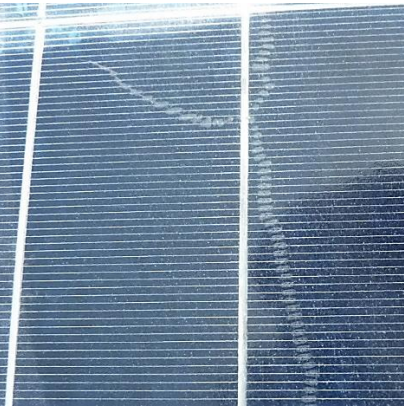
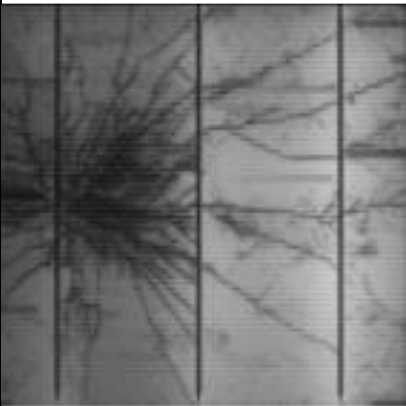
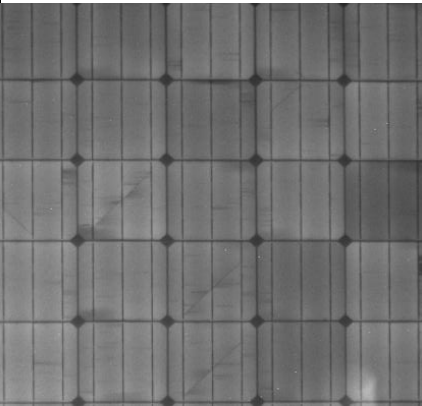
Cell crack with EVA delamination [By the courtesy of TUV Rheinland]. (see also PVFS 1-3)	Typical EL picture of a cell crack caused by hail [By the courtesy of TUV Rheinland].	Repetitive crack pattern due to impact of soldering machine [By the courtesy of SUPSI PVLab].
Severity

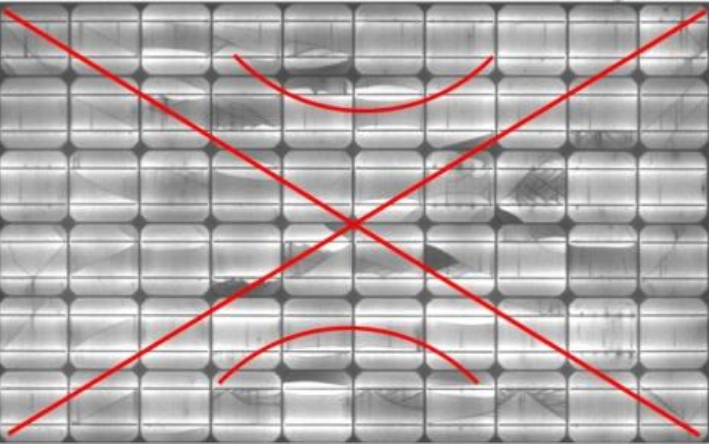
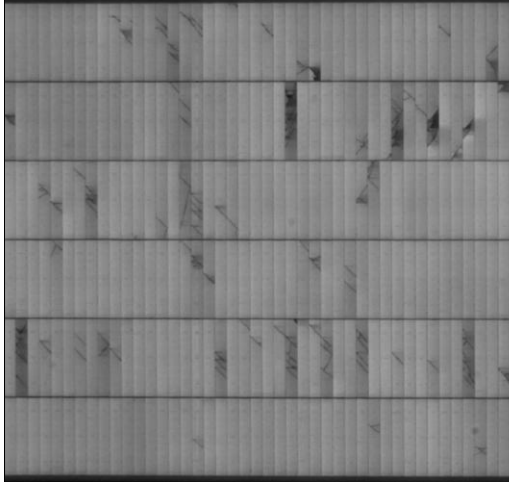
Typical EL picture of cell cracks caused by a heavy homogeneous mechanical load (X-crack pattern) also without glass breakage [Köntges14].	Cell cracks in a module with shingled solar cells [By the courtesy of Aerial Inspection].	
Severity

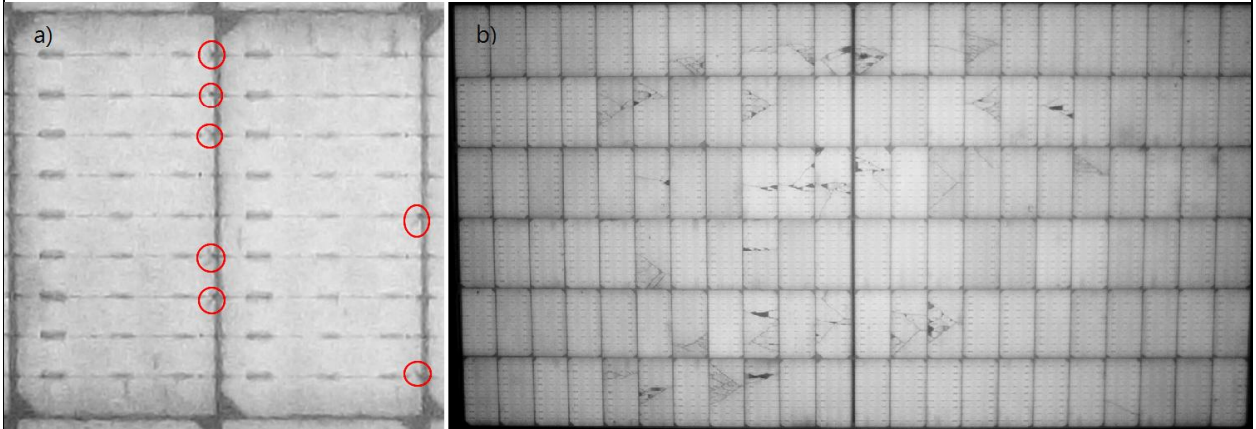
Manufacturer related cell cracks (a) in half cut cells and they grew into larger ones after transportation with inactive cell areas below 5% per cell (B) [Köntges24] .

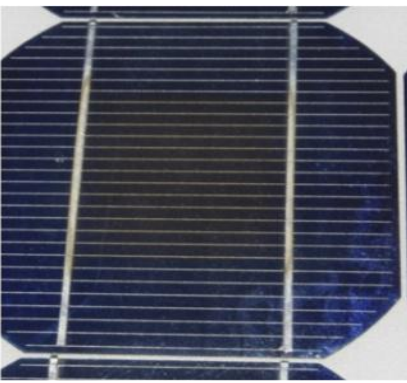
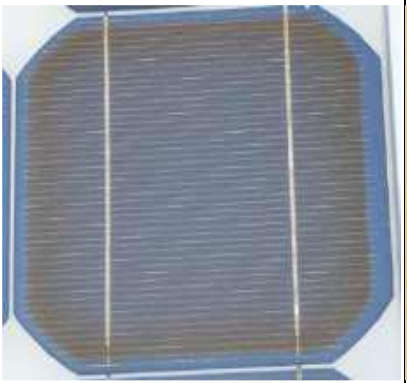
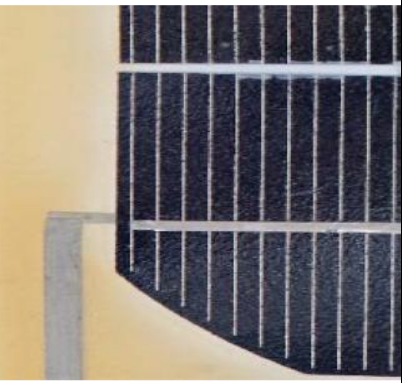
Slightly browned EVA in the centre of the cell with photobleaching at the edges [Köntges14].	Slightly browned EVA in the centre of the cell with photobleaching at the edges [India18].	Yellowed backsheet from the inside [Sinclair17].
Severity

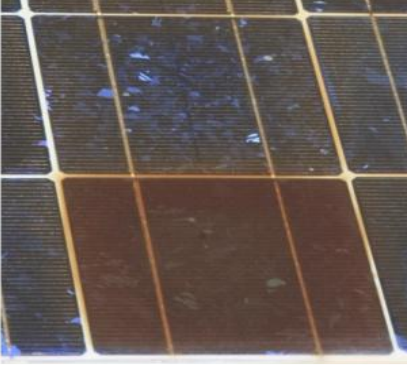
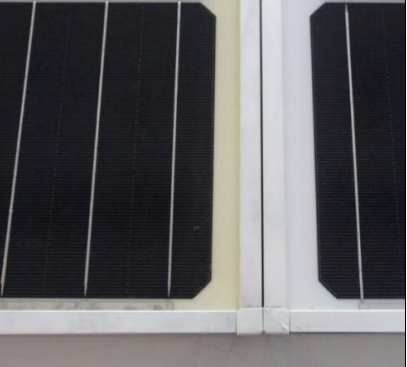
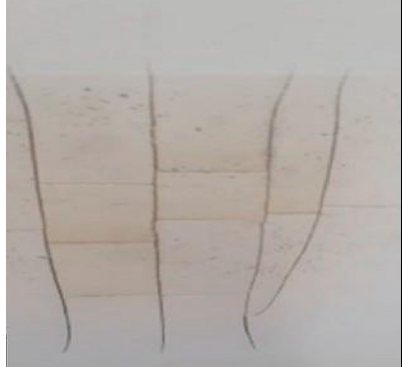
Single cell browned much faster than the others due to local heating [Köntges14].	Yellowed backsheet from the inside [By the courtesy of PCLL].	Yellowing of the backsheet in combination with cracked backsheets caused by hot cell [Eder19].
Severity

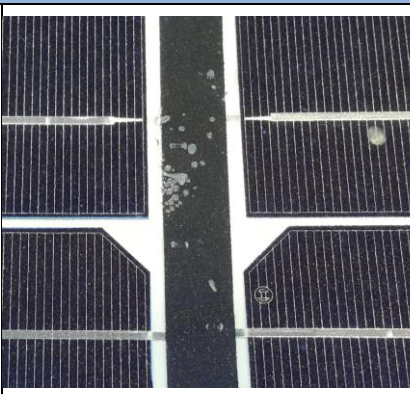
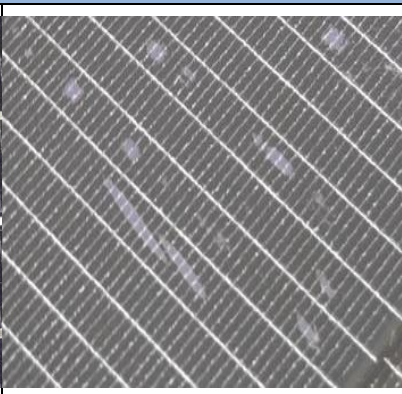
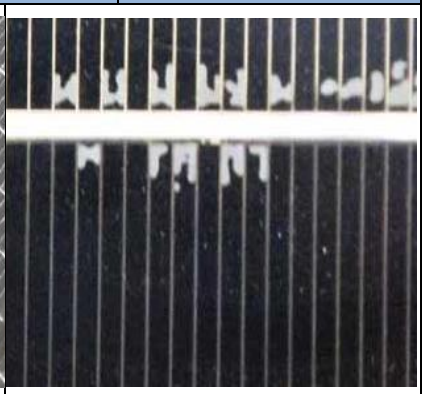
<p>Encapsulant delamination in un-critical position [By the courtesy of SUPSI PVLab].</p>	<p>Encapsulant delamination from cell caused by production process [By the courtesy of SUPSI PVLab].</p>	<p>Encapsulant delamination from cell along grid fingers and bus bar [Packard12].</p>			
<p>Severity</p>

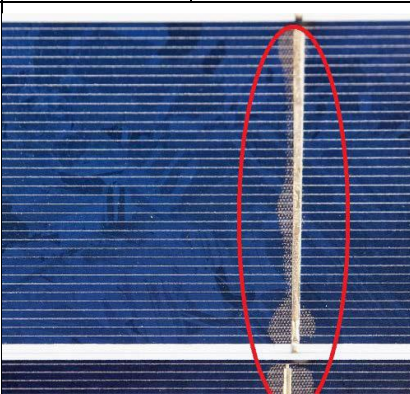
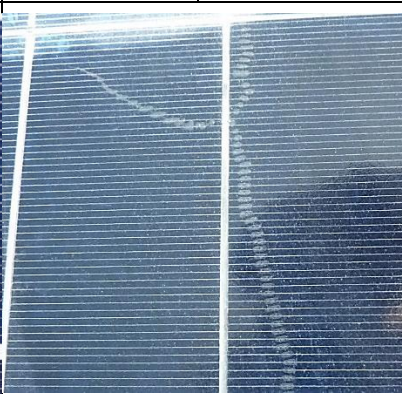
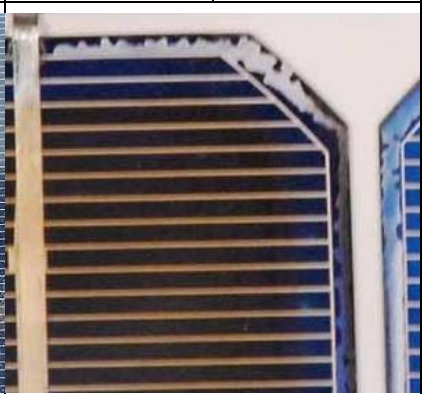
<p>Encapsulant delamination from glass (spotted due to glass texture) along the bus bars [Packard12].</p>	<p>Encapsulant delamination along a cell crack [Köntges16]. (see also PVFS 1-1)</p>	<p>Encapsulant delamination near cell edges in combination with cell browning [Packard12].</p>			
<p>Severity</p>

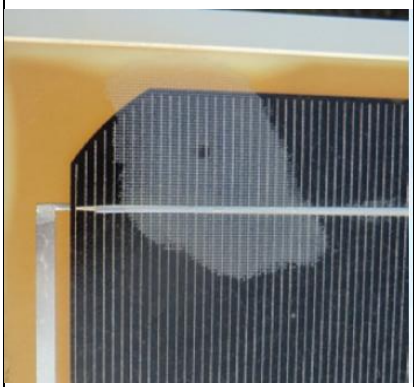
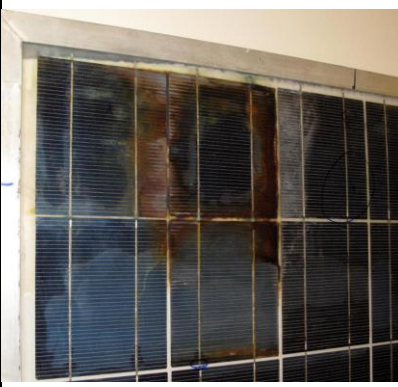
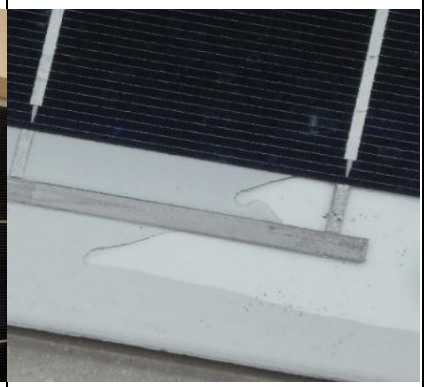
<p>Delamination creating a continuous path between electric circuit and the edge [Moser17].</p>	<p>Delamination with corrosion [Köntges17]. (see also FS1-11)</p>	<p>Delamination caused by detachment of backsheet with exposure of encapsulant from the back [By the courtesy of SUPSI PVLab].</p>
<p>Severity</p>

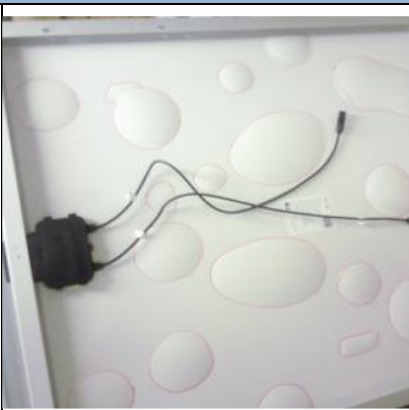
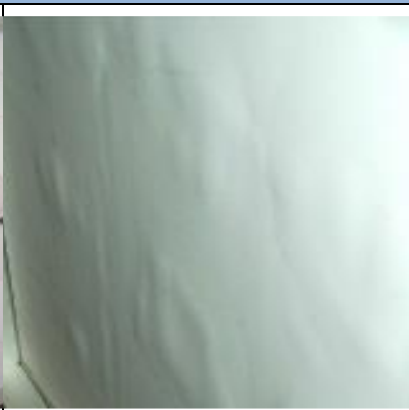
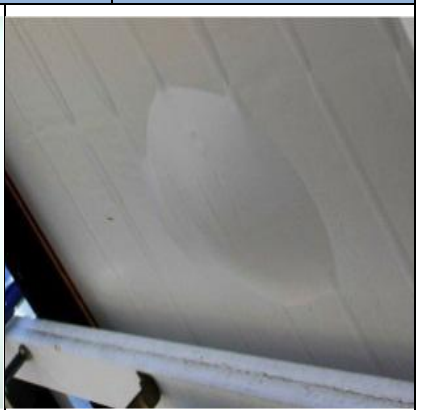
<p>Multiple bubbles in the centre and edge of the backsheet [Köntges16].</p>	<p>Blisters because of vapour barrier, such as aluminium foil [Köntges17].</p>	<p>Big central bubble + wavy delamination [Köntges14].</p>			
<p>Severity</p>						
<p>Examples 4-5</p>

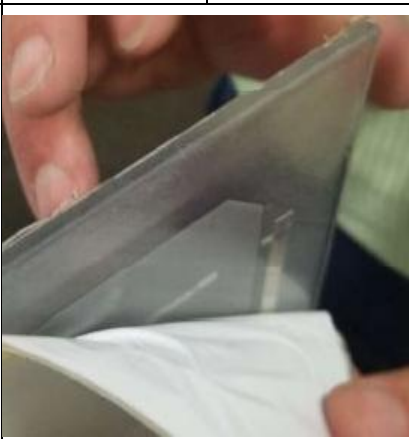
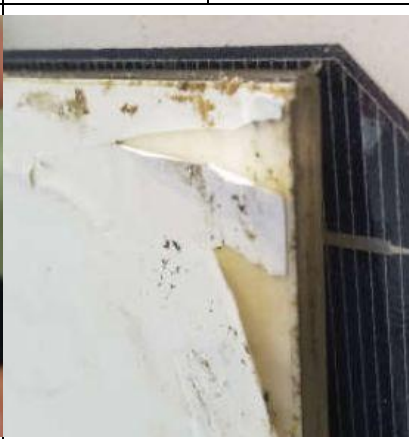
<p>Backsheet delamination with direct exposure of encapsulant [By the courtesy of SUPSI PVLab].</p>	<p>Delamination of top layer without exposure of encapsulant [By the courtesy of SUPSI PVLab].</p>				
<p>Severity</p>

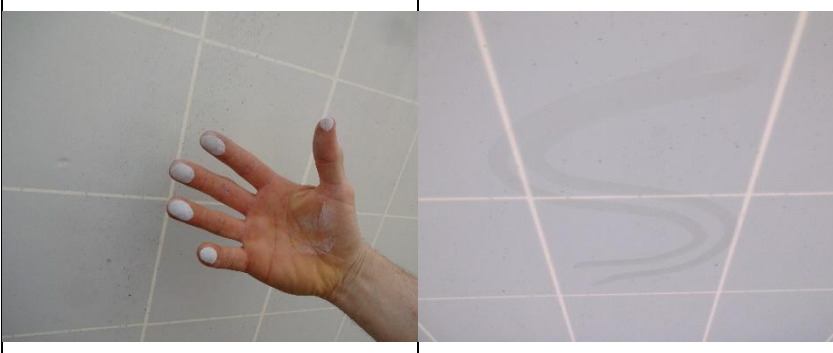
<p>Finger with white powder [By the courtesy of TUV Rheinland].</p>	<p>Fingerprint on a module with chalking [By the courtesy of TUV Rheinland].</p>				
<p>Severity</p>

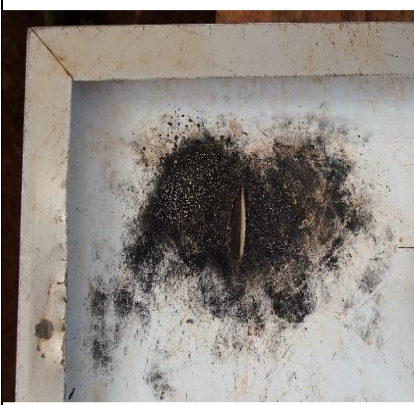
Burn mark at the backsheet with cracked backsheet [Sinclair17].

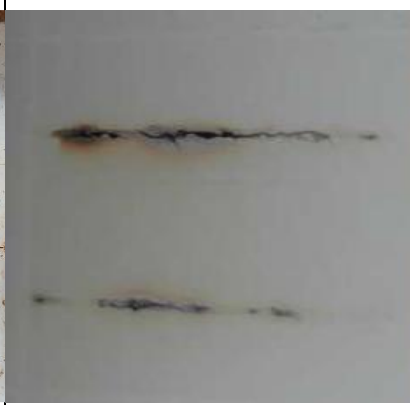
Burn marks at the backsheet due to heating along a busbar [Köntges14].

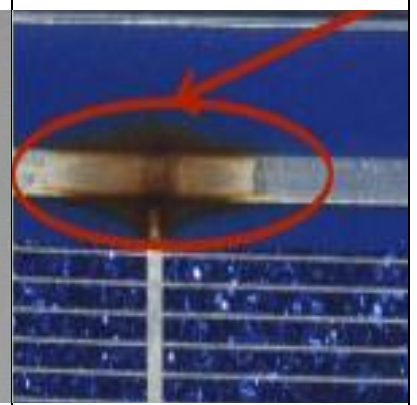
Burn mark associated with overheating along the metallic interconnection (without back-sheet damage) [Köntges14].

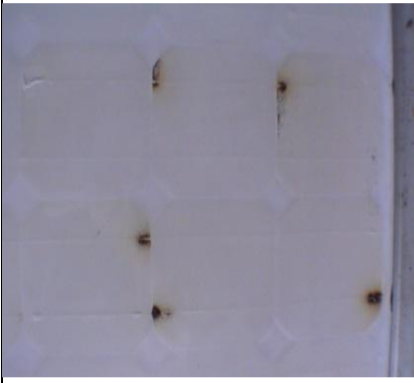
Front and back side view of burn marks caused by open-circuited bypass diodes and current mismatch conditions (due to shading or cracked cells) [Köntges14].

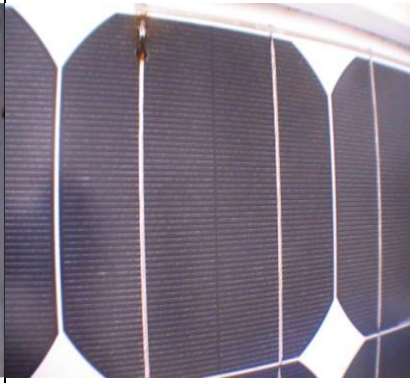
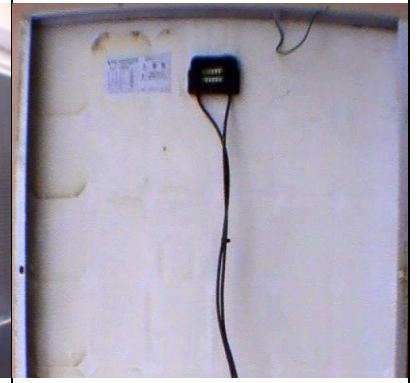
Burn marks caused by defect bypass diodes or an interconnect failure in the junction box [Köntges14].

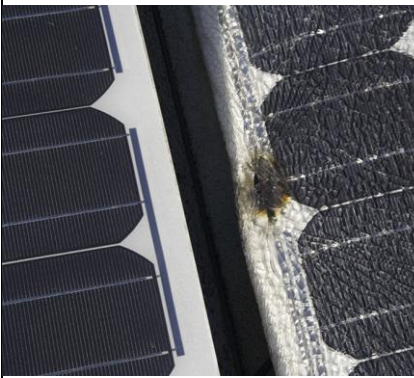
Burn mark with broken glass caused by poor bussing ribbon soldering [Yang19]. (see also PVFS 1-8 and PVFS 1-8)

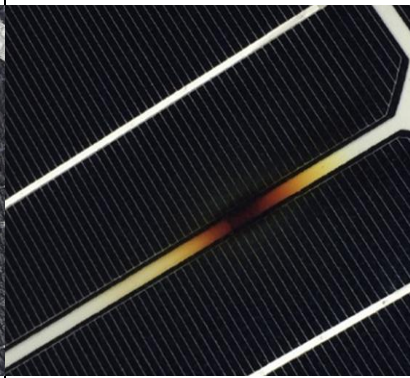
Burn mark due to intrinsic shunting caused by error in manufacturing process [Yang19].

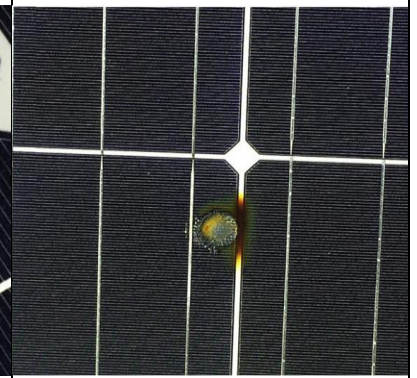
Burn mark due to intrinsic shunting caused by error in manufacturing process [Yang19].

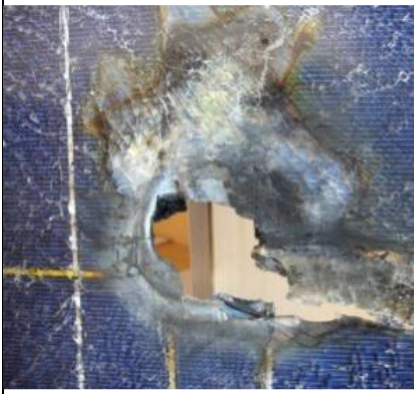
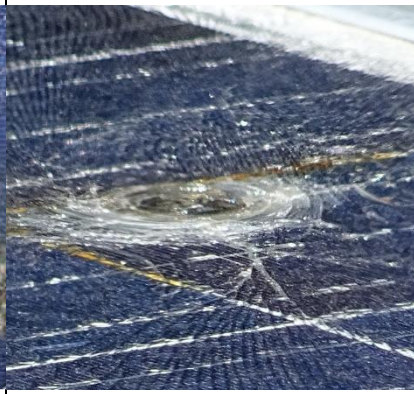
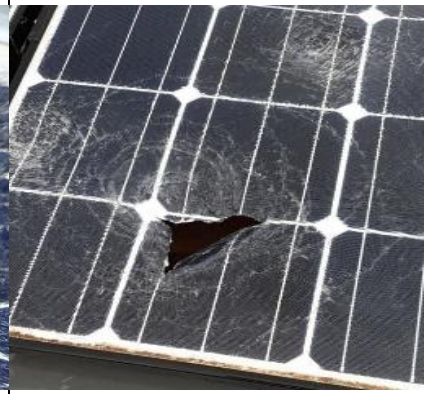
Direct lightning stroke [Köntges16].

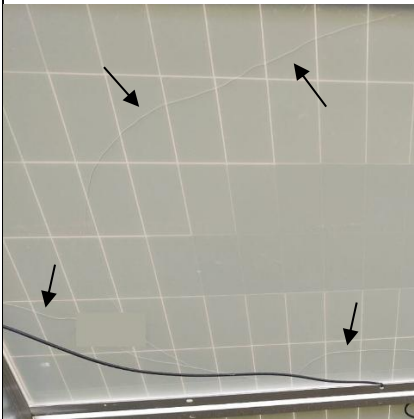
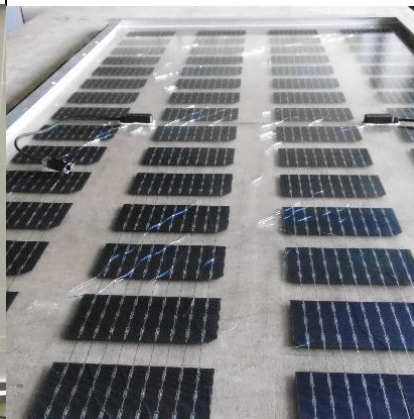
Broken thin (≤ 2 mm) rear glass. Long (many dcm) crack lines without splitting the crack with no clear crack start.

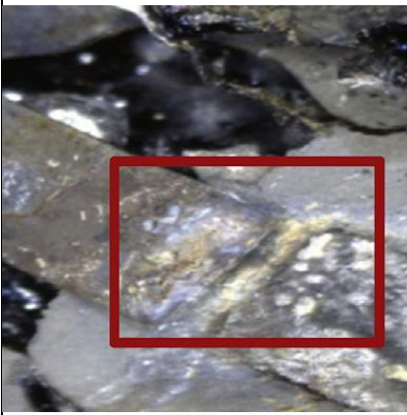
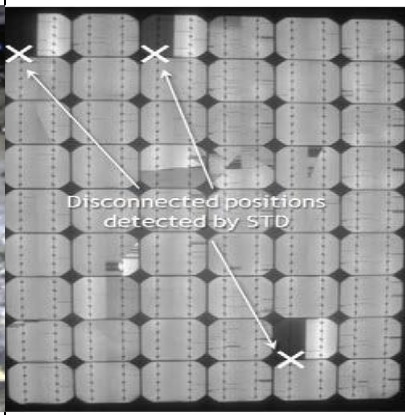
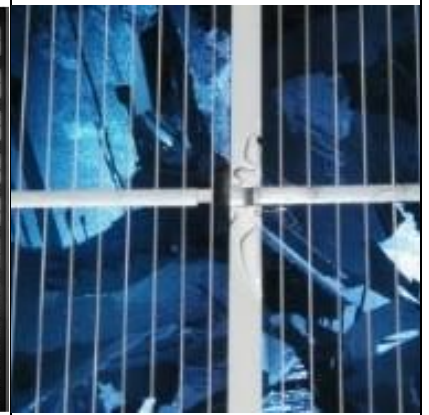
Zoom of a broken cell interconnect [Yang19].

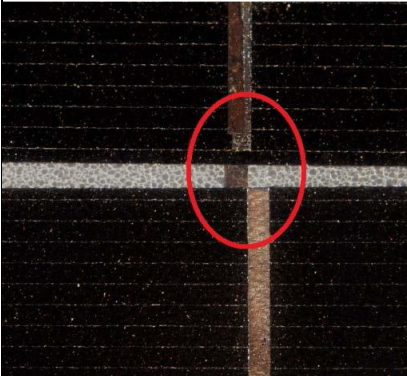
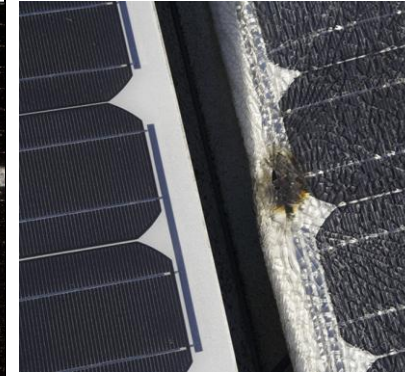
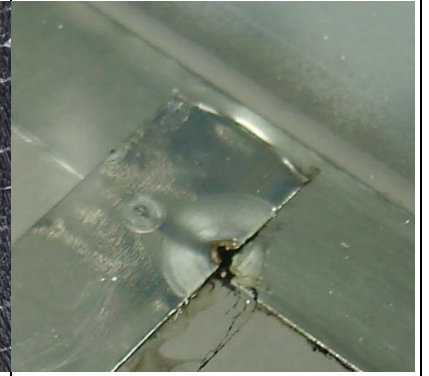
Dislocation of interconnection ribbon [Sinclair17].

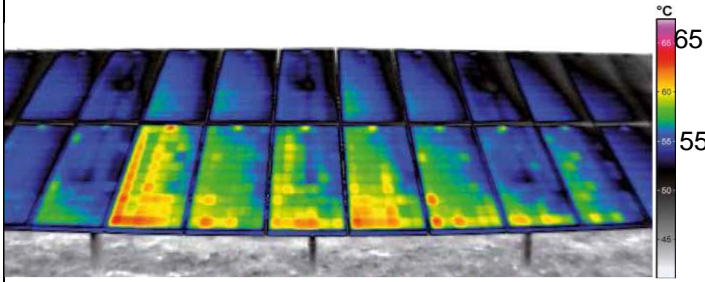
Strings with PID-s, detected with IR thermography [Köntges14].

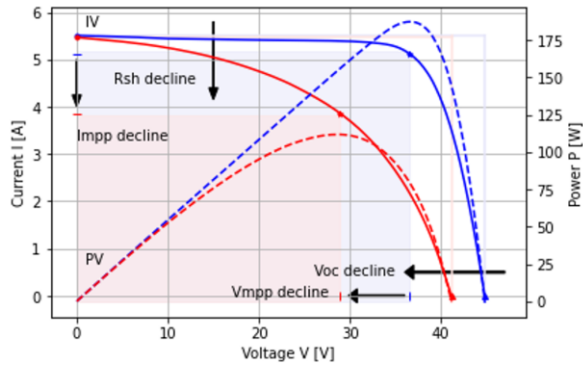
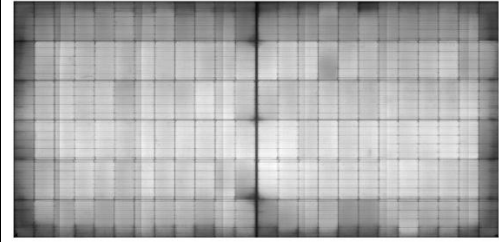
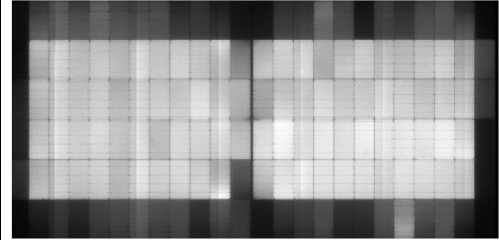
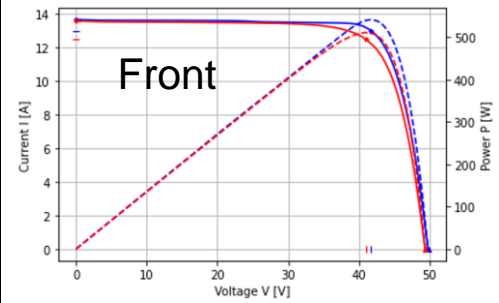
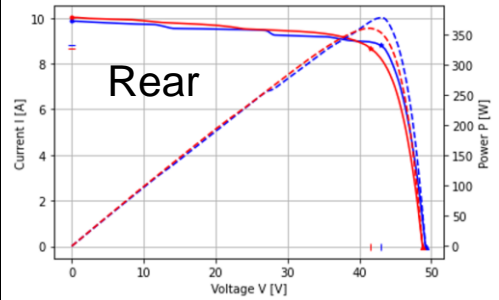
PID-s affected Al BSF module EL imaged at I_{sc} and $0.1 I_{sc}$ shows chessboard pattern degradation, more visible at the lower bias current. STC IV curve shows decreased shunt resistance, FF and V_{oc} [Mahmood2024].

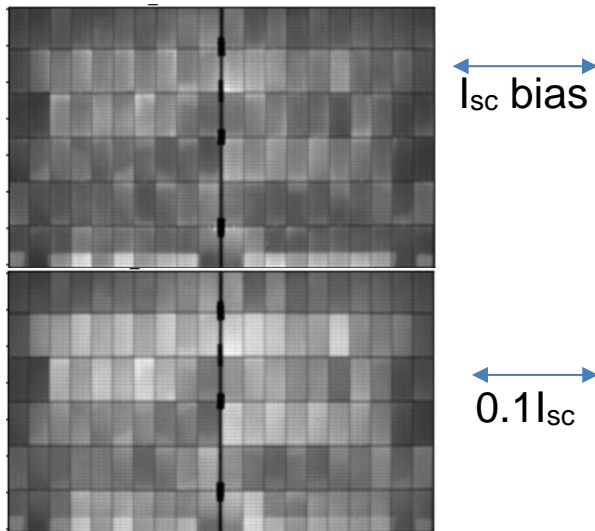
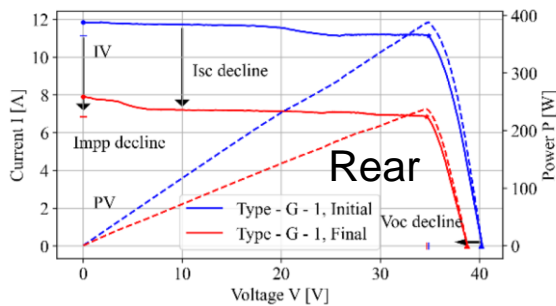
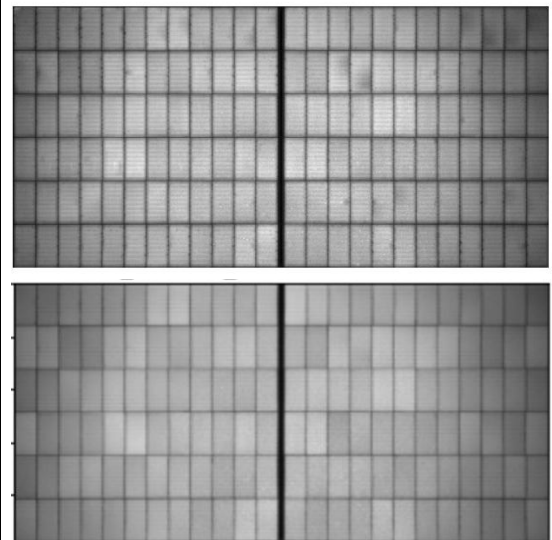
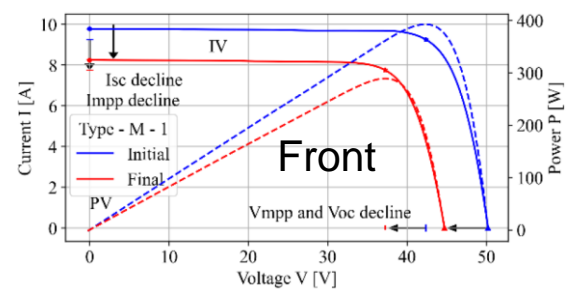
PID-p affected p-type PERC bifacial module EL imaged at I_{sc} and $0.1 I_{sc}$ shows a decrease in minority carrier lifetime and luminescence. Rear side STC IV shows significant decrease of I_{sc} , and moderate decrease of V_{oc} . No noticeable decrease in shunt resistance [Mahmood2024].

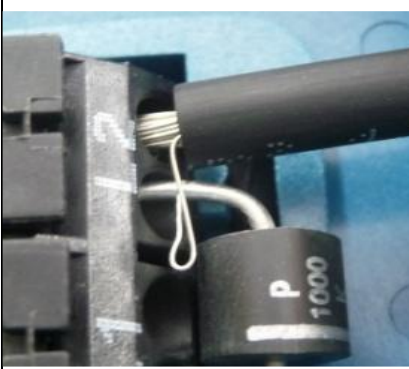
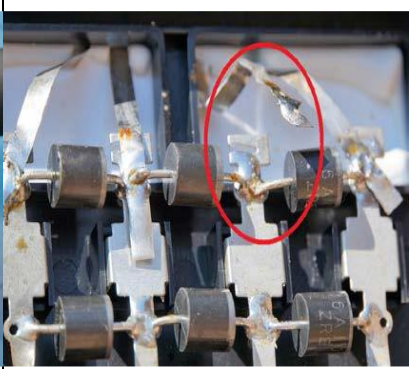
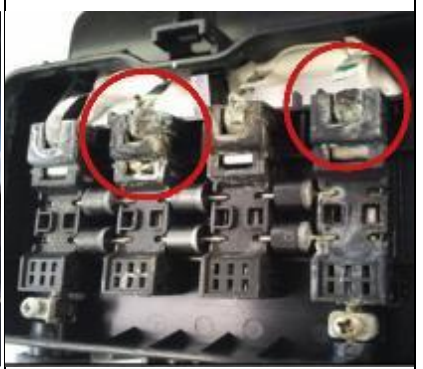
<p>Junction box with poor wiring [Köntges14].</p>	<p>Detached tabbing ribbon due to bad soldering [Köntges14].</p>	<p>Corrosion failure due to water soaking of the IP65 rated Jbox [Yang19].</p>	
<p>Severity</p>

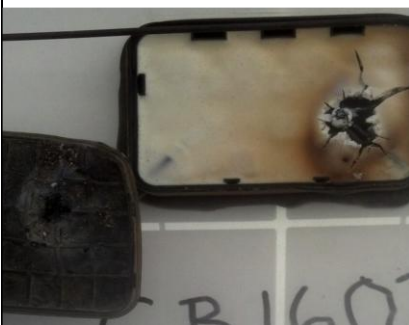
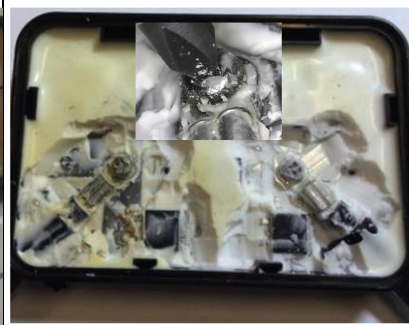
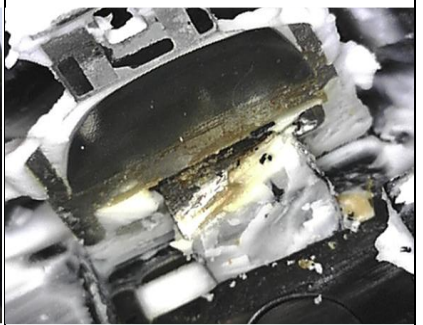
<p>Jbox failure due to poor electric connection [Yang19].</p>	<p>Evidence of loose screw connection inside Jbox with browning of pottant [Yang19].</p>	<p>Cold soldering of module bus-ribbon to the Jbox connection terminal pad with minor browning of pottant [Yang19].</p>	
<p>Severity</p>

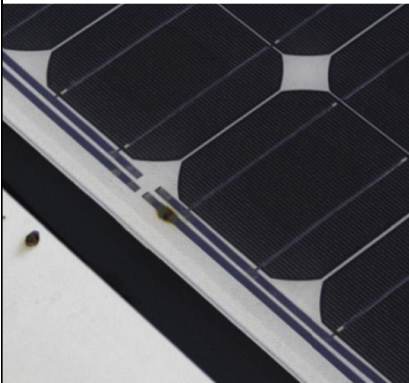
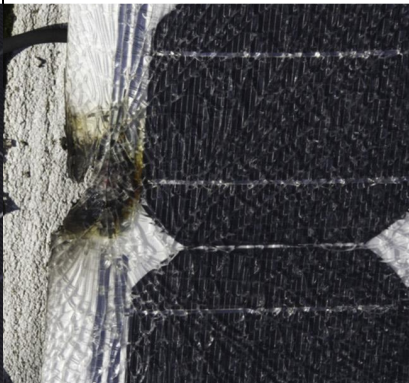
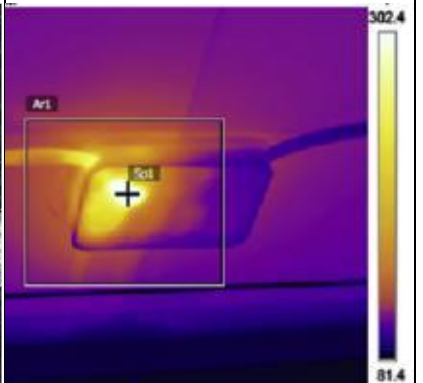
<p>Overheating due to the poor Jbox interconnect leading to light discoloration and burn mark on front and back side [Yang19].</p>	<p>Overheating due to the poor Jbox interconnect leading to burn mark and glass breakage [Yang19].</p>	<p>IR imaging of a hotspot Jbox due to loose electric connection inside [Yang19].</p>

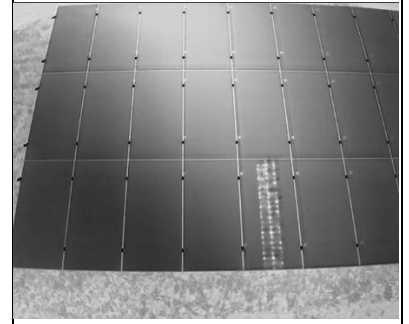
A cold solder joint after the diode in any junction box (either outer or inner) [Köntges25] can result in a safety failure that is undetectable by IRT. The not connected bypass diode is visible with night EL inspection while applying string wise reverse voltage with 3%-5% of rated I_{sc} [by courtesy of Ternus & Diehl GbR].

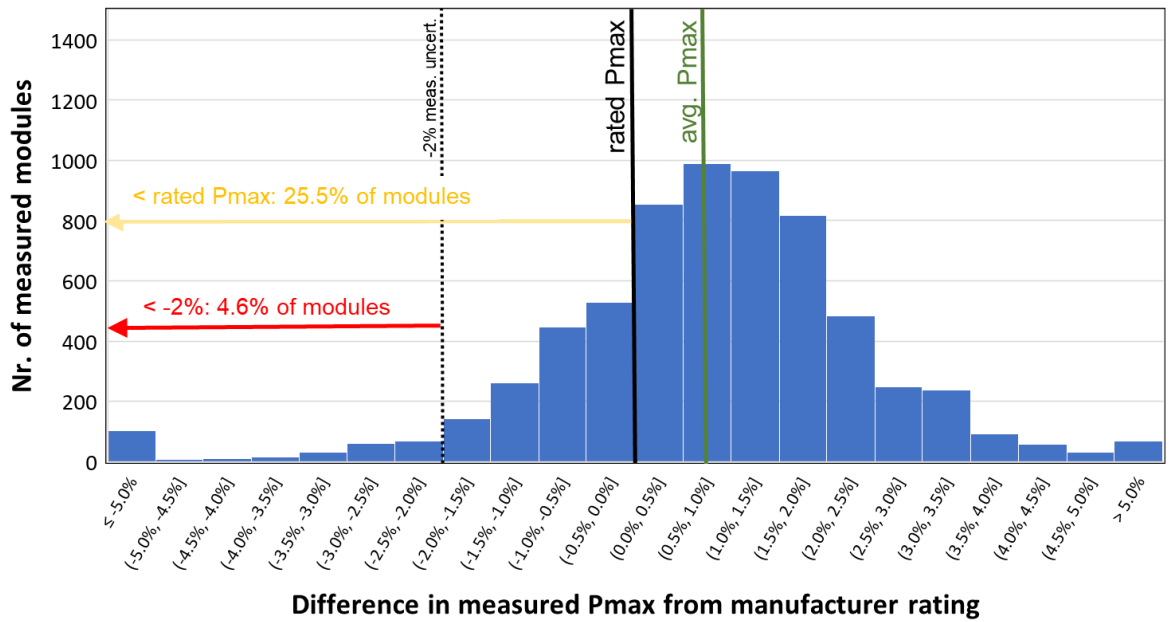
Statistical analysis done by Eternalsun on around 6500 new modules with 96 different PV module types from 29 different manufacturers. [Herrmann21] Considering the measurement uncertainty of +/-2% a total of 4.6% of the modules are below the gate 1 limit defined by the IEC 61215 standard [IEC 61215-1:2021].

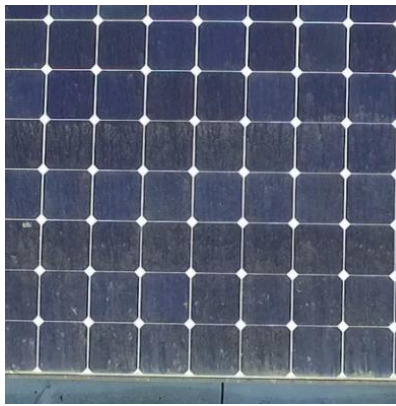
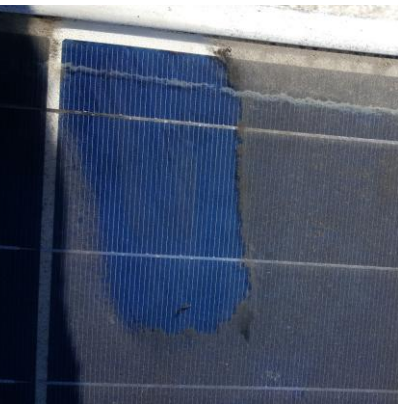
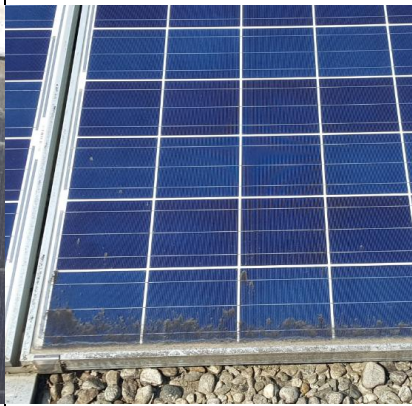
Uniform light soiling, which in ideal conditions is self-cleaning when raining [By the courtesy of SUPSI PVLab].

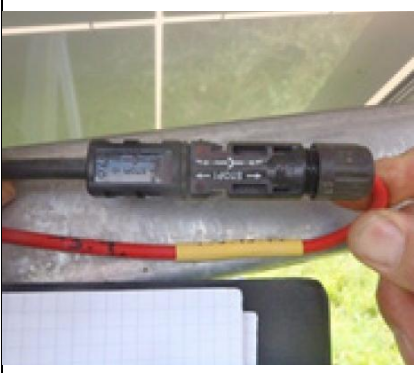
<p>Severity</p>	 	 	 	 	
<p>Examples 3-5</p>	 	 	 		
<p>Severity</p>	 	 	 	 	 
<p>Examples 6-7</p>	 	 	<p>Different types of connectors recognisable by different 'O' rings or logos [ESV guide].</p>		
<p>Severity</p>

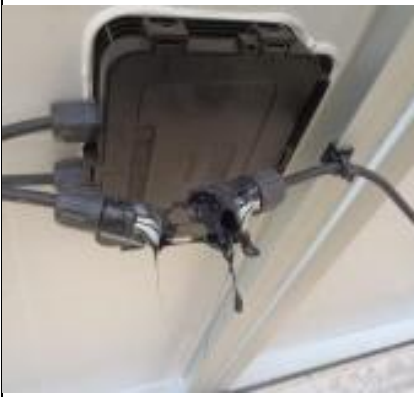
Burned connector [Köntges17].

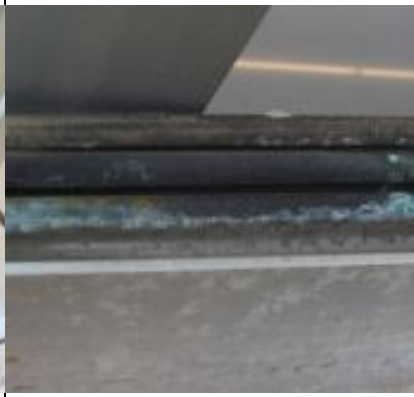
Corroded Cable [Köntges17].

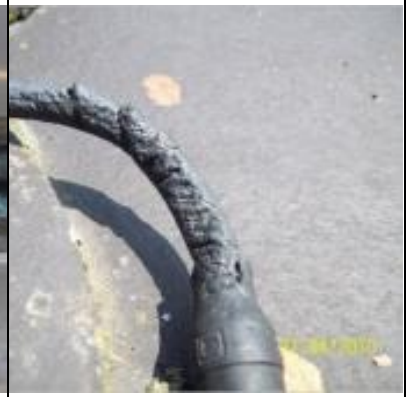
Animal bite on cable [Köntges17].

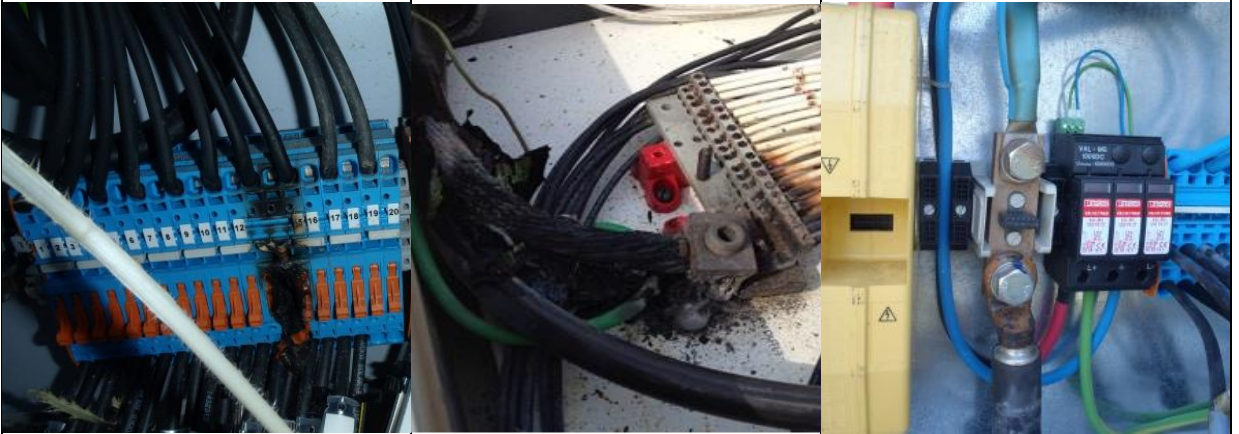
Burned terminal block of the combiner box [TUV Rheinland].

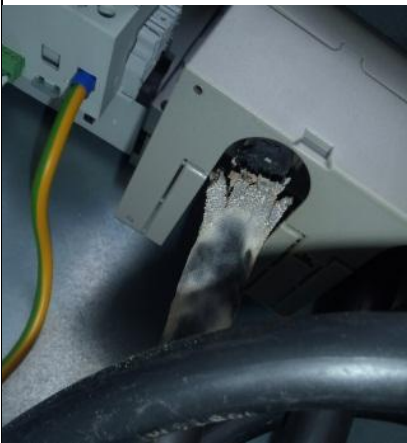
Connecting terminals show signs of burning, have melted or charred [TUV Rheinland].

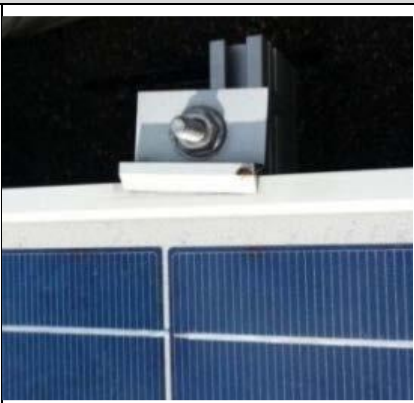
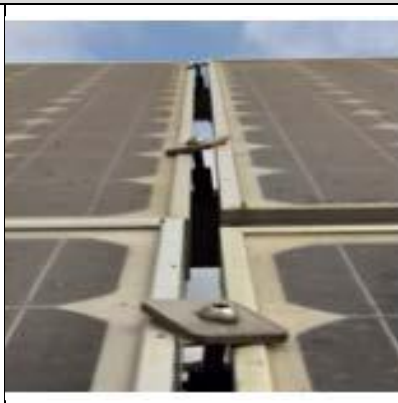
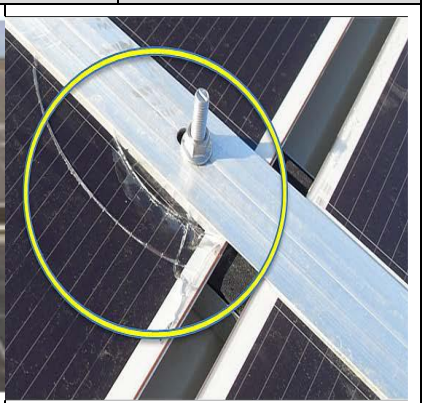
<p>Improper installation of clamp [By courtesy of SUPSI PVLab].</p>	<p>Wrong combination of clamps and modules [Moser17].</p>	<p>Glass breakage caused by too tight screws [Herrmann21]. (see also PVFS 1-8)</p>			
<p>Severity</p>

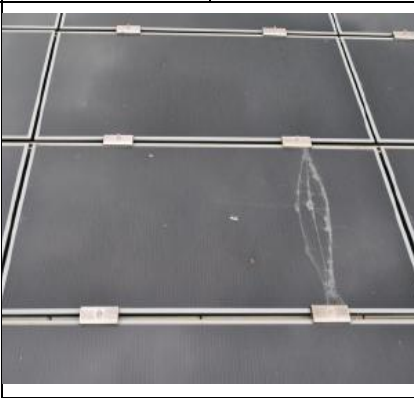
<p>Glass breakage caused by poor clamp design [Moser17]. (see also PVFS 1-8)</p>					
<p>Severity</p>

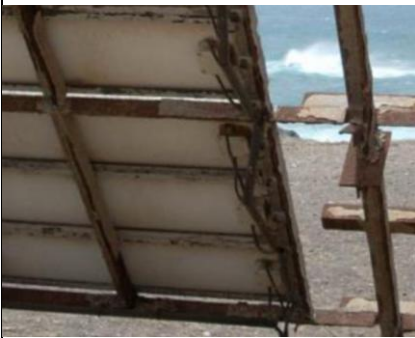
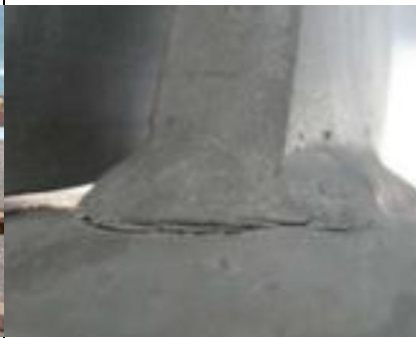
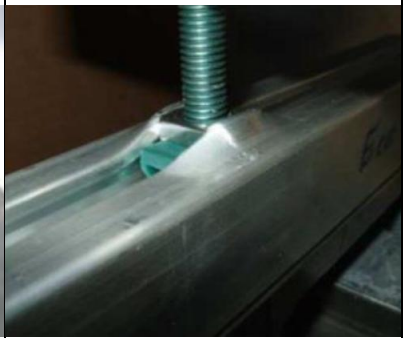
<p>Corrosion due to salt water [Köntges16].</p>	<p>Cracks in mounting structure due to mechanical stress [Köntges16].</p>	<p>Screw canal bends due to mechanical stress [Köntges16].</p>			
<p>Severity</p>

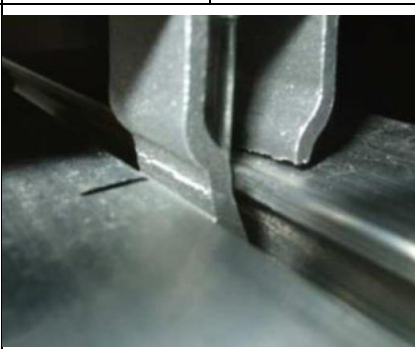
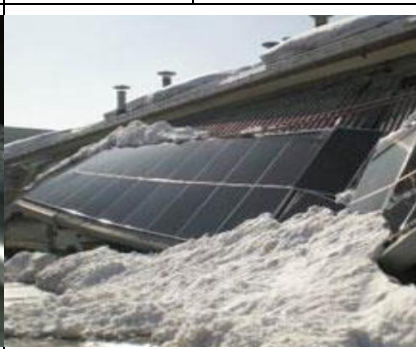
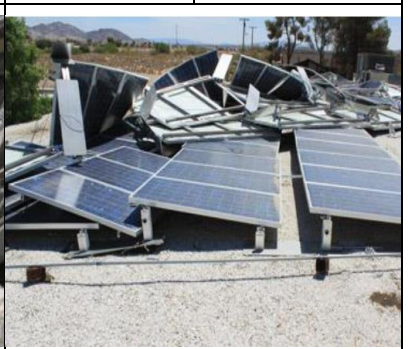
<p>Bracket fractured due to mechanical stress [Köntges16].</p>	<p>Undersized mounting structure for local snow load conditions [Köntges16].</p>	<p>Undersized mounting structure for local wind conditions [India13].</p>			
<p>Severity</p>

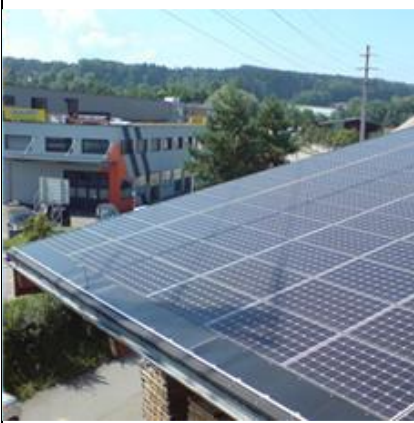
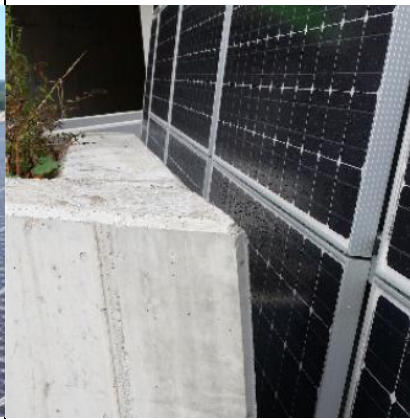
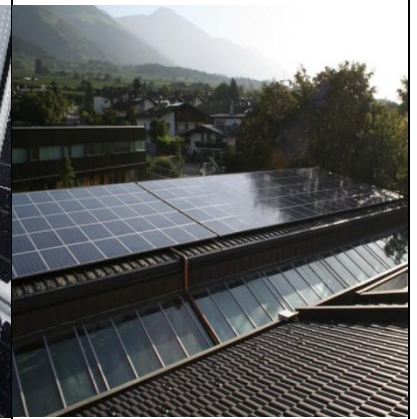
Shading by pole-and-wire (poor design: too close to nearby shading objects) [Jahn18].

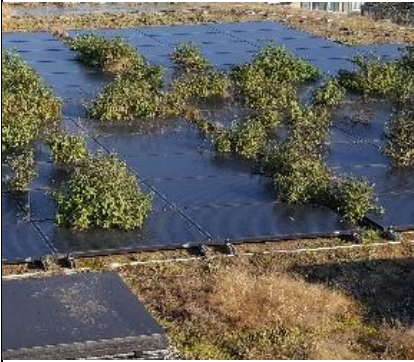
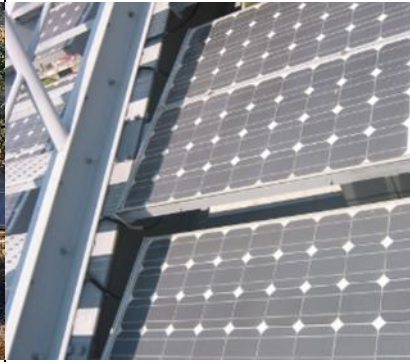
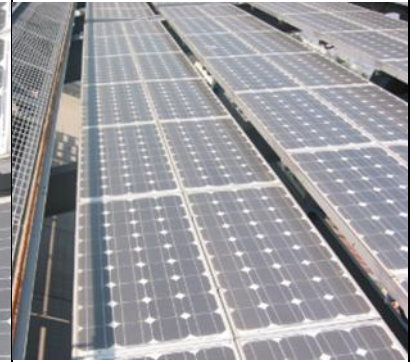
Missing maintenance on flat green roof [By courtesy of SUPSI PVLab].

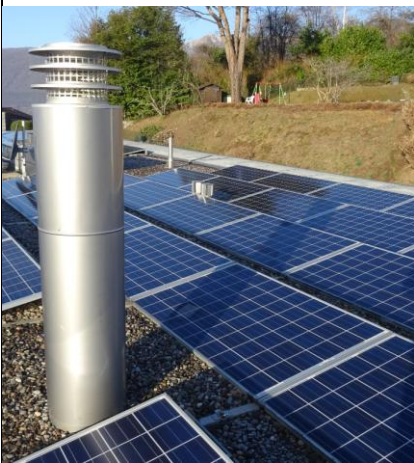
Continuous shading caused by chimney [By courtesy of SUPSI PVLab].

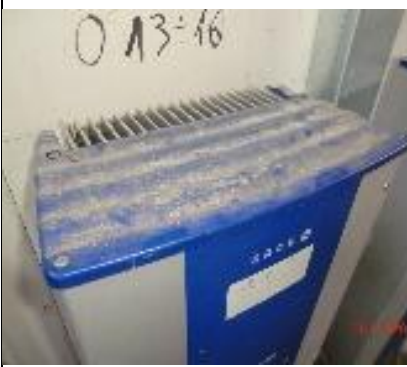
Dust blocking heat dissipation [By courtesy of TUV Rheinland].

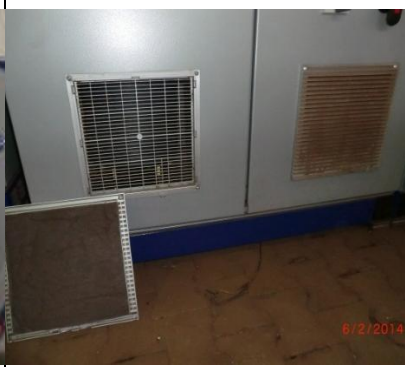
A soiled air filter causes over-heating [By courtesy of TUV Rheinland].

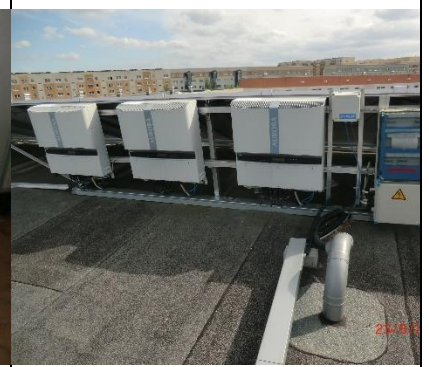
Installation not appropriate (direct exposition to sun) [By courtesy of TUV Rheinland].

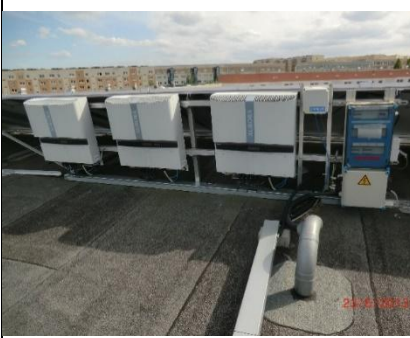
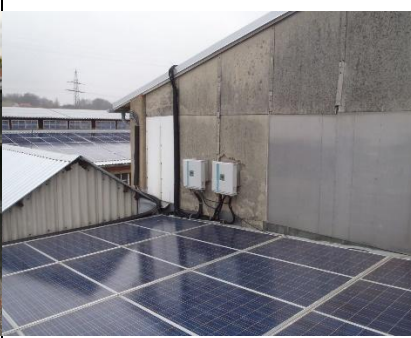
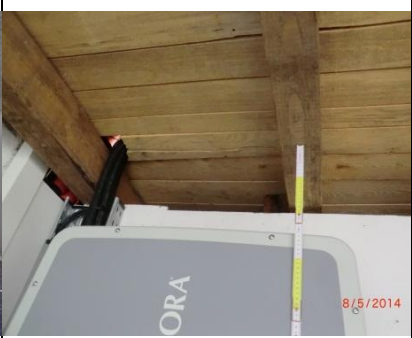
<p>Installation in direct sun light [By courtesy of TUV Rheinland].</p>		<p>Inverters are not or difficult accessible for operation and maintenance [By courtesy of TUV Rheinland].</p>		<p>Distance to bottom, top or to the sides too low [By courtesy of TUV Rheinland].</p>	
<p>Severity</p>

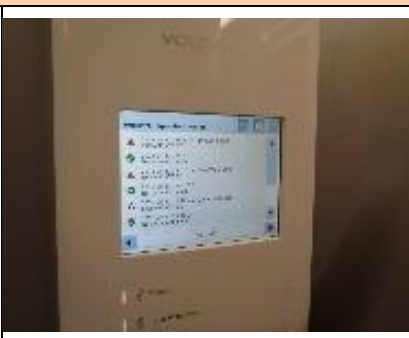
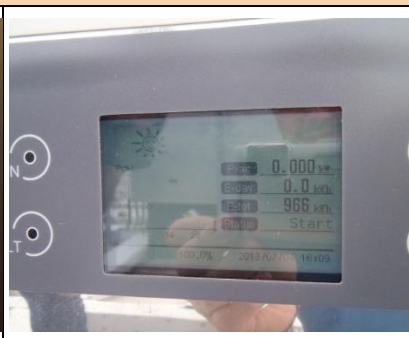
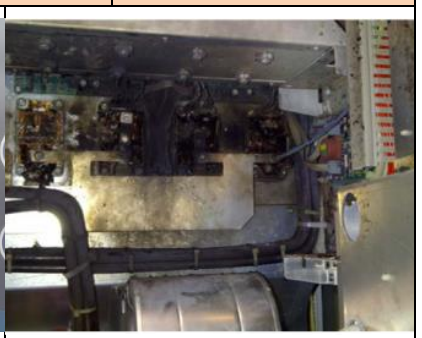
<p>Insulation failure [TUV Rheinland]</p>	<p>Not operating inverter [TUV Rheinland].</p>	<p>Damaged hardware component [Sinclair17].</p>			
<p>Severity</p>

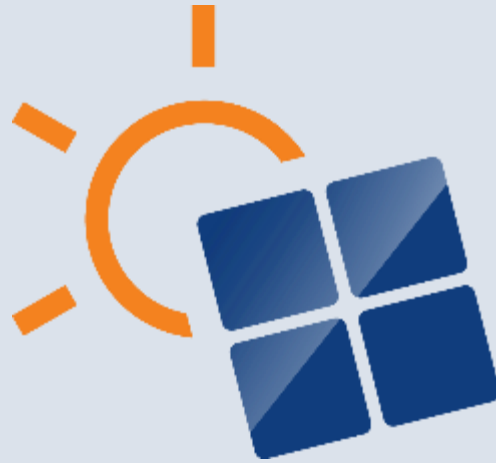
ISBN 978-3-907281-71-0
