# How to deal with cold solder joints in JB of current module designs

Marc Köntges ISFH, Jay Lin PV Guider

DTU, Roskilde, DK, 29th – 30th April 25

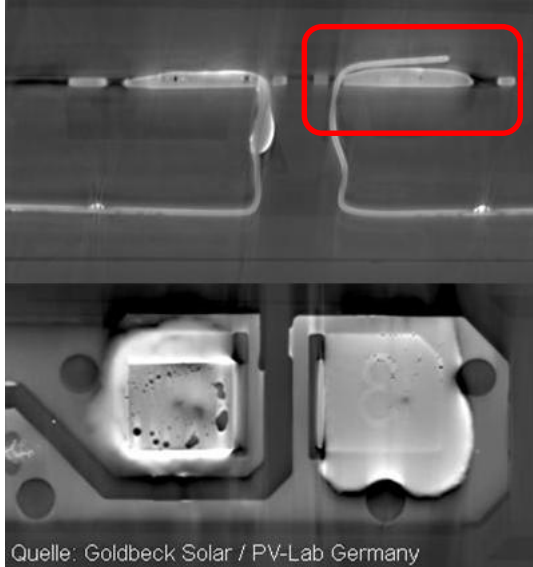
Short ribbon is stiffer  
and easy to rebound

- Press time for soldering must be adjusted properly
- Inspection of solder joint required

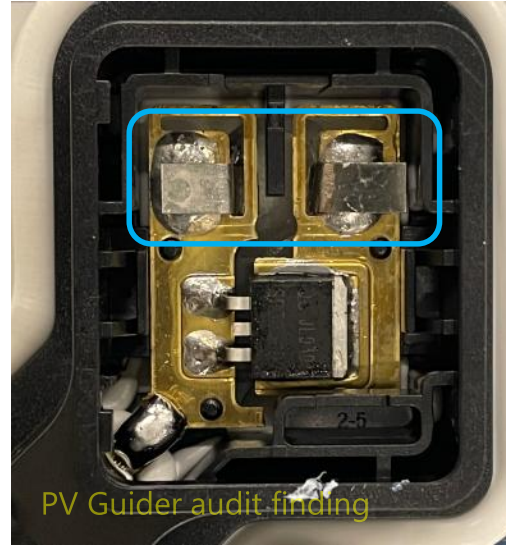
PV Guider audit finding

- High precision required for ribbon length and positioning

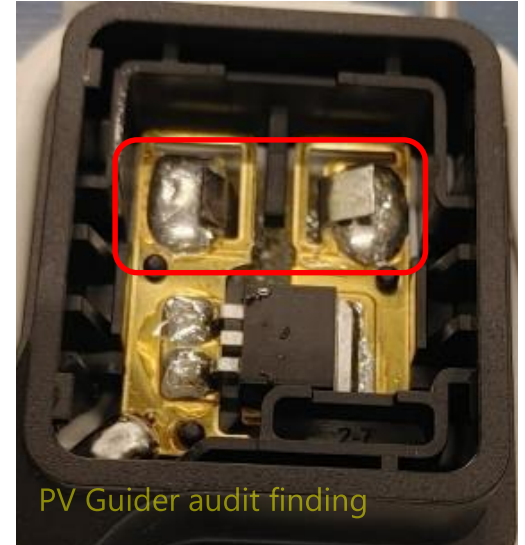
Ribbons too short

PV Guider audit finding

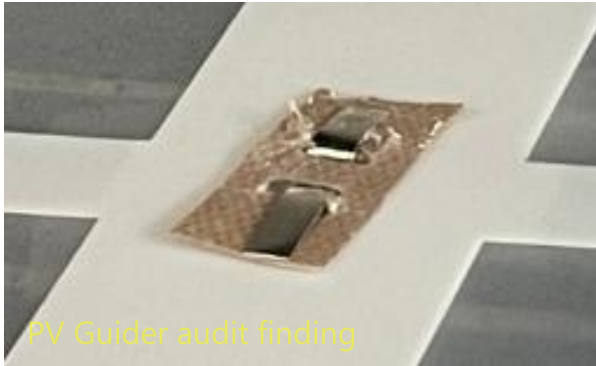
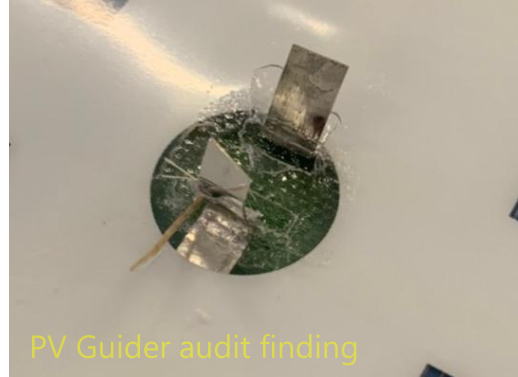
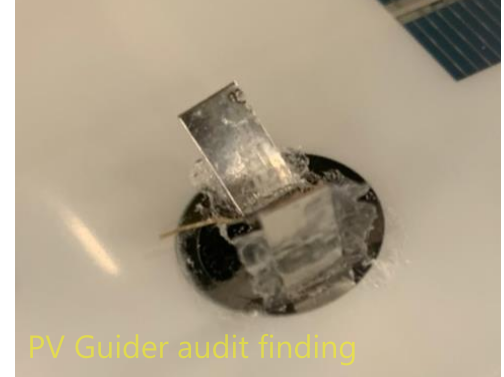
Short ribbon is easy to be covered by overflowed EVA

It's very difficult to remove the EVA.  
**And no one do it in the production !**

- Require stable proces without lamination material on ribbon

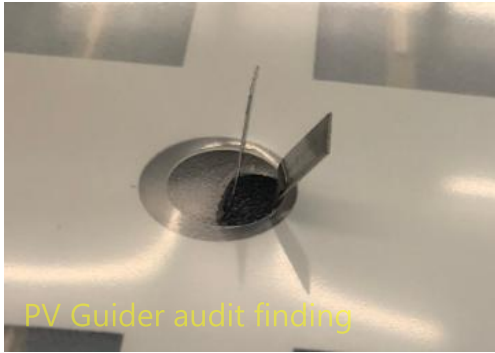
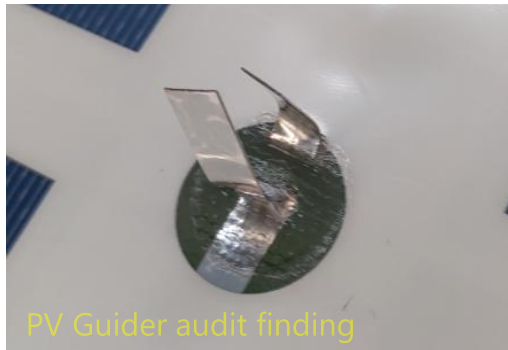
Layup dislocation makes  
one ribbon too short

- High precision required for layup positioning

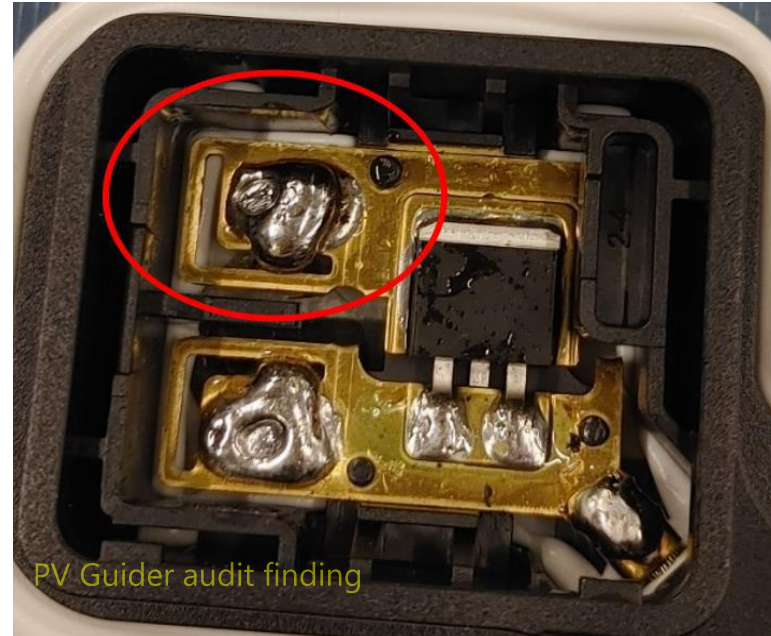
One ribbon is too short

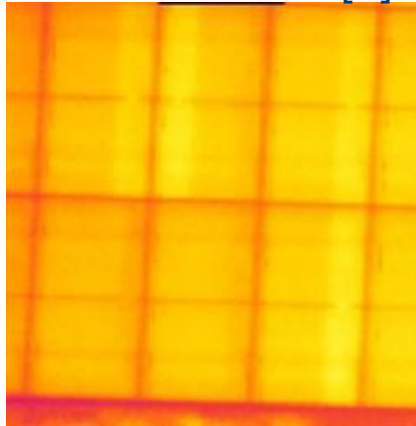
Failure mode B [1]

- Use standard TG inspection
  - Homogenous slightly hotter substrings together with hot junction box → failure mode B
  - Full string is not active in TG inspection → failure mode C
- Visual inspection needed

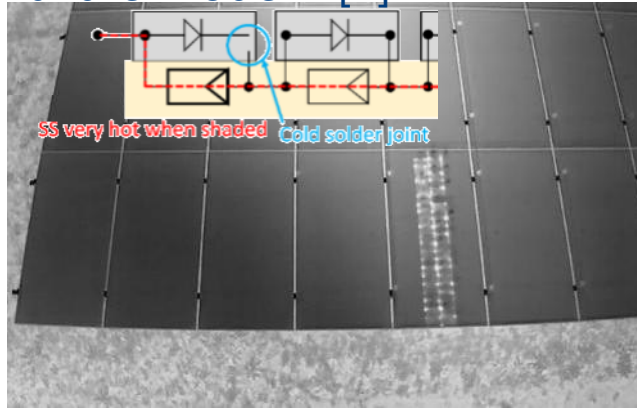
## Failure mode A [1]

- Failure mode A
- Reverse current of 3-5% of  $I_{sc}$  in the night applied to module strings, you should get  $\ll 50$  V
- Across a cell string without BYD a voltage of  $15...25$  V x  $20...24$  (cells) =  $300...600$  V drops
- Search for heated strings with thermographic camera in the night
- Up to two open circuit bypass diodes per string are detectable with a 1000 V power source
