Introduction to PV Failure Fact Sheets (PVFS)

Gabi Friesen, Senior Researcher, SUPSI-PVLab

IEA PVPS Task 13 Focus Workshop/Webinar on Operation & Maintenance, Fraunhofer ISE, 30 September 2021

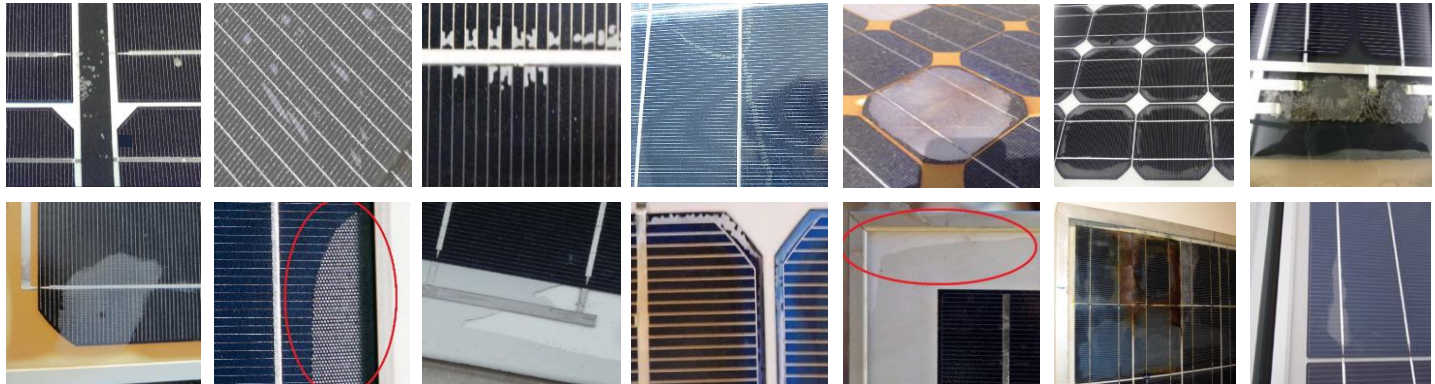
Component	Module	PVFS
Defect	Front delamination	1-3
Appearance	Any local separation of the layers between (i) the front glass and the encapsulant or (ii) the cell and the encapsulant, visible as bubbles or as bright, milky area/s. It may appear continuous or in spots. The position and size of the delamination or bubble depends on the origin and progress of the failure.

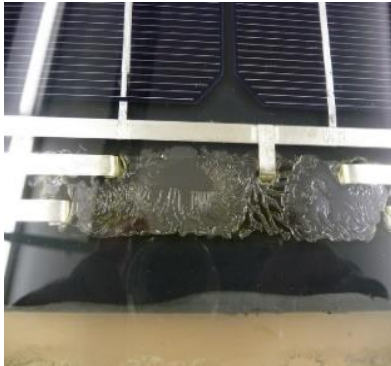
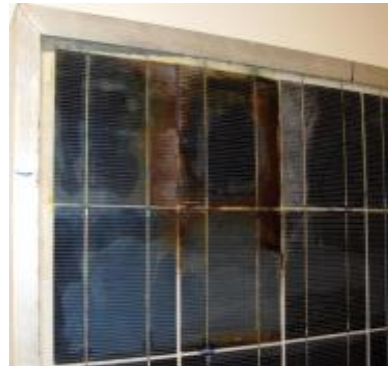
Component	Module	PVFS
Defect	Front delamination	1-3
Origin	The adhesion between the glass, encapsulant, active layers, and back layers can be compromised for many reasons. Typically, it is caused by the manufacturing process (e.g. poor cross linking of EVA, too short lamination times, too high pressure in the laminator, contaminations, improper cleaning of the glass, incompatibility of EVA with soldering flux, inadequate storage of the raw material) or environmental factors (e.g. thermal stresses, external mechanical stresses, UV). Delamination is generally followed by moisture ingress and corrosion . It is therefore more frequent and severe under hot and humid conditions.	
	Production <input checked="" type="checkbox"/>	Installation <input type="checkbox"/> Operation <input checked="" type="checkbox"/>
