## IEA-PVPS Task 13 Webinar - Enabling 2<sup>nd</sup> life photovoltaics

# Enabling 2<sup>nd</sup> life photovoltaics

## Development of a repair methodology for PV modules with damaged backsheets

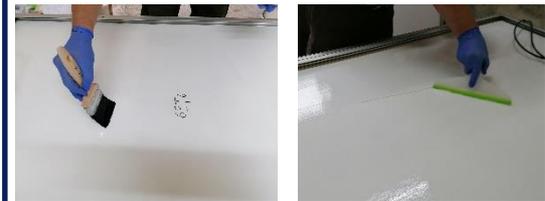
- + brush
- + spatula / wipper / squeegee
- + spray-coating

→ applicable in one or two-step (with solvent) process

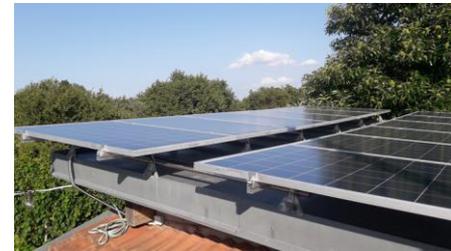
Test-case II : **Repair of damaged BSs (fully cracked) with restoration of electrical insulation properties** was performed on dismantled modules (insurance claim). Complete crack filling of full-cracked backsheets (longitudinal cracks) and permanent restoration of the electrical insulation properties was achieved. First promising results on the long-term behaviour of repair solutions with flowable silicone and polyurethane (2K) are obtained: the test-site with 12 repair-modules is in operation since summer 2021 (Vienna/Austria).

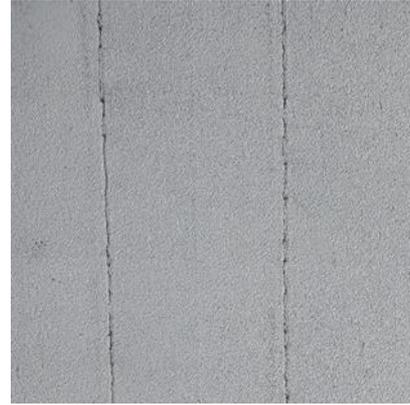
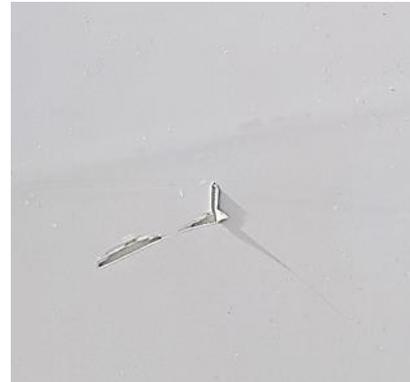
Repair strategies for refurbishment of PV modules with damaged BSs for different scenarios

- (preventive) restoration of insulation resistance of PV modules
- repair of defective BS (cracks)
- repair of mechanical damage due to transport or assembly
