“Soiling, Antireflective Coatings, Antisoiling Coatings, and Cleaning in Different Locations”

IEA PVPS Task 13 Autumn 2024 Workshop, “Adapting Solar PV Solutions for Climate and Applications”
Thursday, 2024/10/17 10:40-10:55 NREL, RSF X344 (San Juan) B and C, Golden CO

Soiling, cleaning, and abrasion: The results of the 5-year photovoltaic glass coating field study

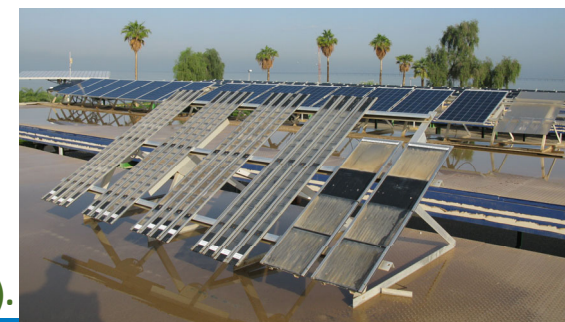
Field soiling experiment in Kuwait (this study).

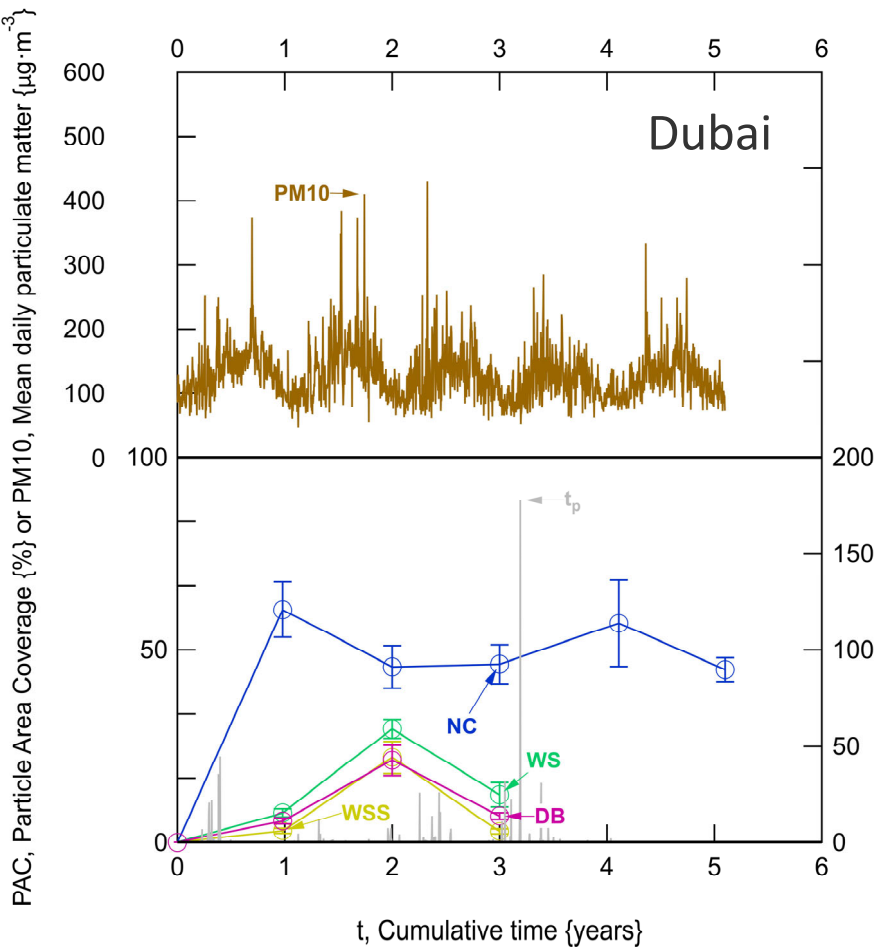
- Particle area coverage (% contamination) from ImageJ.
 - Coupon cleaning eventually limited by CoVID.
- **PM10**, precipitation from web meteorological resource.
- In depth examination of 5/10 “materials”.

- Cleaning can improve efficiency by 10’s of percent! (NC: PAC 60% vs. WS, DB, WSS: 10<PAC<30%).
- Level of contamination asymptotes according to cleaning method.
 - Cleaning more frequently than monthly warranted in Dubai (prevent cementation).
 - Erratic PAC with time in may reflect timing of sample collection (relative to natural cleaning.)

Data shown for all 4 cleaning methods for Dubai, AVG[B, D, G, J, U] coupons, when the history of cleaning was not affected by the CoVID pandemic.

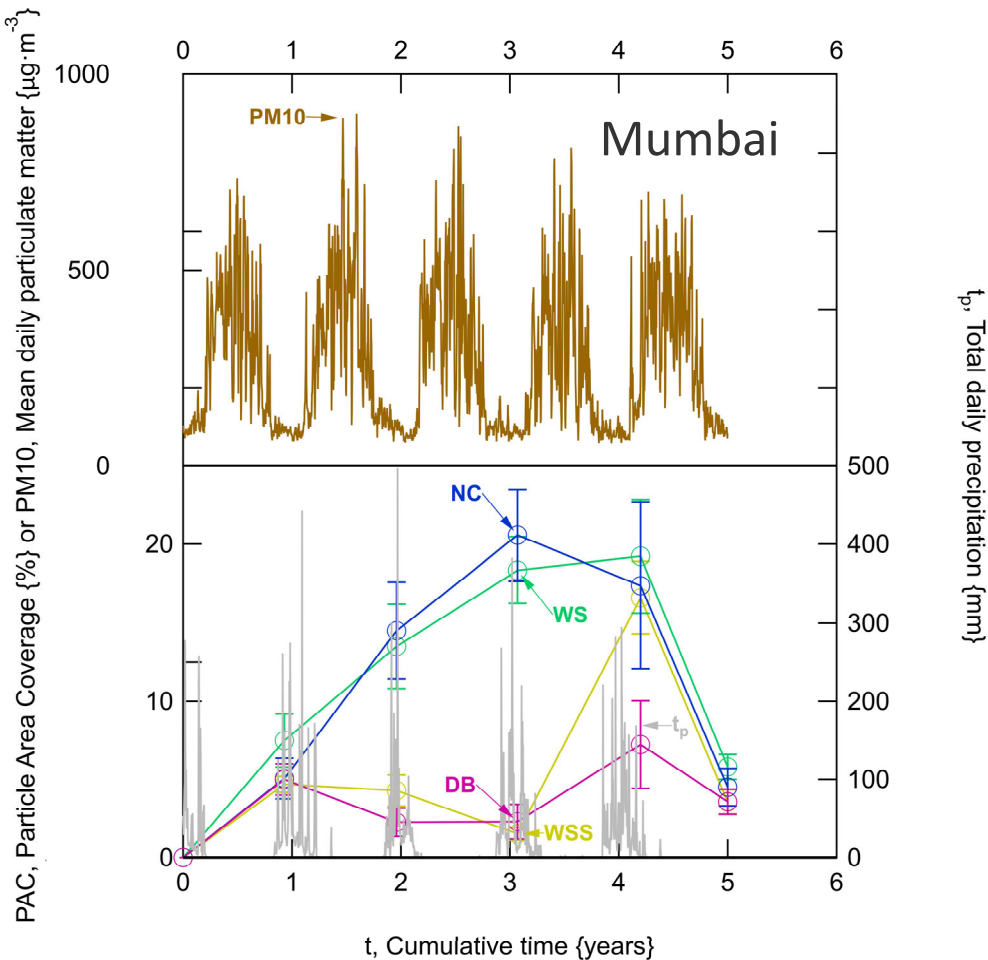
- Mumbai: Aw (tropical savannah), 2.3 m annual rain
- Dubai, Kuwait, Mesa: BWh (hot desert), 9-20 cm rain.
- Mumbai read points typically before rainy season.

- No Clean still overtly distinguished from DB, WSS.
- Low pressure Water Spray not effective.
 - Contact cleaning previously found to be required to remove fungus. <https://doi.org/10.1016/j.solmat.2018.05.039>.
 - Fungus can trap inorganic contamination, magnifying its effect.
 - Coarse annual read points; rain, organic species can vary through the day.

Data shown for 4 cleaning methods for Mumbai, AVG[B, D, G, J, U] coupons.

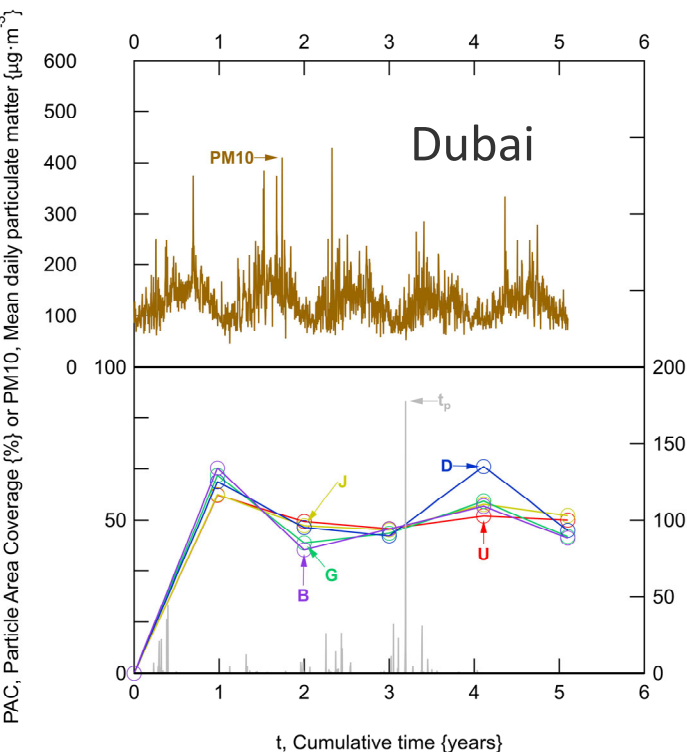
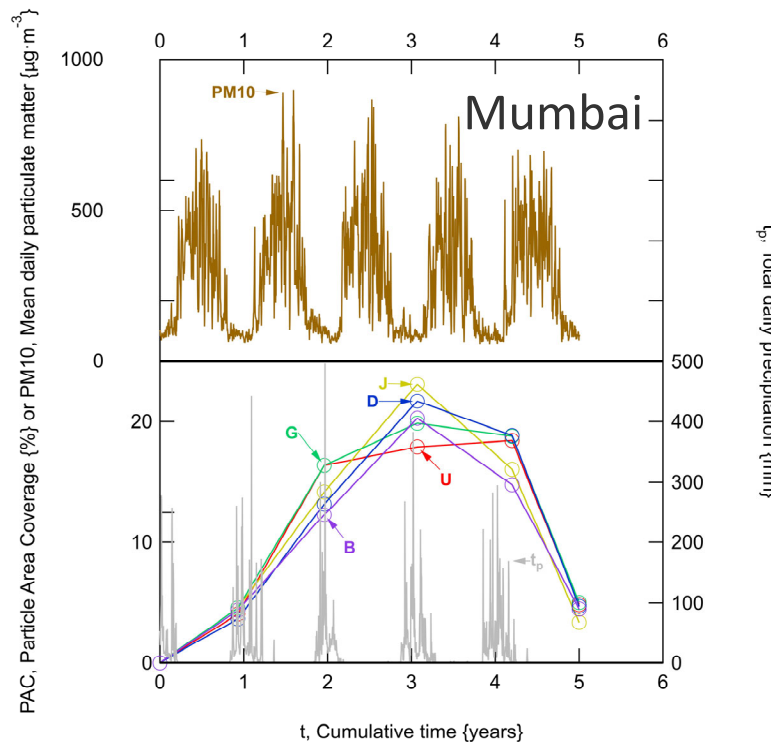
•No overt effect of AS relative to glass substrate.

- ImageJ PAC analysis compares effectiveness of coatings.
- Examine No Clean coupons to avoid convoluting effect of cleaning.
- AR, AS: B, D, G. AS only: U. B, G, U are hydrophobic. D is oleophobic Uncoated glass: J.

Data shown for No Clean coupons, including AR, AS, and uncoated specimens.

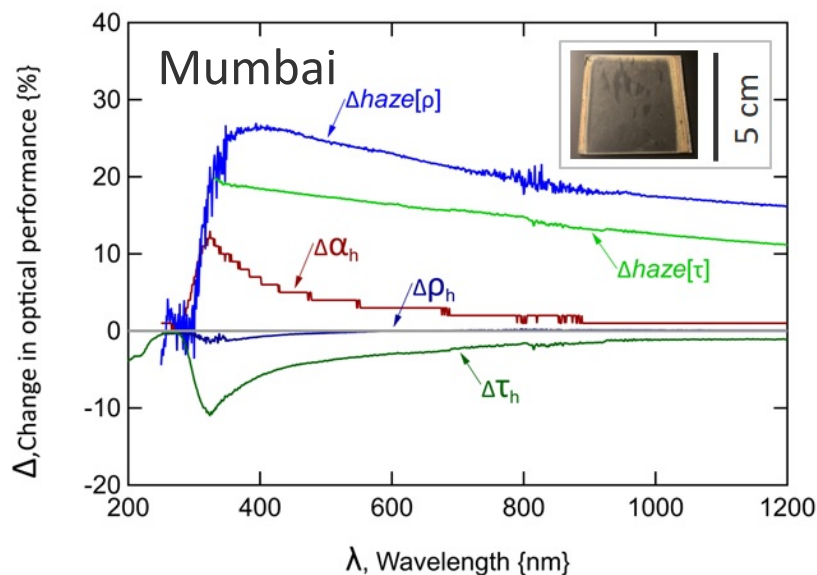
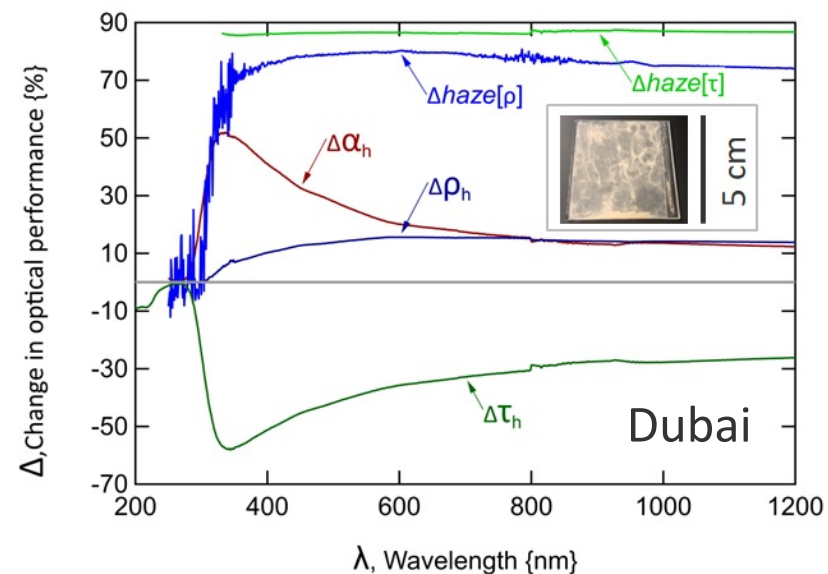
- Comprehensive optical characterization of No Clean coupons at all sites, at 3y.
Compare **transmittance**, **reflectance**, **absorptance**, final-initial, including haze (scattering).
- Transmittance is reduced most in UV-VIS wavelengths, above λ_{cUV} . (greatest refractive index).
- Much of loss of transmittance results from optical absorptance (PAC), then forward scattering.
- Overall reflectance is often reduced ... backscattering is often increased by soiling.
- Reflectance instead overtly increased for Dubai, attributed to local calcite contamination.

Comprehensive optical performance for Mumbai (left) and Dubai (right) at 3y, including hemispherical (integrating sphere): transmittance (τ), reflectance (ρ), and absorptance (α). The haze is evaluated from the difference between the hemispherical and direct (no integrating sphere) measurements.
