Combined stress testing simulating different climatic conditions

- how always testing at extremes may miss things -

Peter Hacke

National Renewable Energy Laboratory, Golden, CO, 80401, USA

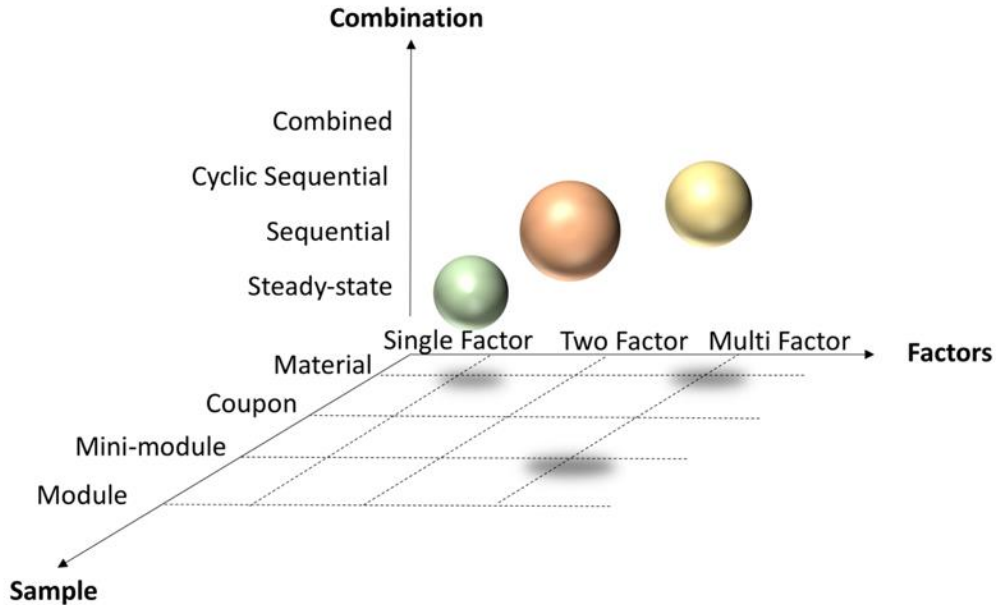
Comprehensiveness of representation in testing

“Sample”: representation of the materials interfaces, boundary conditions of the shipping module

“Factors”: extent of inclusion of the stress factors of the natural environment

“Combination”: representation of the actual combination and sequences of stress factors as in the natural environment and their balance (exceeding vs not exceeding real-world stress levels)

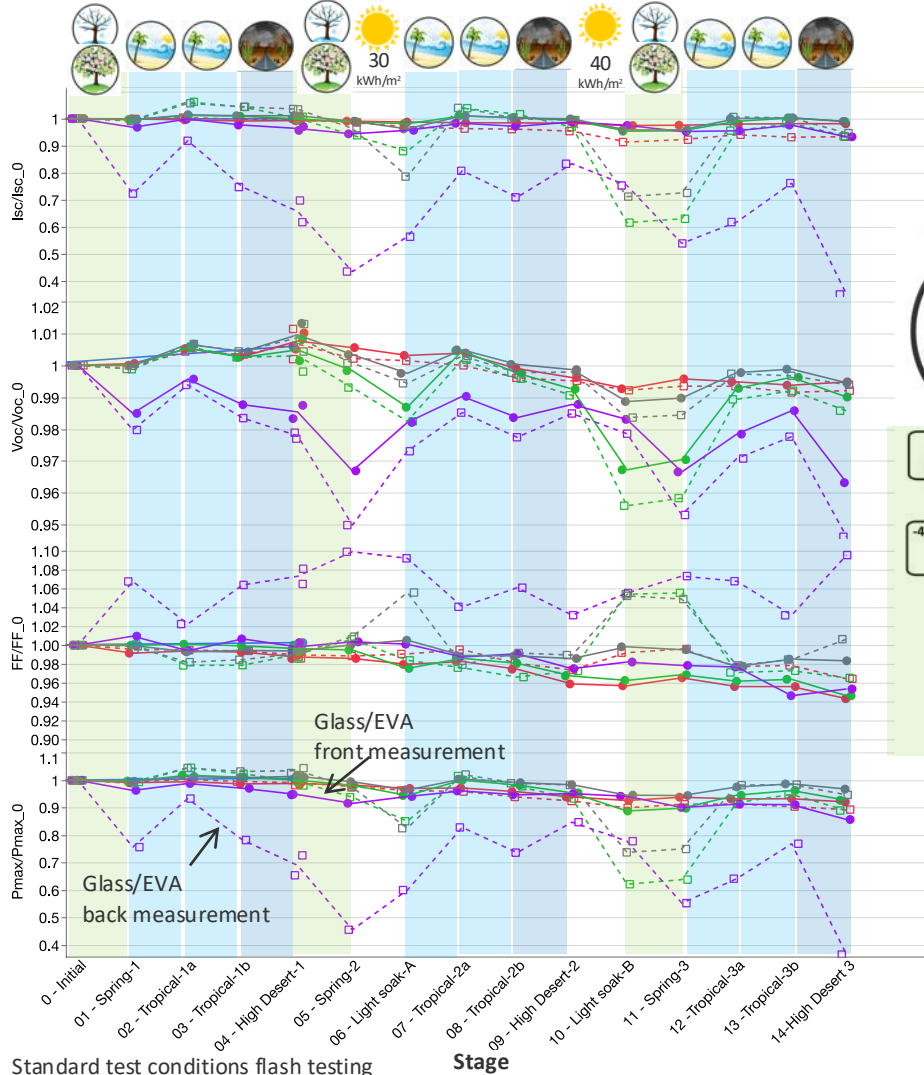
Dead of winter (18 h)

-40°C, 1% RH, DML × 8k (1 s),
SL × 5 (40 m)
18 h

Spring (2 d)

Tropical (35 d – 24h/cycle)
(ASTM D7869-based)

High desert (7 d)

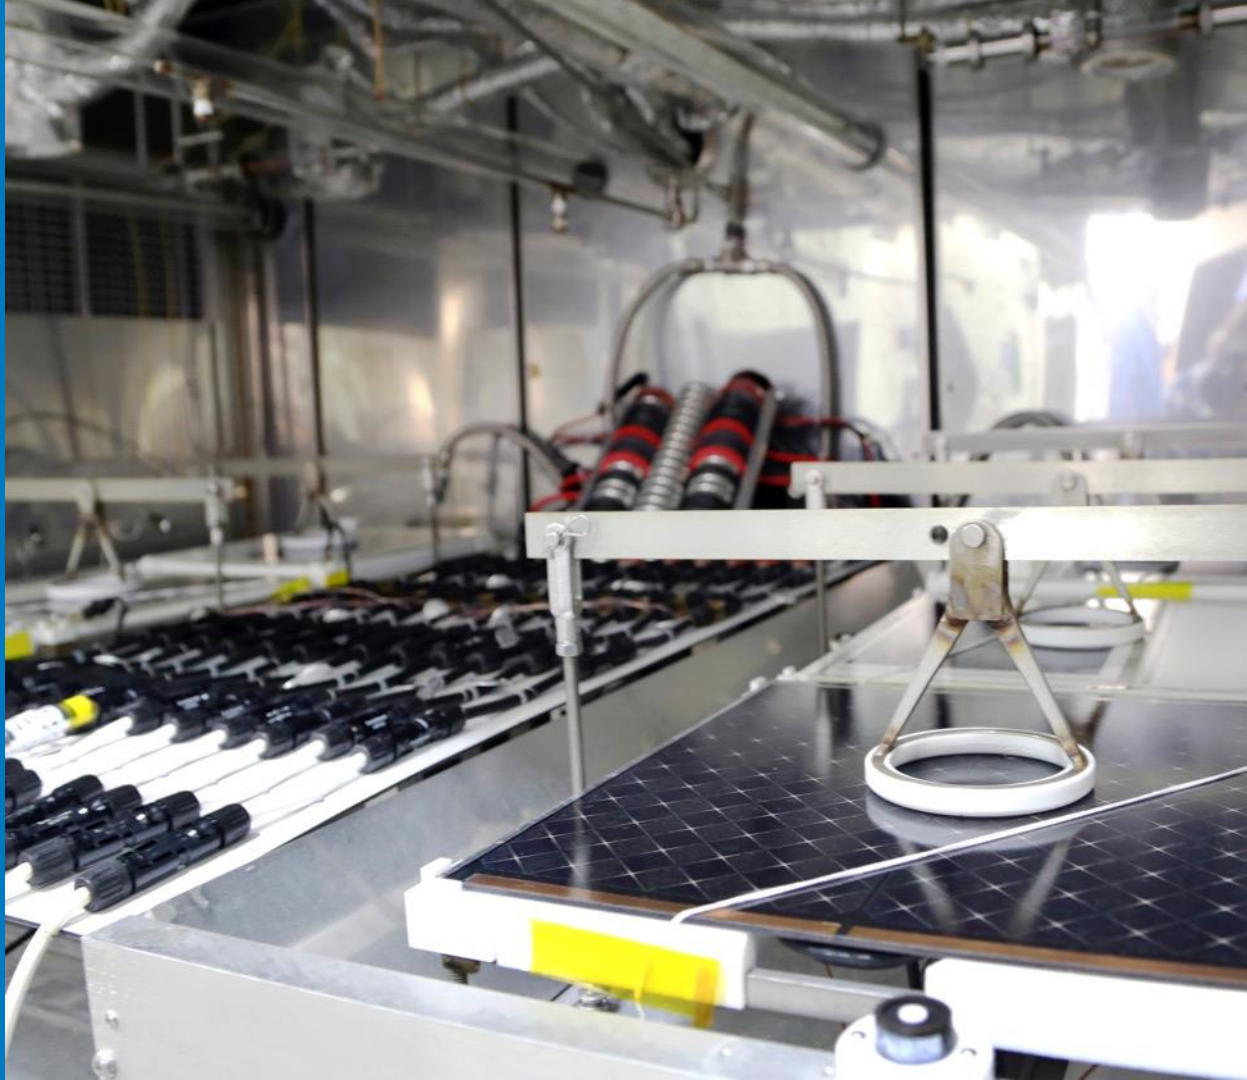
PVDF backsheet cracking in CAST

PVDF cracking

Loss of humidity
-loss of plasticizing effect
-shrinkage

Analysis: cause of the PVDF cracking

- (1) desiccation (20 °C, <5% RH)
- (2) moisture saturation (40 °C / 96% RH)

Moisture leads to plasticization of the backsheet – whereas the desiccated PVDF is harder, more rigid, less prone to creep. Dry conditions on the weathered material finally produce the cracking.

Cracking is believe associated with phase changes in the PVDF in weathering and poly(methyl methacrylate) PMMA additive used for adhesion, processing, and cost

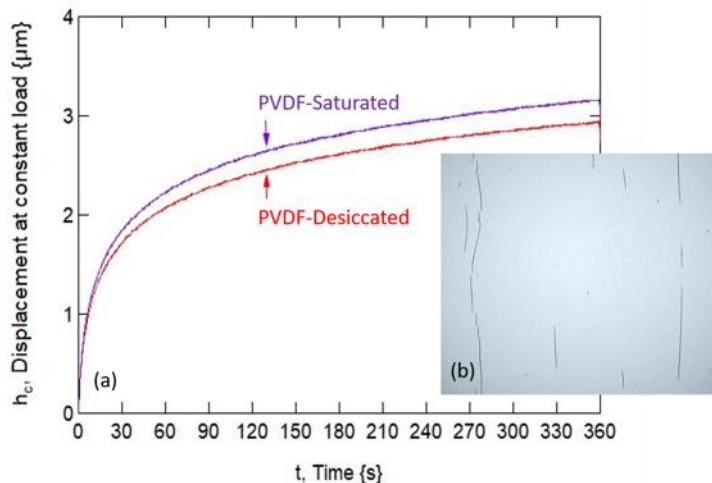
Indentation testing

Displacement/time data for creep–hold indentation tests for a PVDF backsheet type following 24-weeks in C-AST Tropical followed by the following courses for 14 days:

CONDITION	BERKOVICH HARDNESS		VICKERS HARDNESS		ELASTIC MODULUS (INDENTATION)	
	AVG H_B , {MPa}	2 STD H_B , {MPa}	AVG H_V , {MPa}	2 STD H_V , {MPa}	AVG E_i , {GPa}	2 STD E_i , {GPa}
DESSICATED	85.9	22.8	8.0	2.1	1.60	0.14
SATURATED	76.0	18.0	7.0	1.7	1.27	0.08

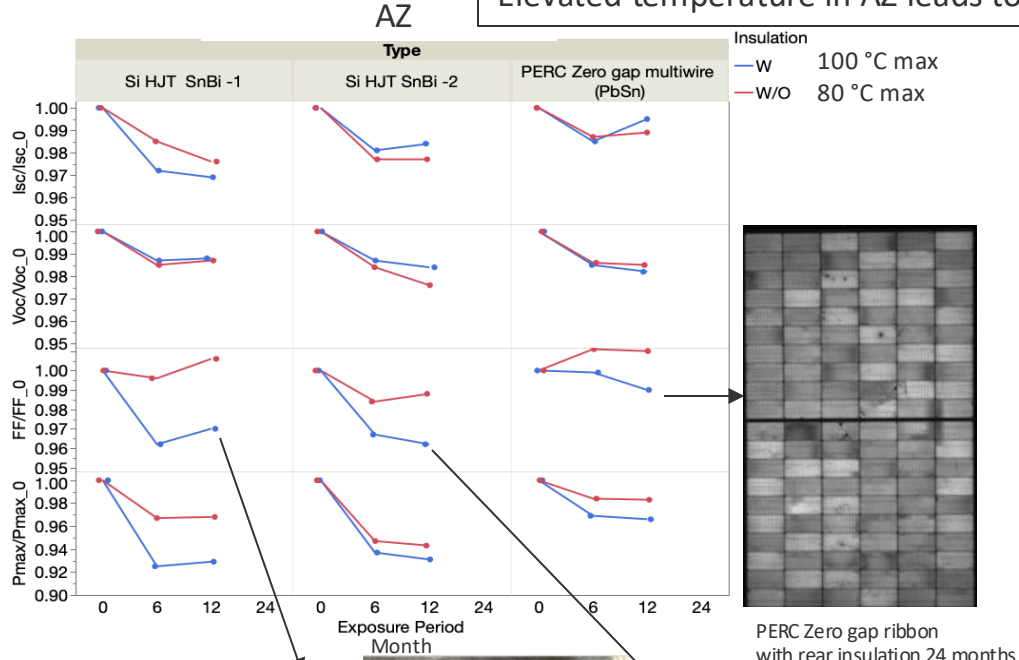
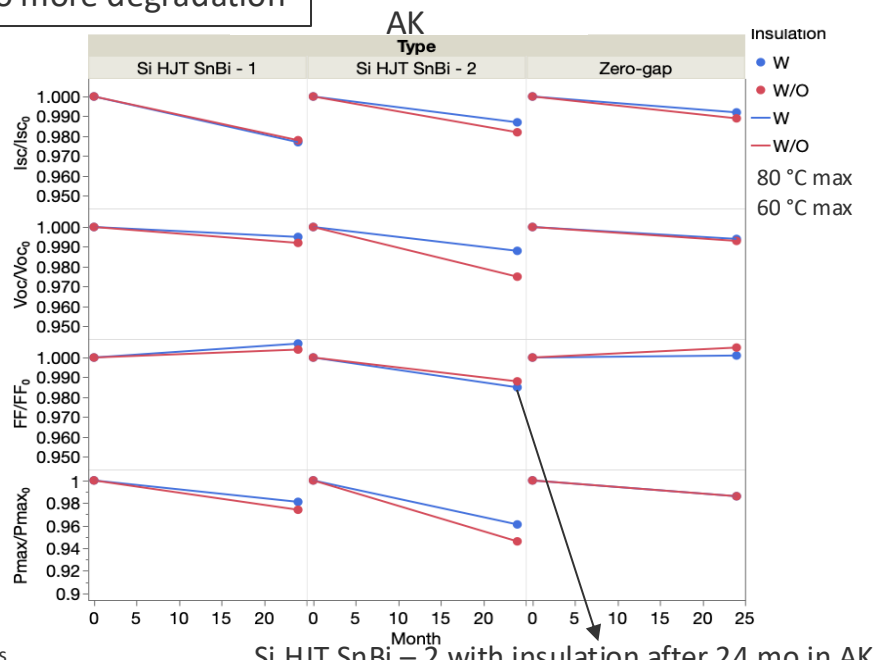
Si HJT SnBi -1 with rear insulation 24 months

Si HJT SnBi -2 with rear insulation 24 months
