# Failure in current PV systems and their relevance to find them

Marc Köntges

Hamelin, GER, 23<sup>rd</sup> Oct. 25, Task13 WS Characterization of Photovoltaic Systems

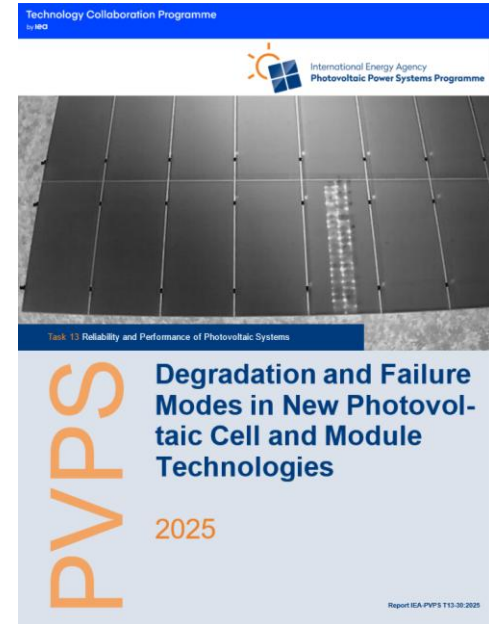
Report IEA-PVPS T13-30:2025, February 2025

**This report overviews currently known degradation modes and failures and their mitigations**

# Photovoltaic Failure Fact Sheets (PVFS) 2025

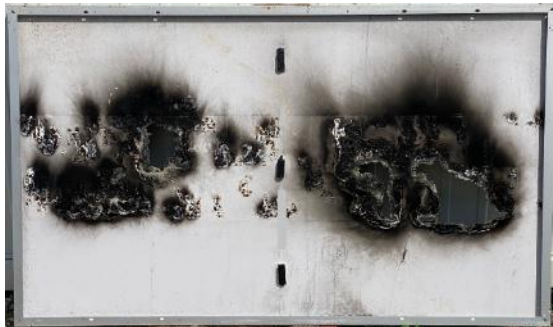
## Failure mode A<sup>1</sup>

- Failure mode A
- Reverse voltage at 3-5% of  $I_{sc}$  in the night applied to module strings, you should get  $\ll 50$  V
- Across a cell string without BPD a voltage of  $15...25$  V x  $20...24$  (cells) =  $300...600$  V drops
- Search for heated strings with thermographic camera in the night
- Up to two open circuit bypass diodes per string are detectable with a  $1000$  V power source

| EXAMPLES (page2) | PVFS 1-14 vs. 02 |
|---|---|
| <p><b>Example 10</b></p> <p>A cold solder joint after the diode in any junction box (either outer or inner) can result in a safety failure that is undetectable by IRT. The not connected bypass diode is visible with night EL inspection while applying string wise reverse voltage with 3%-5% of rated <math>I_{sc}</math> [Köntges24].</p> <p><b>Severity</b> </p> | |

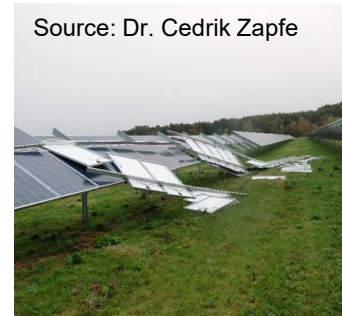
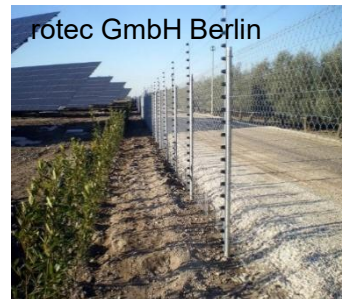
- Different cost structure, as fault finding, material and working time is financed by insurer
- It is worthwhile for park operators to find almost all faults
- Typical faults and methods are:
- Hail damage (VIS, EL, UVFL, DPL)
- Snow damage (VIS, EL, UVFL, DPL)
- Storm damage (VIS, EL, UVFL, DPL)
- Water damage (VIS, ISO)
- Theft (VIS)
