Reliability Study of Grid Connected PV Systems

Field Experience and
Recommended Design Practice

Report IEA-PVPS T7-08: 2002

March 2002

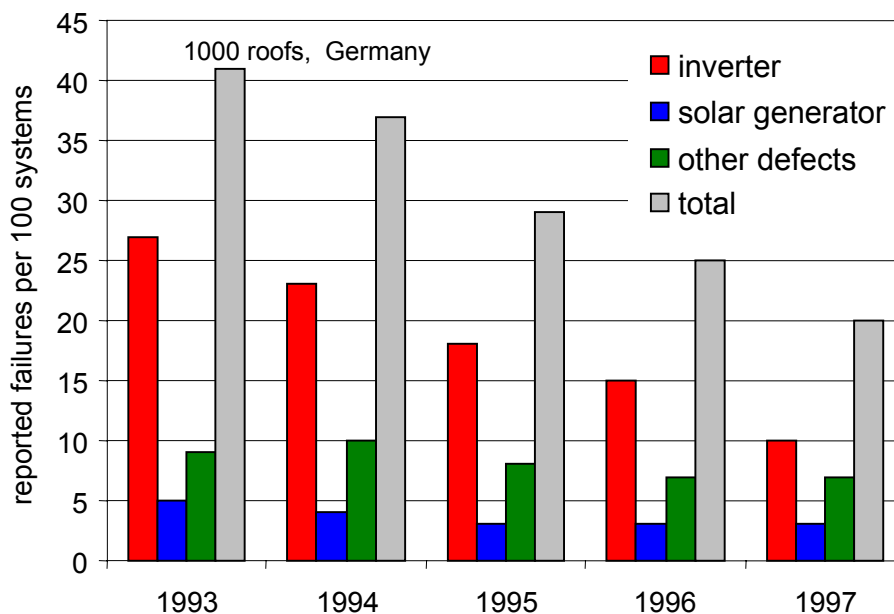
Fig: 1: Failures by main component as reported by the system owners under the »1000-Roofs-Programme« (Erge et al. 1998).

In all reports the inverter was by far the most troublesome component. It accounts for about 66 % of reported troubles. However, it is obvious that the number of troubles decreases continuously over time. Reports from recently installed system show a significant lower failure rate for inverters (compare figure 1 and 3).

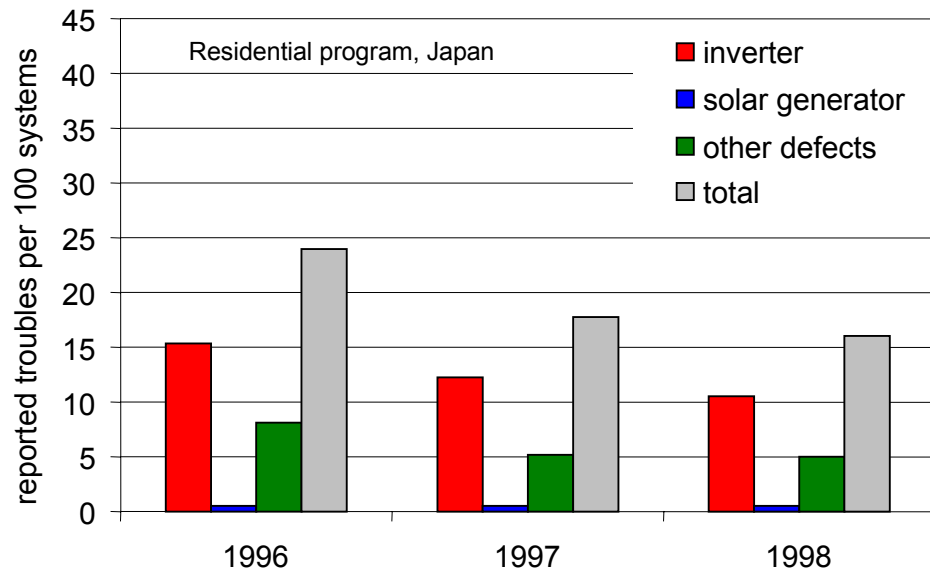
Fig. 2: Failures by main component as reported by the system owners under the »Subsidy Program for Residential PV systems « (Nishikawa 2000).

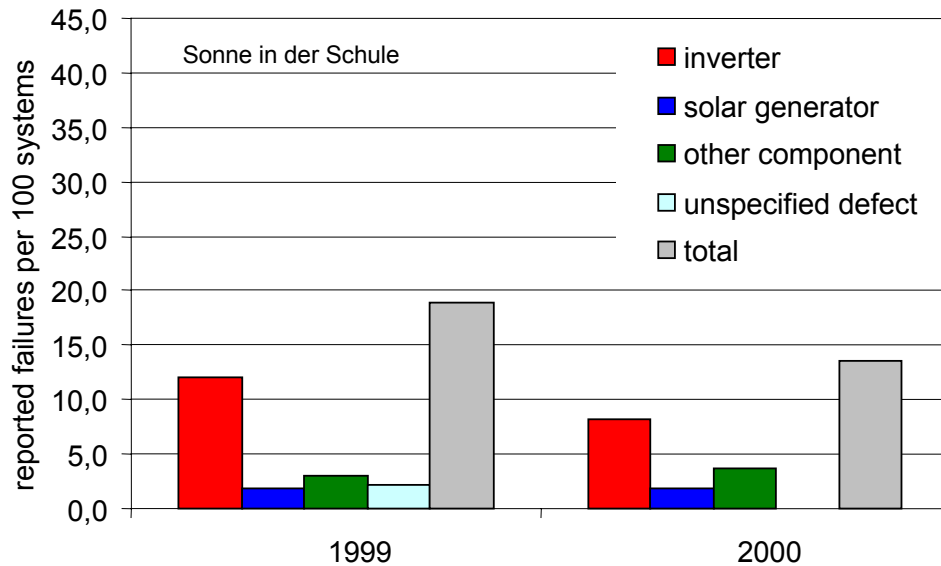
Fig.3: Reported troubles and failures per 100 systems from »Sonne in der Schule« (Hoffmann 1999 and 2000).

The information given from owners does not always distinguish between a temporary malfunction, (which automatically resets) and a failure, i.e. a defect requiring a repair. Even less a malfunction can be distinguished from an inverter shut down due to irregular grid conditions. Data for figure 3 include all such effects. Considering true hardware reliability of the inverter, these data are conservative.

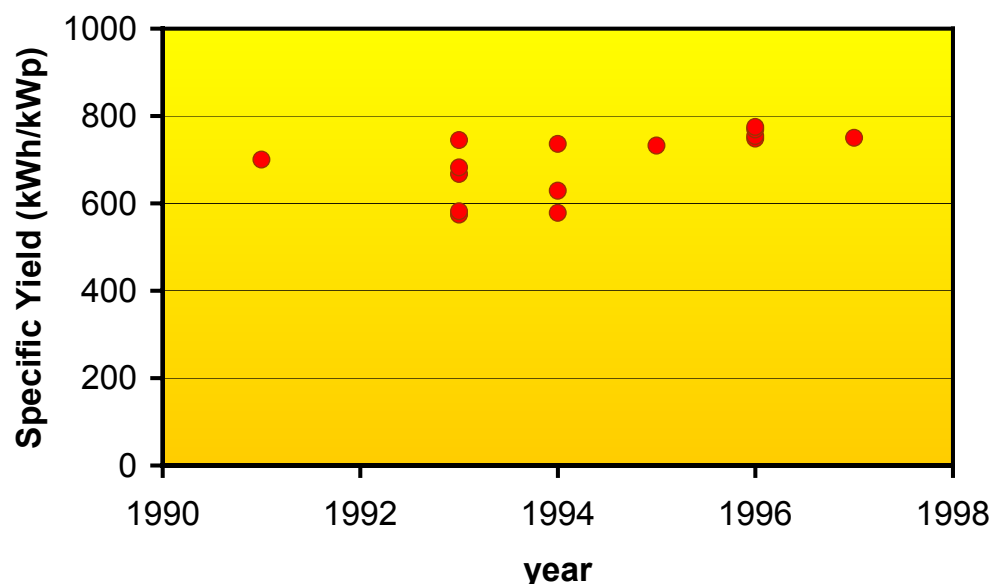
Fig. 4: Specific yield of Dutch PV systems over the year of commissioning.

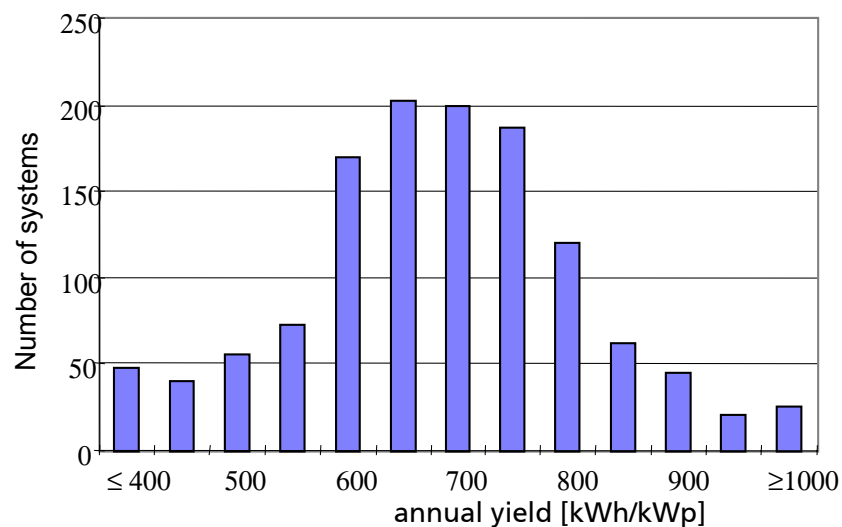
Looking at the annual yield of the systems shows an astonishing broad distribution (figure 5). This cannot be explained by the slightly uneven irradiation over Germany.

To understand the phenomenon a special investigation was conducted. It revealed that a significant fraction of the poor performance was caused by prolonged inverter failures. Accounting for these systems still left some 100 systems with too low yield. Nearly all of these systems were inspected and 17 were analysed in detail (Hoffmann V.U. et al., 1998, Erge Th., et al., 1998).

Fig. 5: Distribution of annual specific yield in 1996 (data from 1243 PV systems).

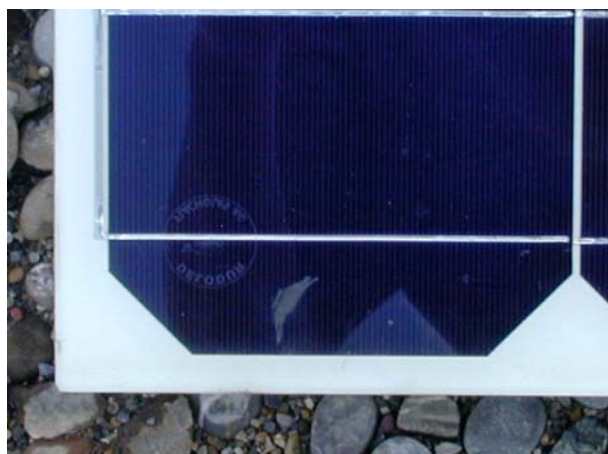
The most critical part of a module is the lower edge. Especially with rather low inclinations, soiling at the edge of the frame occurs. By often repeated water collection in the shallow puddle between frame and glass and consecutive evaporation dirt accumulates (Fig 13). Once it causes shading of the cells, this dirt reduces the available power from a module. Densely packed modules with little distance between cells and frame are especially concerned. Laminates allow free run-off of the water. Therefore, they are less prone to this effect (Fig. 14).

Fig. 15 This laminate is free of dirt (ewz).

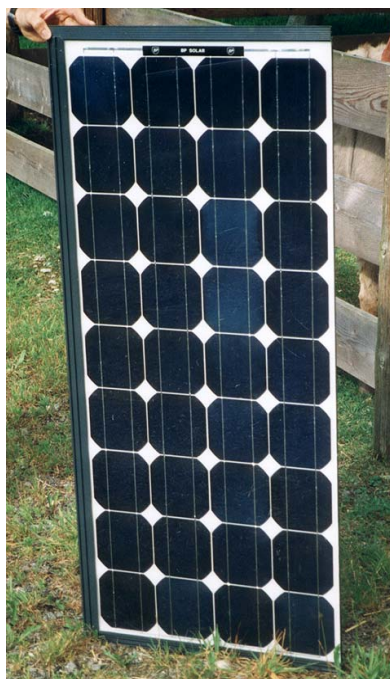
Fig. 17: SOLRIF® module with a 3/4 frame (ewz).

3/4 frame means that at the lower edge, only the rear part of the frame is mounted and the front part is omitted. Thus, the module is protected by a frame and simultaneously water can drain freely. Currently, one such system is available –called SOLRIF®. It is designed for integration into sloped roofs. These modules can be mounted the same way as conventional roof tiles.

Over time dirt accumulation may collect enough soil to allow plant growth (Fig. 16). This effect can be resolved only by yearly manual cleaning, by using laminates or by using a new development – a $\frac{3}{4}$ frame (Fig. 17).

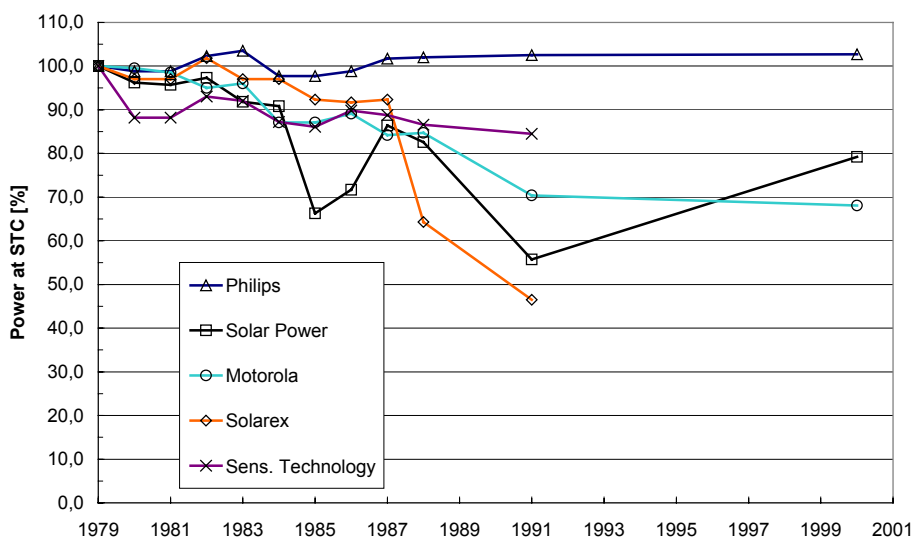
Fig 20: Relative power at STC referred to initial power. Long-term measurements at the Swedish test site Sandkullen show that a good module performs without detectable power degradation over 21 years.

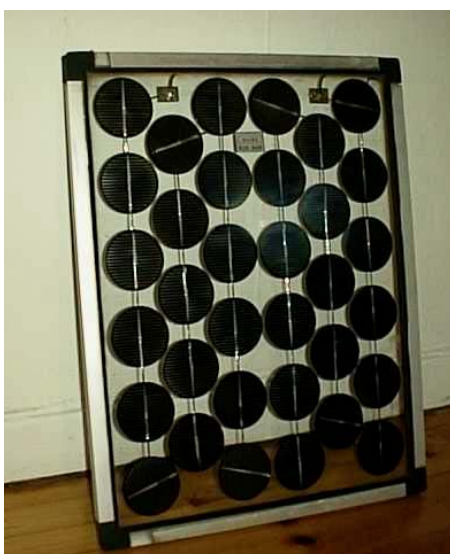
Visual inspection of the „Phillips“ module shows its integrity (figure 21).

Fig 21: The „Phillips“ module from Sandkullen after 22 years outdoors.

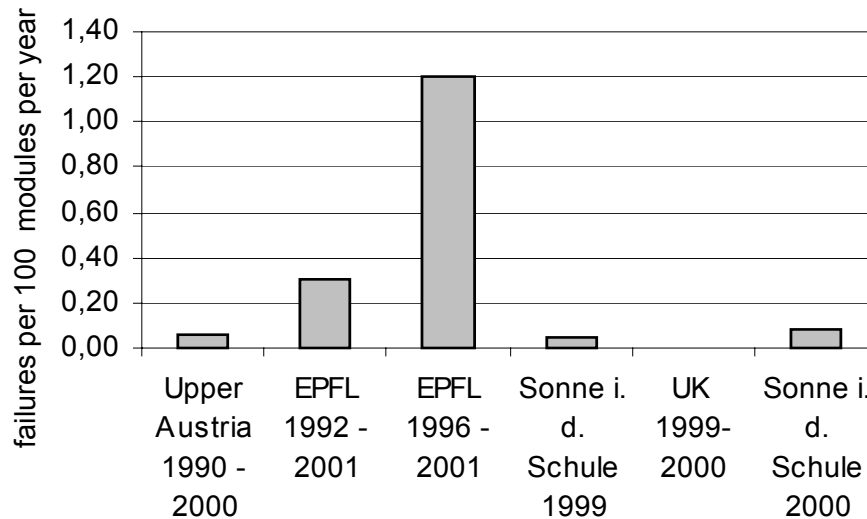
Fig. 22: Module failures and operational troubles for different task 7 survey responses normalised to 100 modules operating for one year. EPFL and UK data are based on failure information from an experienced system operator/installer, the three other columns are based on questionnaire and monitoring information from lay persons. The high values in columns 2 and 3 result from one flawed module type. The fifth column is indeed empty. Nominal module power was normalised to 50 W.

The task 7 survey showed low module failure rates. Excluding one flawed module type, which caused the peak failure rate at EPFL, no module failures were noted at EPFL and UK. Surveys in upper Austria and »Sonne in der Schule« showed failure rates below 0.1 % per year. For this figure modules were assumed to be standard modules of 50 Wp.

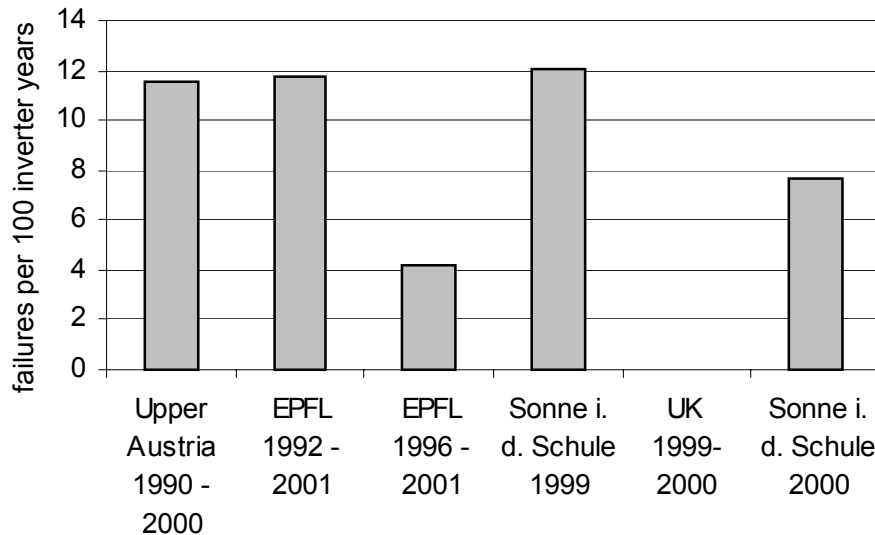
Figure 23 shows inverter failure rates from the task 7 survey. It shows an average of about 10 years between failures.

Fig. 23: Inverter failures and operational troubles for different task 7 survey responses normalised to 100 inverters operating for one year. The quoted year is that of commissioning. Only for the two »Sonne i.d. Schule« columns the quoted year indicates the reporting year. Columns 2, 3, and 5 are based on failure information from an experienced system operator/installer, the three other columns are based on questionnaire and monitoring information from lay persons. The fifth column is indeed empty.

Considering reports from experienced operators the graph indicates a clear improvement of average failure rates in recent years. Considering lay persons' reports this conclusion is less apparent. We assume that installation flaws and troubles with the »ENS«, the German islanding protection system, in the inverters cause some of the fault reports. The trend to lower failure rates is most likely due to reliability improvements in »younger« systems with more advanced inverters. But also older systems benefit from improved components, since unreliable inverters have been replaced by new products.

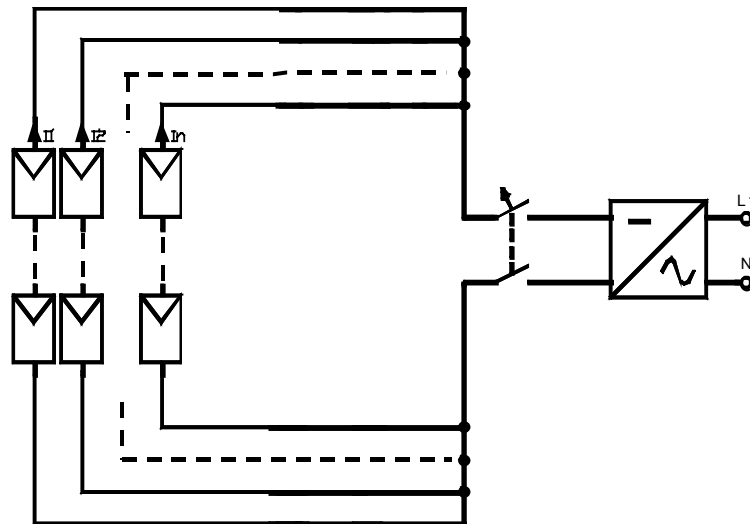
Fig. 24: Simple system design using class II¹ equipment and double insulated wires with extended temperature rating (IEC, 1999).

In many cases diodes and fuses may safely be omitted (fig. 24). This had been first appreciated in a German draft standard for residential PV systems (Laukamp and Bopp, 1996). Currently an IEC (International Electrotechnical Commission) standard is under development (IEC 60364 part 712) using the same approach (IEC, 1999). The exact requirements to be defined in this standard are under discussion. Therefore, we present the reasoning behind this approach. Publication of IEC 60364 part 712 is planned for late 2002. An extensive introduction into the matter of electrical safety of PV systems can be found in (Laukamp and Bopp, 1996).

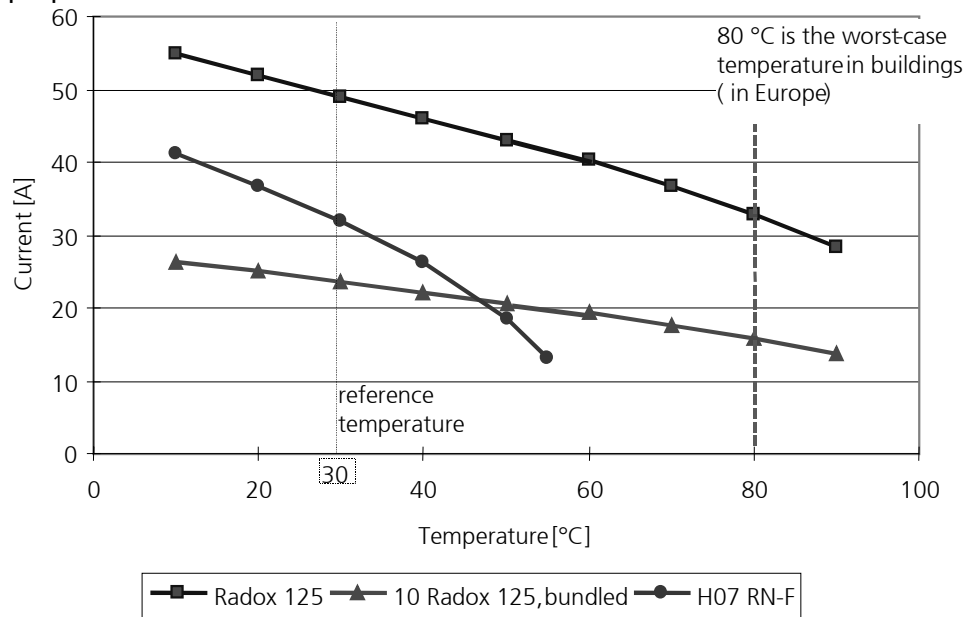
String diodes and fuses are not necessary, if the wires and the modules can carry the worst case fault current. The worst case current can be assumed to be $1.2 \cdot I_{sc,array}$, the short circuit current at STC of the whole PV generator. Critical is the temperature dependence of the cable used (fig. 25). Regular cables are rated up to 60 °C or 70 °C and reach their temperature limit in a rooftop installation. They may not at all be used in an heat insulated facade, where temperature peak above 80 °C.

There are cables on the market with increased temperature resistance. These offer a huge advantage with respect to permissible currents at elevated temperature. Modern cables of 2.5 mm² cross section are rated for a current capacity of several 10 A (fig. 25). These cables employ special materials for insulation, for example cross-linked polyolefines. The cable named »Radox 125« in figure 25 is just an example, cables with similar properties are available from several manufacturers.

Fig. 25: Current capacity versus ambient temperature for single wires of different cable types and 10 wires of a modern, temperature improved cable type laid close together (bundling). H07 RN-F is a standard cable described in the German standard DIN VDE 0298 Teil 4. Radox 125 is a cable with improved temperature rating. Data are taken from DIN VDE 0298 Teil 4 and manufacturers data sheets. For Radox 125 values below 30 °C were extrapolated. 30 °C is a standard reference temperature.

In smaller systems with up to 6 parallel strings of standard modules (I_n ca. 3 A), such a modern cable of 2.5 mm² cross section is sufficient to provide overload and short circuit protection, because it can carry all the generator short-circuit current. Incidentally, this is about the current which a module can carry in forward direction (Gajewski 1998).
