# Case Studies of Accidents and Their Causes in PV Systems

Structural Performance Evaluation Institute (SPEI)

Researcher Kota Sato

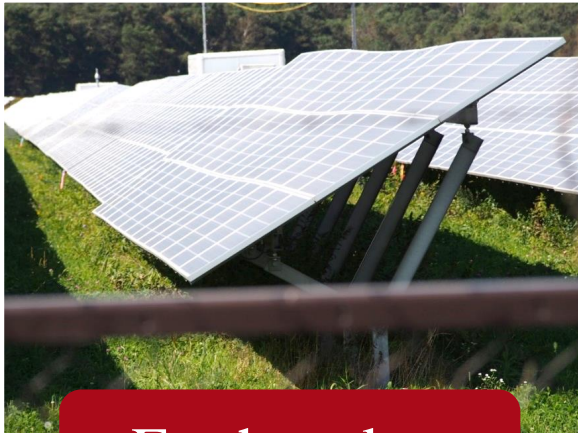
Earthquakes

- PV systems are relatively lightweight compared to buildings and other structures, so they tend to **suffer less damage from earthquakes**.

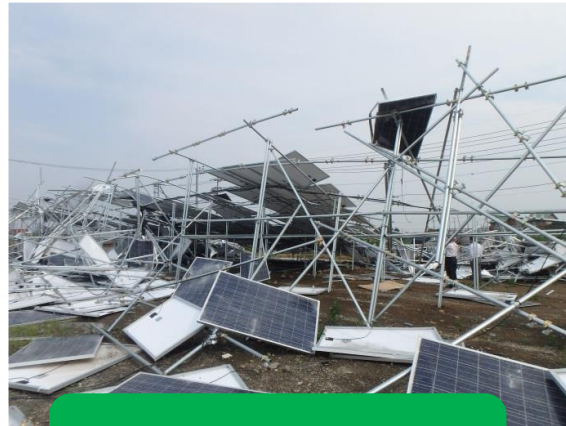
Strong winds

- However, due to their lightweight, PV systems are **more vulnerable to damage from strong winds**, with a high incidence of systems being blown off or torn apart.

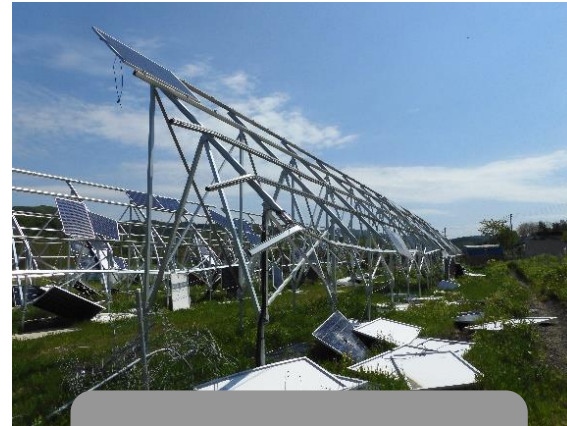
Heavy snow

- **In regions with heavy snowfall, snow-related damage is frequent**. In some cases, the entire system may be completely destroyed.

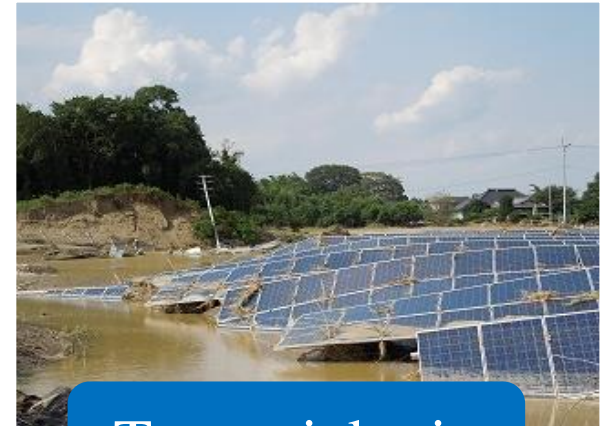
Torrential rain

- In recent years, **Slope-mounted PV Systems** has increased, leading to a rise in damage from **landslides caused by heavy rain** and **erosions of the ground due to rainfall**.
