# How to deal with cold solder joints in JB of current module designs

Marc Köntges ISFH, Jay Lin PV Guider

DTU, Roskilde, DK, 29th – 30th April 25

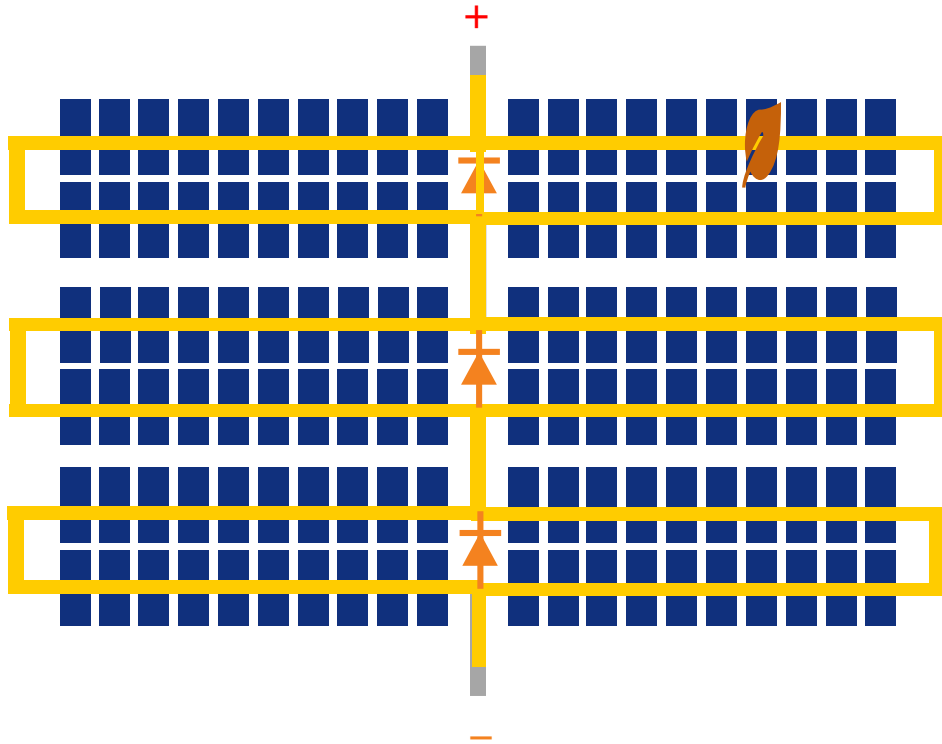
- Bypass diodes avoid local high breakthrough currents of solar cells in the case of shading
- Voltage at a shaded cell is below voltage of a substring
- Electric currents of cell strings and bypass diode add up to  $I_{mpp}$  of the inverter
- ➔ The bypass diode limits the dissipating power to the maximum power of one **module substring**

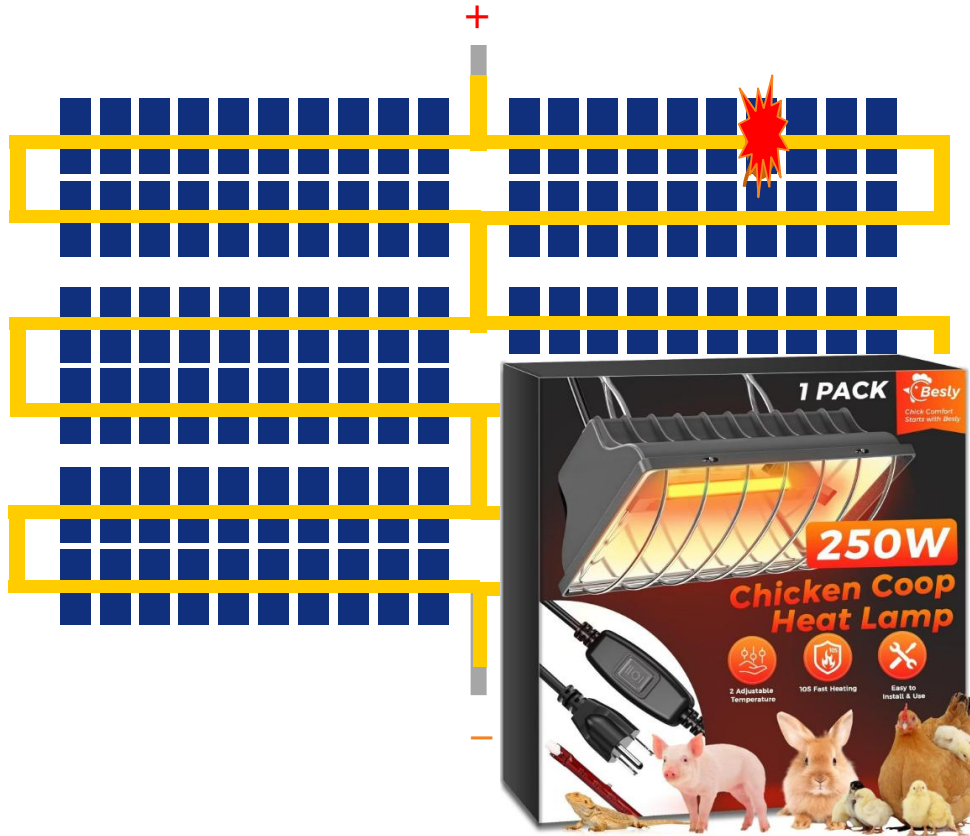
- Shaded cell voltage gets negative: typically between -15 V...-25 V
- The maximum dissipating power can now be powered by the voltage of the **full module string**
- As we have -15 V... -25 V per cell we have at  $I_{mpp} \sim 10 \text{ A}$  a power dissipation of **150-250 W** per cell.
- ➔ Cell temperature can rise above **150°C**
- ➔ Up to **600 V** between cells in one substring

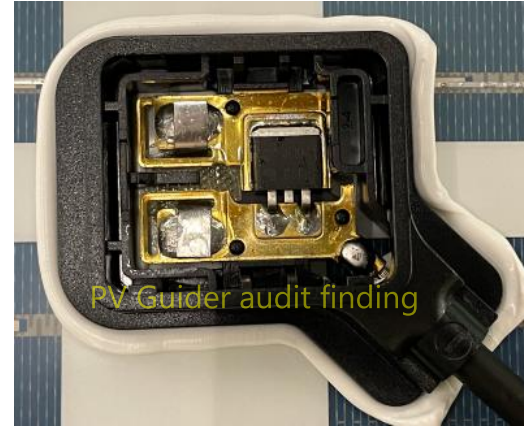
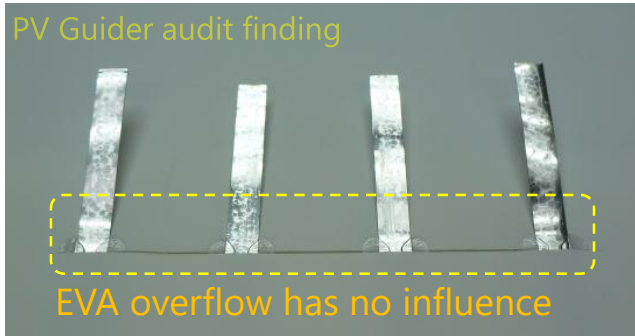
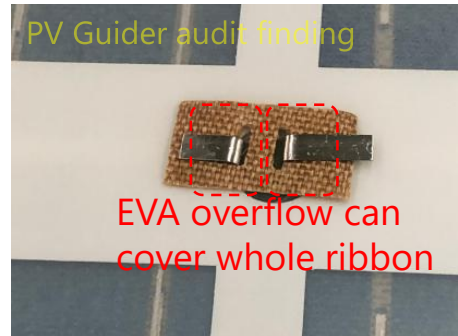
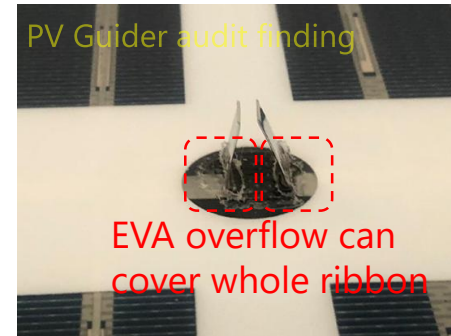
Junction box for butterfly module

**Inherent risks of butterfly module**

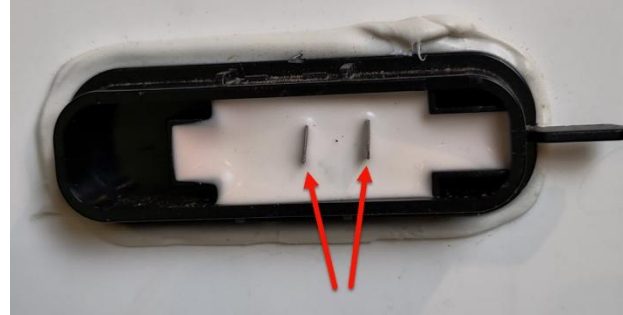
Short ribbon is stiffer  
and easy to rebound

- Press time for soldering must be adjusted properly
- Inspection of solder joint required

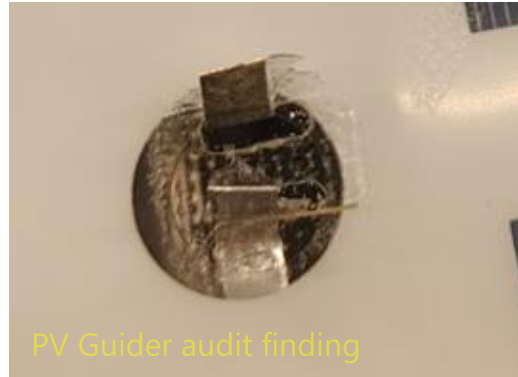
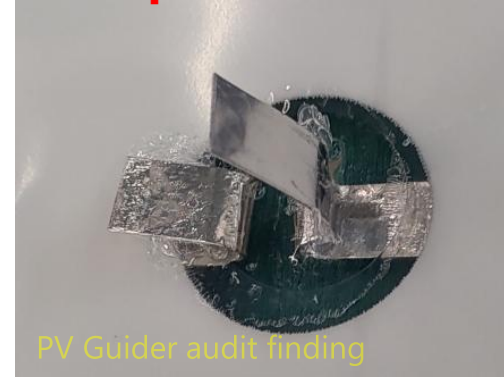
Short ribbon is easy to be covered by overflowed EVA

It's very difficult to remove the EVA.  
**And no one do it in the production !**

- Require stable proces without lamination material on ribbon

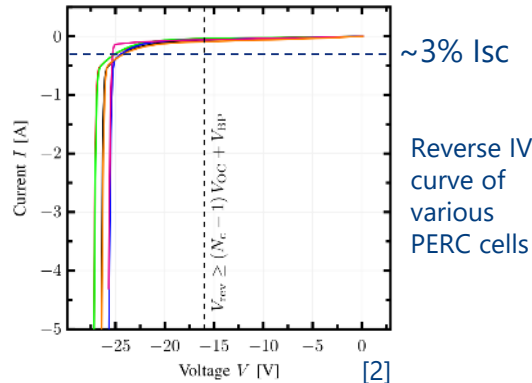
[2]

- Failure mode A
- Reverse current of 3-5% of  $I_{sc}$  in the night applied to module strings, you should get  $\ll 50$  V
- Across a cell string without BYD a voltage of  $15...25$  V x  $20...24$  (cells) =  $300...600$  V drops
- Search for heated strings with thermographic camera in the night
- Up to two open circuit bypass diodes per string are detectable with a 1000 V power source

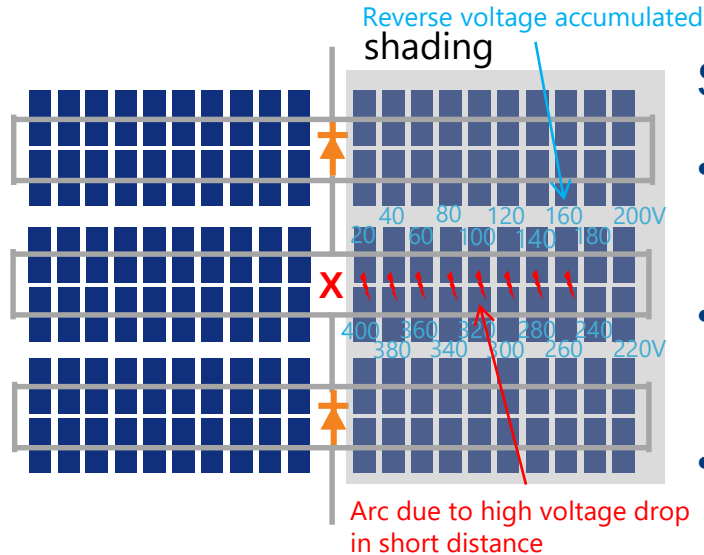
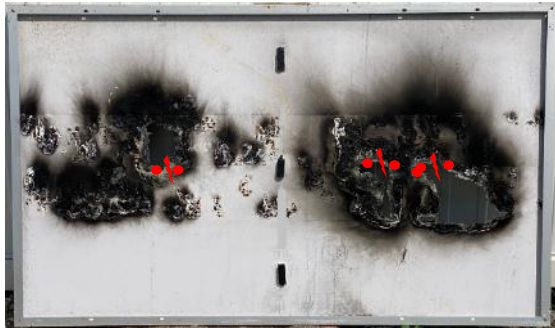
Shading of the module may cause:

- High reverse voltage across cells -15 V ... -25 V without bypass diode
- High reverse voltage may cause hot cells and local breakthrough of cells, often at the cell corners •
- High voltage difference between cells of one substring 300...600 V
- High temperatur + high voltage may cause arcing between cells of one substring ⚡
