Task 13 Performance, Operation and Reliability of Photovoltaic Systems

Quantification of Technical Risks in PV Power Systems

2021

Report IEA-PVPS T13-23:2021
October 2021

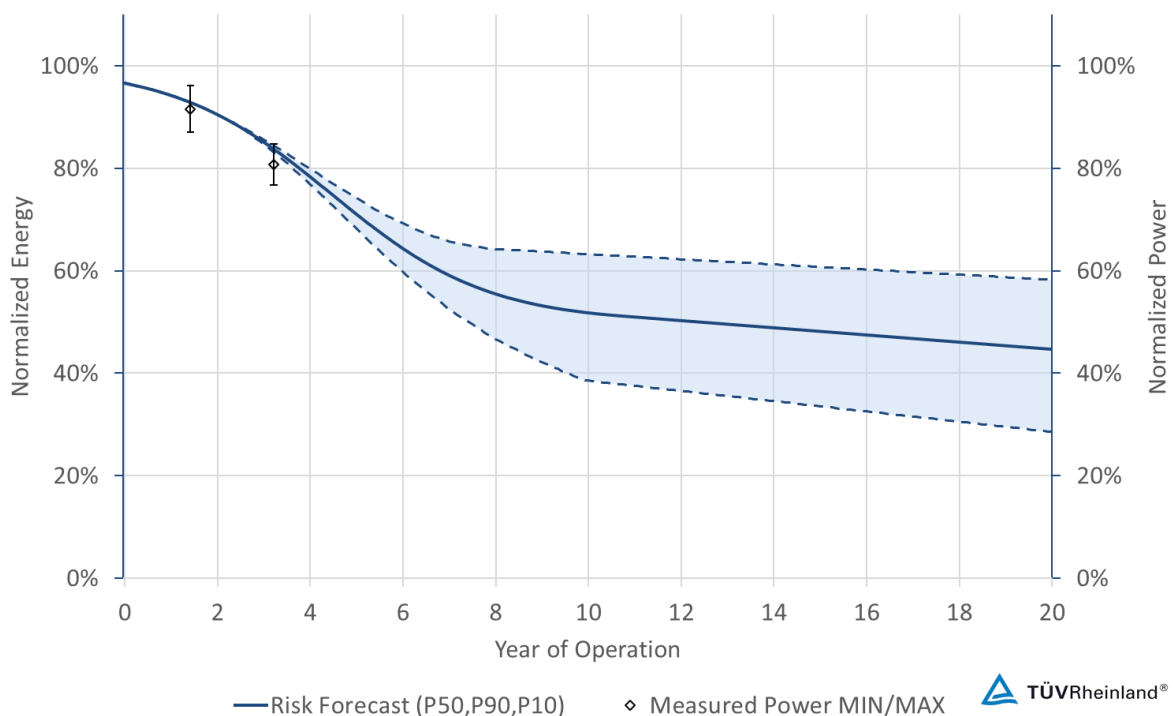
Figure 18: Energy forecast of No-Mitigation Scenario.

Taking the behaviour of the identified root cause into account, the potential future PLR is expected to increase further with an expected saturation of 50%. After this value is reached, the PLR is expected to stagnate at a constant level of 0.7% per year. This prediction of performance development for 20 years of operation is shown together with the exceedance probability P10 and P90 for a confidence level of 68.2% in Figure 18. Taking CAPEX, OPEX and annual revenues into account, the project’s financial profit after 20 years of operation is 48% below original expectations for the defined scenario without mitigating actions.

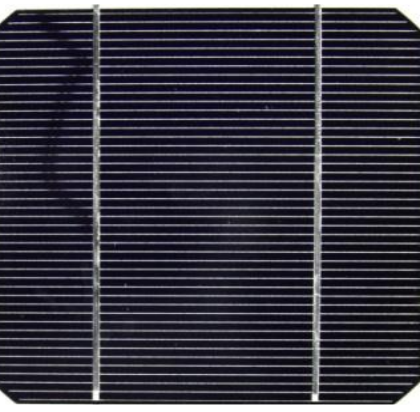
EXAMPLES (page1)		PVFS 1-1vs.01	
Examples 1-3

Cell chipping. A very small region is missing from the edge of the cell, but does not enter metalized region. [16]	Large crack at cell corner visible by eye - small portion of the cell (<10%) is no longer electrically connected. [16]	Cell crack with snail track. No isolation of any cell part. The propagation could isolate a cell area >10%. [16]
Severity

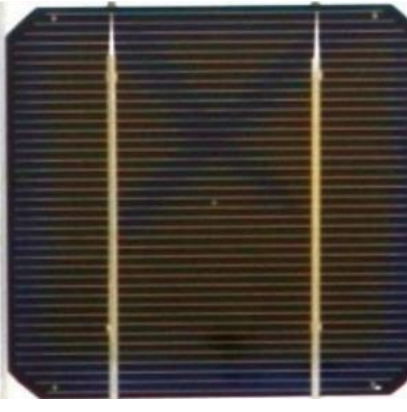
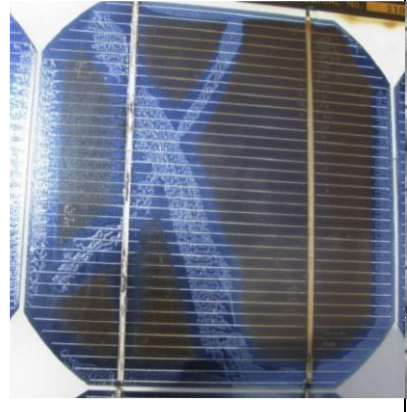
Examples 4-6

Cell cracks visible by the photo-bleaching effect. This may not be mistaken for snail tracks. [16]	Two cell cracks with extensive delamination, EVA browning and photo bleaching. [41]	EL image of 2 cell cracks which isolates more than 10% of the cell area. [TUV Rheinland]
Severity

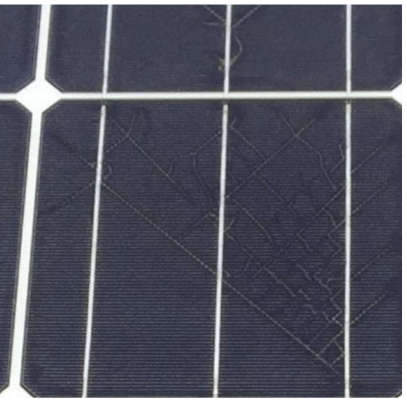
Examples 7-9

Snail track example. [41]	Snail track example. [41]	EL of cell cracks with snail tracks. [16]

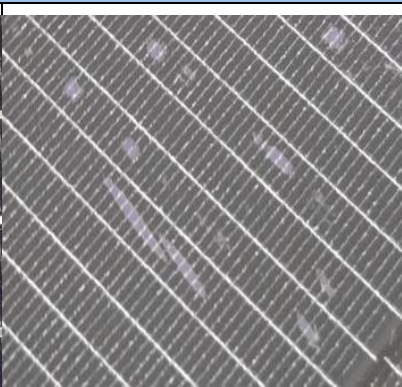
<p>Examples 1-3</p>

<p>Encapsulant delamination in un-critical position. [SUPSI]</p>	<p>Encapsulant delamination from cell caused by production process. [SUPSI]</p>	<p>Encapsulant delamination from cell along grid fingers and bus bar. [38]</p>			
<p>Severity</p>

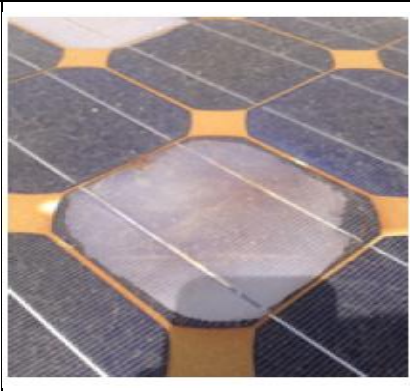
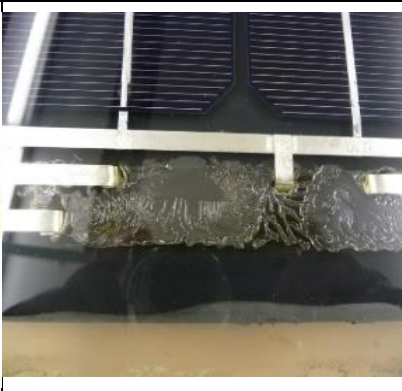
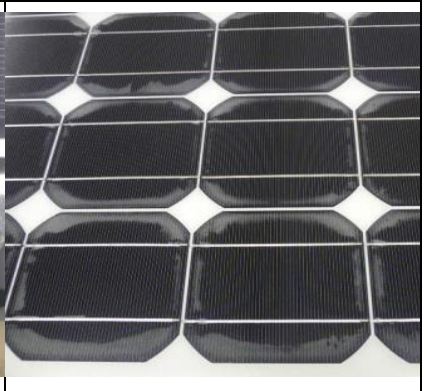
<p>Examples 7-9</p>

<p>Delamination in front of cell in the centre of the module. [40] (see also FS 1-2)</p>	<p>Delamination at module insert connections of a glass/glass module (junction box). [SUPSI]</p>	<p>Delamination at cell edges. [16]</p>

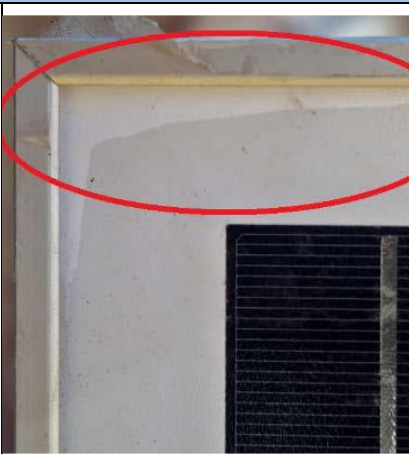
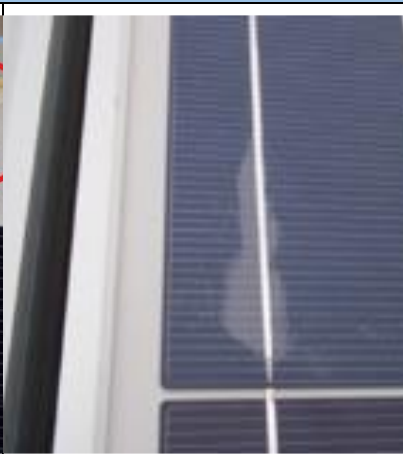
<p>Examples 10-12</p>

<p>Encapsulant delamination at borders. [37]</p>	<p>Encapsulant delamination along a bus-bar in a cell close to the module edge. [40]</p>	<p>Encapsulant delamination of from glass (spotted due to glass texture) at the edge of the cell. [37]</p>			
<p>Severity</p>

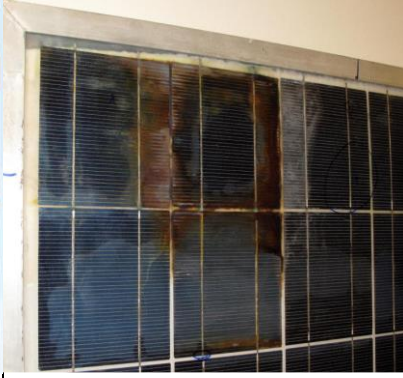
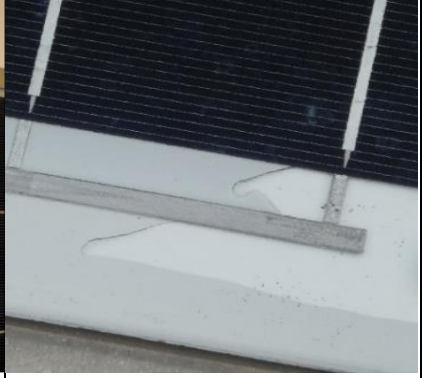
<p>Examples 13-15</p>

<p>Delamination creating a continuous path between electric circuit and the edge. [40]</p>	<p>Delamination with corrosion. [1] (see also FS1-11)</p>	<p>Delamination caused by detachment of backsheet with exposure of encapsulant from the back. [SUPSI]</p>			
<p>Severity</p>

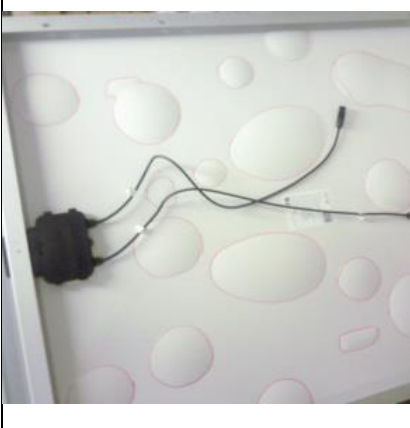
<p>Examples 1-3</p>

<p>Multiple bubbles in the centre and edge of the backsheet. [46]</p>	<p>Blisters because of vapour barrier, such as aluminium foil. [1]</p>	<p>Big central bubble + wavy delamination. [16]</p>			
<p>Severity</p>

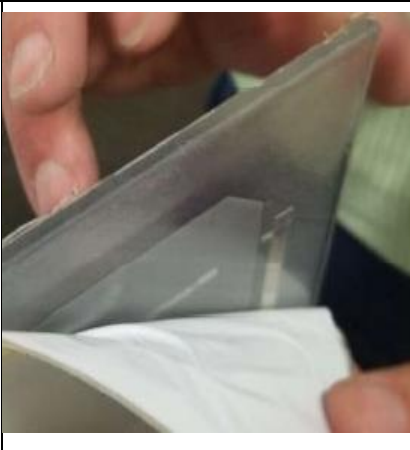
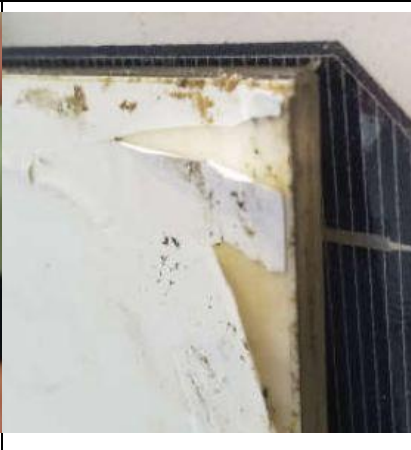
<p>Examples 4-5</p>

<p>Backsheet delamination with direct exposure of encapsulant. [SUPSI]</p>	<p>Delamination of top layer without exposure of encapsulant. [SUPSI]</p>				
<p>Severity</p>

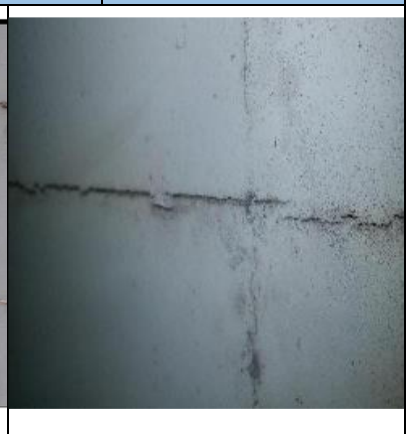
<p>Examples 1-3</p>

<p>Cracked backsheet in combination with yellowing under a hot cell. [39]</p>	<p>Squared cracks beneath cell interspaces. [39]</p>	<p>Cracking between cells. [38]</p>			
<p>Severity</p>

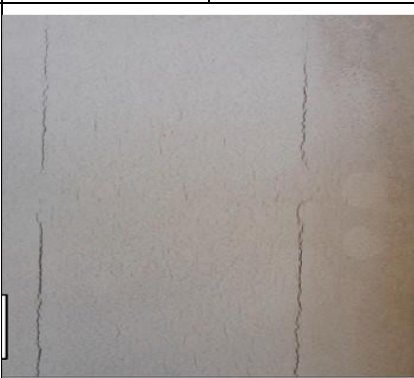
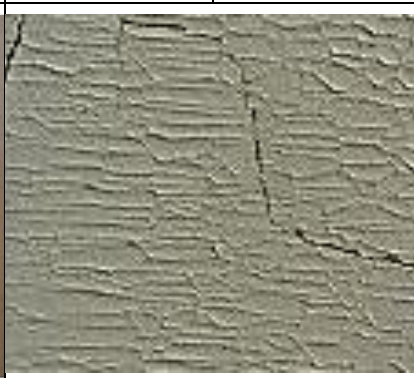
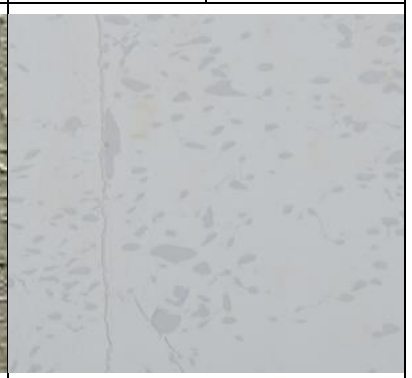
<p>Examples 4-6</p>

<p>Longitudinal cracks located under bus bars. [39]</p>	<p>Backsheet cracking. [57]</p>	<p>Backsheet cracking. [57]</p>			
<p>Severity</p>

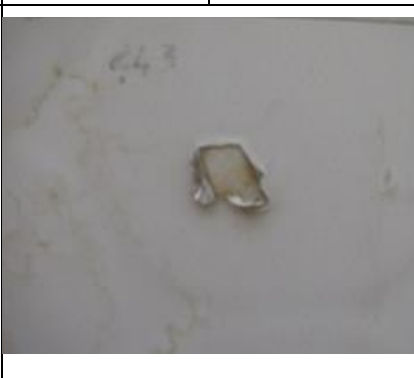
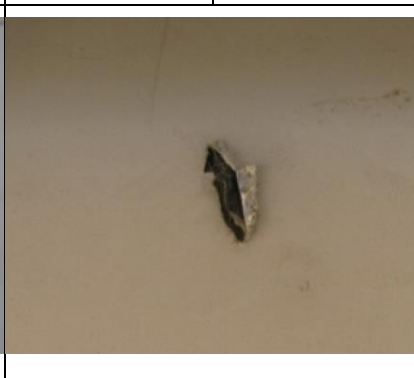
<p>Examples 7-8</p>

<p>Localized superficial damage. [1]</p>	<p>Deep scratch on backsheet. [TUV Rheinland]</p>				
<p>Severity</p>

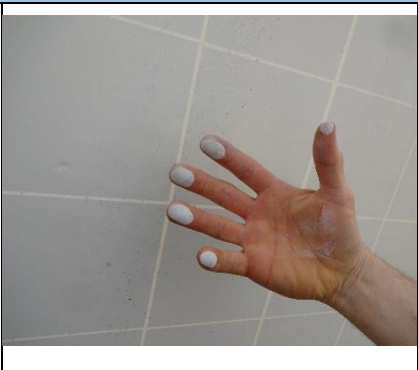
<p>Examples 1-2</p>

<p>Finger with white powder. [TUV Rheinland]</p>	<p>Fingerprint on a module with chalking. [TUV Rheinland]</p>				
<p>Severity</p>

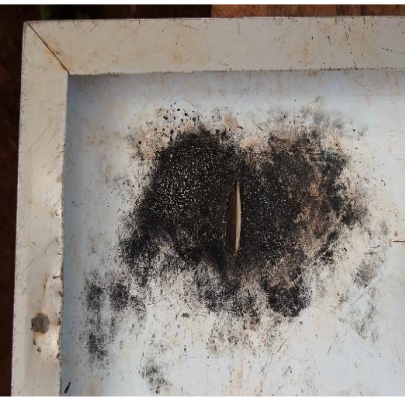
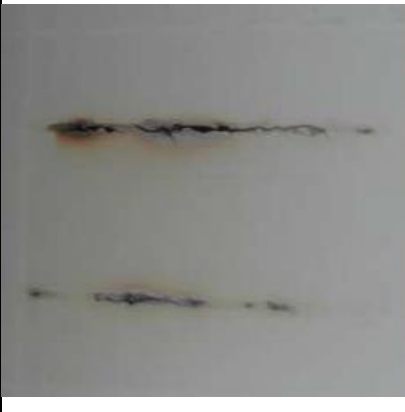
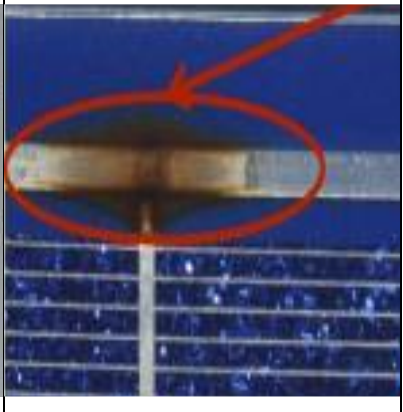
<p>Examples 1-3</p>

<p>Burn mark at the backsheet with cracked backsheet. [37]</p>	<p>Burn marks at the backsheet due to heating along a busbar. [16]</p>	<p>Burn mark associated with overheating along the metallic interconnection (without backsheet damage). [16]</p>
<p>Severity</p>

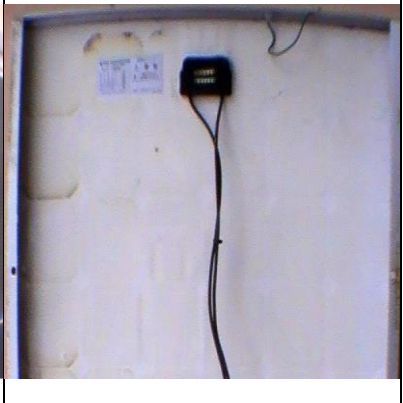
<p>Examples 4-6</p>

<p>Front and back side view of burn marks caused by open-circuited bypass diodes and current mismatch conditions (due to shading or cracked cells). [16]</p>		<p>Burn marks caused by defect bypass diodes or an interconnect failure in the junction box. [16]</p>
<p>Severity</p>

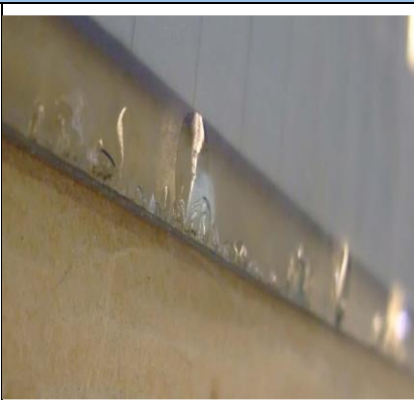
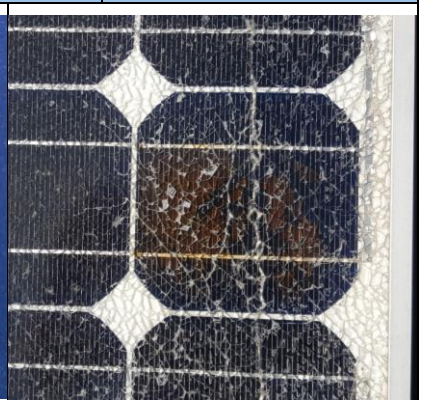
<p>Examples 1-3</p>

<p>Chipped glass at the corner. [38]</p>	<p>Glass breakage along the string interconnect ribbons due to weak manufacturing process. [SUPSI]</p>	<p>Glass breakage of tempered glass induced by a hot-spot. [SUPSI]</p>			
<p>Severity</p>

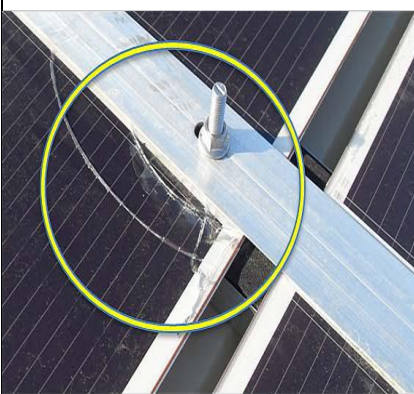
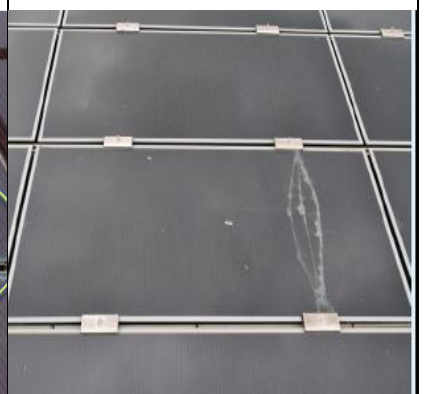
<p>Examples 4-6</p>

<p>Glass breakage caused by too tight screws. [16] (see also PVFS 3-1)</p>	<p>Glass breakage caused due to poor clamp design. [16]</p>	<p>Glass breakage caused due to poor clamp design. [1] (see also PVFS 3-1)</p>			
<p>Severity</p>

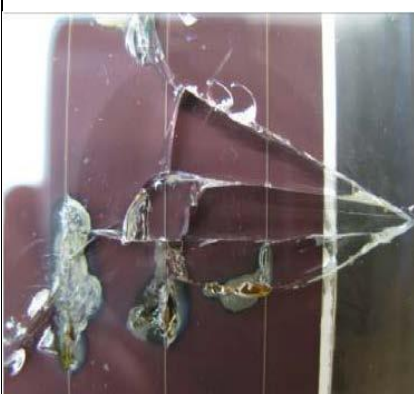
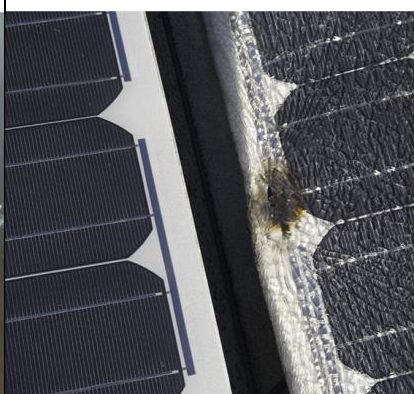
<p>Examples 7-9</p>

<p>Glass breakage through high temperature gradient and not tempered glass. [16]</p>	<p>Glass breakage of tempered glass induced by burn mark. [1] (see also PVFS 1-7 and PVFS 1-9)</p>	<p>Breakage of tempered glass. [1]</p>			
<p>Severity</p>

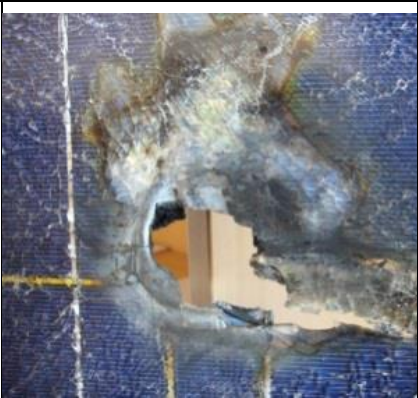
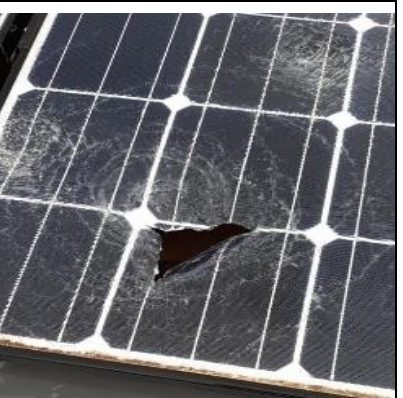
<p>Examples 10-12</p>

<p>Direct lightning stroke. [46]</p>	<p>Impact damage caused by a heavy object. [SUPSI]</p>	<p>Hail damage. [SUPSI]</p>
<p>Severity</p>

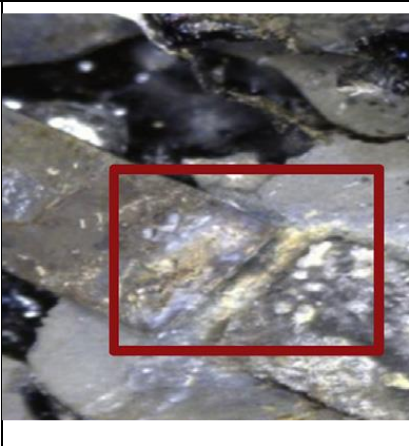
<p>Examples 1-3</p>

<p>Zoom of a broken cell interconnect. [41]</p>	<p>EL image of a module with 3 cells with disconnected interconnect ribbons. [16]</p>	<p>Disconnected cell interconnect with delamination. [1]</p>
<p>Severity</p>

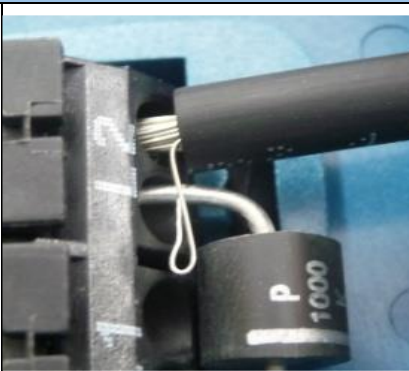
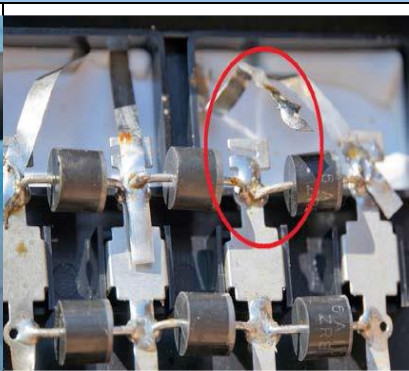
<p>Examples 1-3</p>

<p>Junction box with poor wiring. [16]</p>	<p>Detached tabbing ribbon due to bad soldering. [16]</p>	<p>Corrosion failure due to water soaking of the IP65 rated Jbox. [41]</p>
<p>Severity</p>

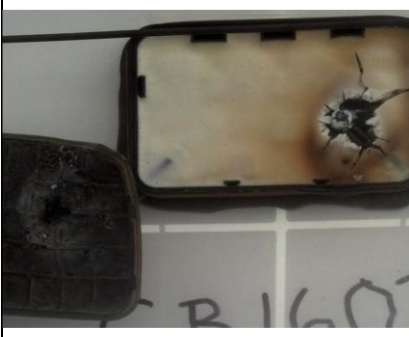
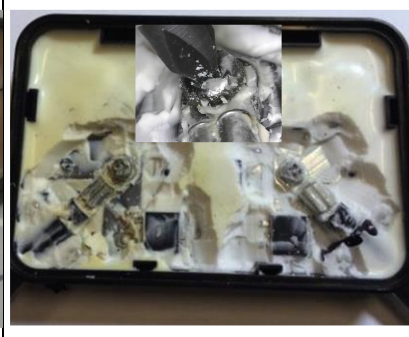
<p>Examples 4-6</p>

<p>Jbox failure due to poor electric connection. [41]</p>	<p>Evidence of loose screw connection inside Jbox with browning of pottant. [41]</p>	<p>Cold soldering of module busing ribbon to the Jbox connection terminal pad with minor browning of pottant. [41]</p>	
<p>Severity</p>

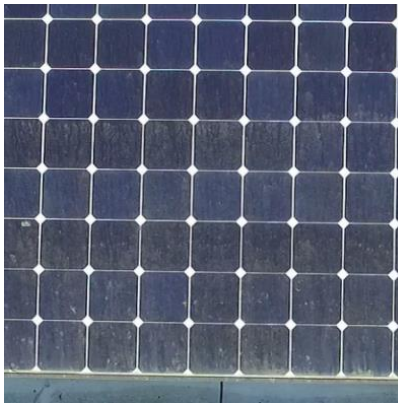
<p>Examples 1-3</p>

<p>Uniform light soiling, which in ideal conditions is self-cleaning when raining.</p>	<p>Uniform heavy soiling caused by rail way station. [SUPSI]</p>	<p>Non-uniform soiling caused by low inclination and close mounting to roof. [SUPSI]</p>
<p>Severity</p>

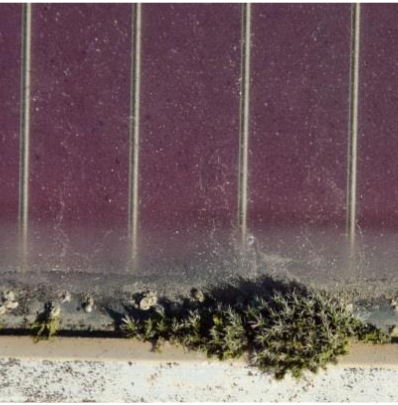
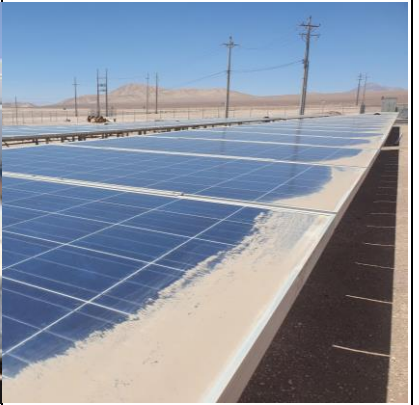
<p>Examples 4-6</p>

<p>Moss growing on the edge of a module combined with edge soiling. [1]</p>	<p>Soiling pattern on a system in the Atacama desert. [ISE]</p>	<p>Soiling pattern demonstrating dominant wind direction on a test site in Atacama desert. [ISE]</p>
<p>Severity</p>

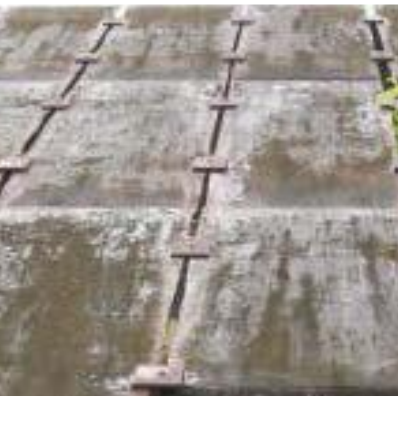
<p>Examples 7</p>

<p>Heavy biofilm soiling. [46]</p>		
<p>Severity</p>

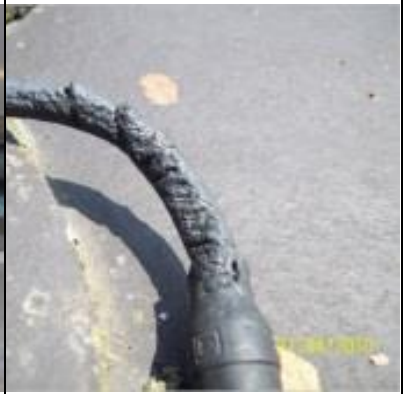
<p>Examples 8-10</p>

<p>Burned connector. [1]</p>	<p>Corroded Cable. [1]</p>	<p>Animal bite on cable. [1]</p>			
<p>Severity</p>

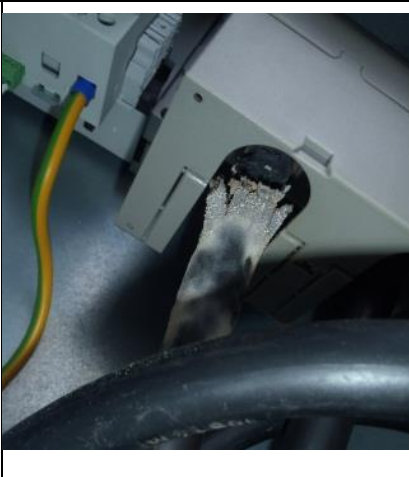
<p>Examples 4</p>

<p>Connecting terminals show signs of burning, have melted or charred. [TUV Rheinland]</p>

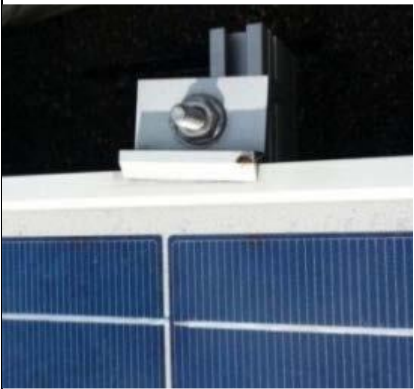
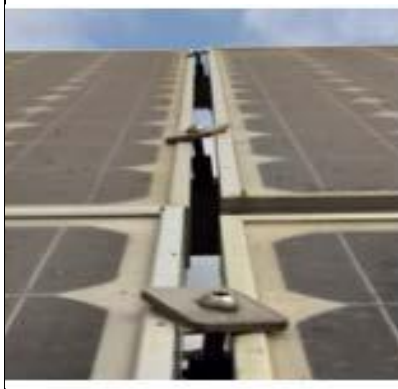
<p>Examples 1-3</p>

<p>Improper installation of clamp. [?]</p>	<p>Wrong combination of clamps and modules. [40]</p>	<p>Glass breakage caused by too tight screws. [35] (see also PVFS 1-8)</p>
<p>Severity</p>

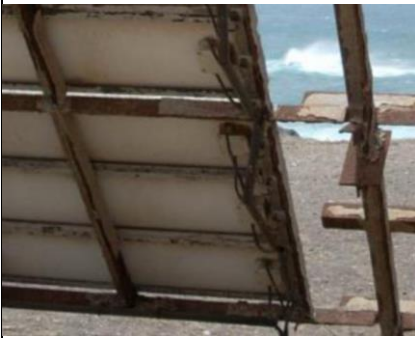
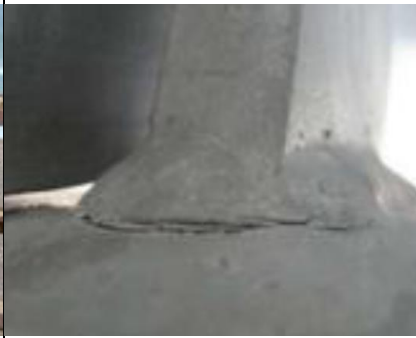
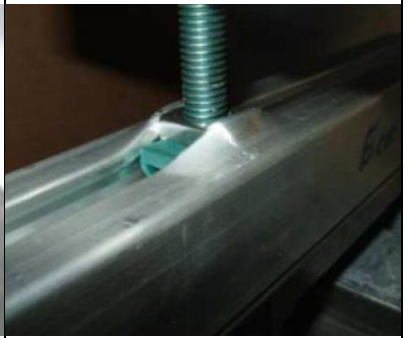
<p>Examples 1-3</p>

<p>Corrosion due to salt water. [46]</p>	<p>Cracks in mounting structure due to mechanical stress. [46]</p>	<p>Screw canal bends due to mechanical stress. [46]</p>			
<p>Severity</p>

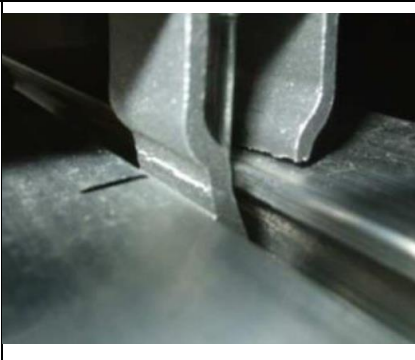
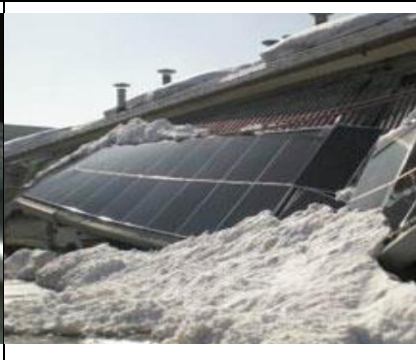
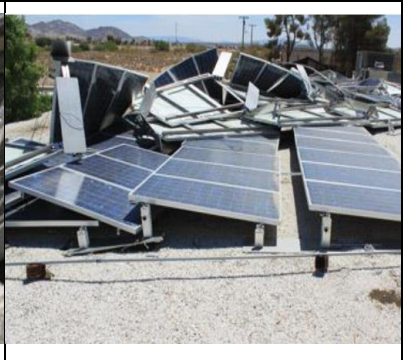
<p>Examples 4-6</p>

<p>Bracket fractured due to mechanical stress. [46]</p>	<p>Undersized mounting structure for local snow load conditions. [46]</p>	<p>Undersized mounting structure for local wind conditions. [15]</p>			
<p>Severity</p>

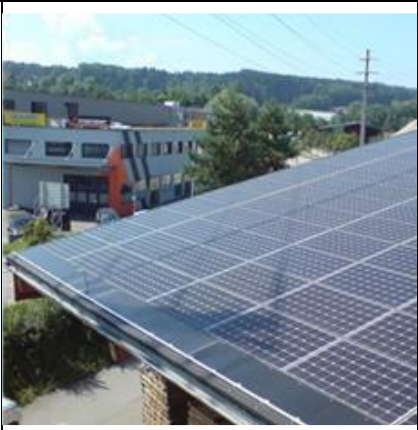
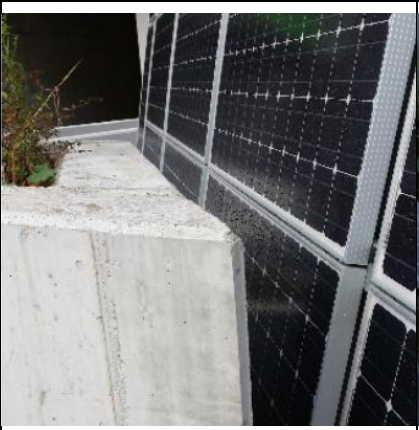
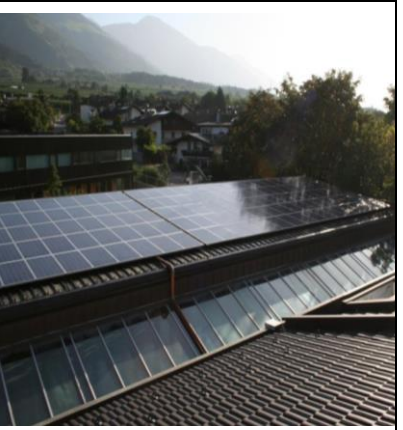
<p>Examples 1-3</p>

<p>Shading by pole-and-wire (poor design: too close to nearby shading objects). [36]</p>	<p>Shading due to bad planning or coverage by afterwards build construction element. [40]</p>	<p>Shading by tree with seasonal changes due to foliage. [40]</p>			
<p>Severity</p>

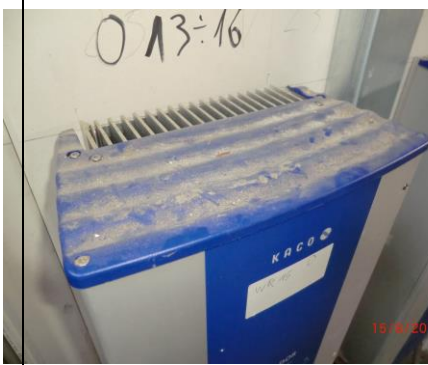
Dust blocking heat dissipation [TUV Rheinland]

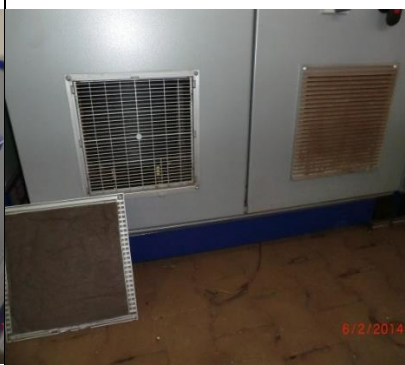
A soiled air filter causes overheating [TUV Rheinland]

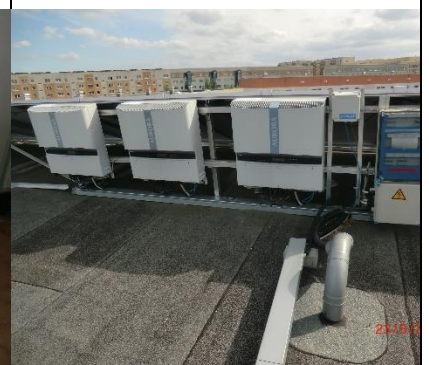
Installation not appropriate (direct exposition to sun) [TUV Rheinland]

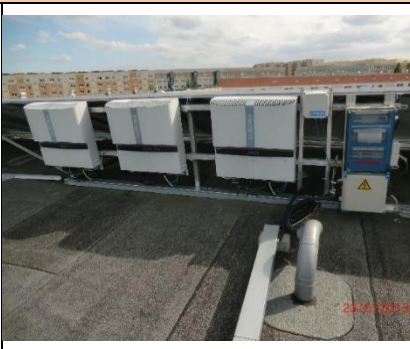
<p>Examples 1-3</p>

<p>Installation in direct sun light. [TUV Rheinland]</p>	<p>Inverters are not or difficult accessible for operation and maintenance. [TUV Rheinland]</p>	<p>Distance to bottom, top or to the sides too low. [TUV Rheinland]</p>			
<p>Severity</p>

Component	Inverter			PVFS 4-2vs.01
Defect	Incorrect installation			
Appearance	The inverter must be installed according to the installation instruction. A common failures is the installation near flammable, explosive, corrosive or humid sources. Also the minimum distances to bottom, top or to the sides are not always fulfilled. If the input cables are not fixed properly, increased temperatures can occur at the loose contact point which lead to lower performance or risk of fire. Inverters must always be accessible for operation and maintenance and properly secured to an appropriate base.			
Detection	VI (MON)			
Origin	Violating instruction manual, e.g. installed nearby flammable materials as wood or in direct sun light. Minimum distance to adjacent components not maintained.			
	Production <input type="checkbox"/>	Installation <input checked="" type="checkbox"/>	Operation <input type="checkbox"/>

Impact	Incorrect installation of the inverter can cause danger to users and hazardous conditions and can result in overheating of the inverter. The use of the inverter in the presence of flammable vapours or gases can lead to explosions. The inverter housing can become very hot under operation. Follow the instruction to provide gaps from both sides and top for adequate cooling. Direct sunlight on the inverters must be avoided. The inverter must be safely accessible to avoid accidents during maintenance work.			
	Safety:

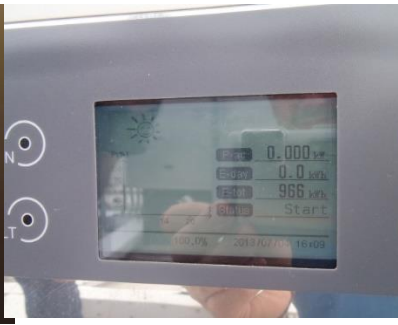
Examples
1-3

Not operating inverter. [TUV Rheinland]

Component	Inverter			PVFS 4-3vs.01
Defect	Not operating (complete failure)			
Appearance	If the inverter does not work despite good production conditions, common problems are the lack of restart after grid faults or isolation faults . The inverter may show fault codes to help understanding the problem. This can be observed by checking the display or the data log of the monitoring system. Examples for hardware defects in the inverter are discoloured or burned cable interconnections or fuses. Damaged parts can be found by visual inspection or infrared thermography (IRT).			
Detection	MON, (VI, I-V, VOC)			
Origin	A complete failure of the inverter occurs due one or more malfunctions of single hardware or software component of the inverter or faults due to grounding issues, e.g. high humidity inside the inverter, or a firmware issue.			
	Production <input type="checkbox"/>	Installation <input type="checkbox"/>	Operation <input type="checkbox"/>

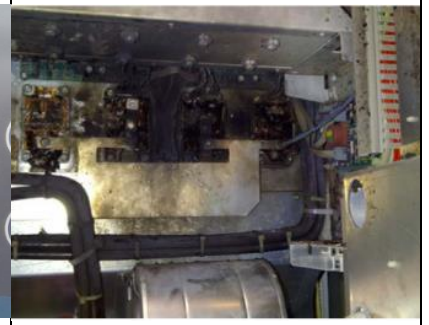
Damaged hardware component. [37]

Action	Corrective actions	Preventive actions (recommended)		Preventive actions (optional)
	Restart the inverter. Replace the components with defect or abnormal temperature. Update the software.	Use IRT and VOC to check the components and connection to find poor connection or defect components.
