# Frame Conditions for Thermography Inspections of Photovoltaic Plants

Sergiu Spataru  
Technical University of Denmark  
sersp@dtu.dk

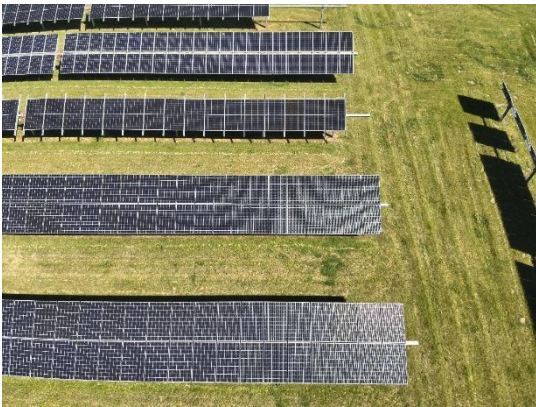
Drone + RGB + LWIR  
~ 6 k€

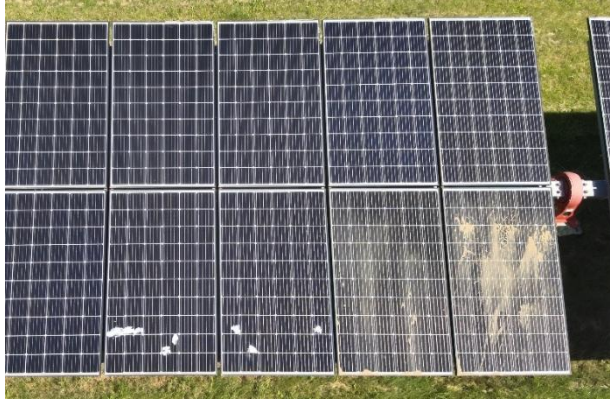
- **Soiling**

- 12 modules
- Power loss 66%

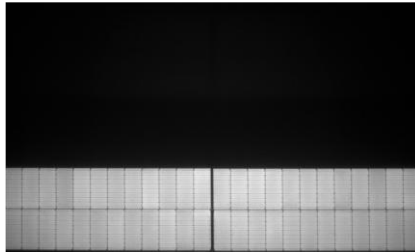
- **Shorted bypass diode**

- 7 modules
- Power loss 33-66%

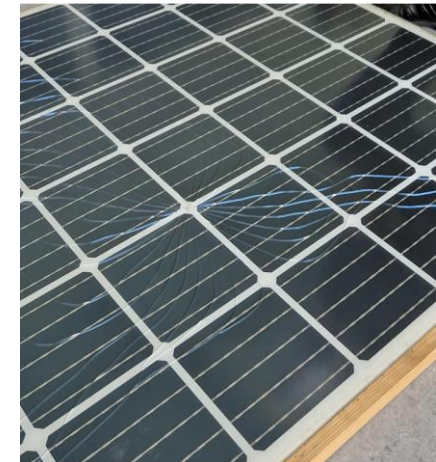
- **Glass cracks**

- 2 modules
- Power loss <1%

| Defect Type | # of modules | Range of Power Loss [%] | Module type | Details |
|---|---|---|---|---|
| Glass crack | 2 | < 1% | • Bifacial PERC 540 W (Half-cut cells) | Glass cracked in front and rear side |

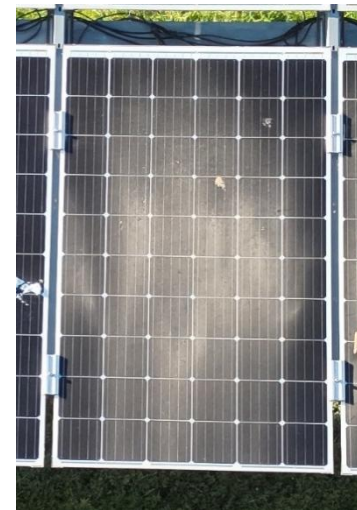
# What is the impact of soiling in IRT?

- Soiling 2 – Homogeneous dirt across the module surface
  - Desert soiling conditions
- Hotspots vs full module heating
- Assessment is not conditioned by image spatial resolution
- Even at 200 W/m<sup>2</sup> the  $\Delta T > 10^{\circ}\text{C}$

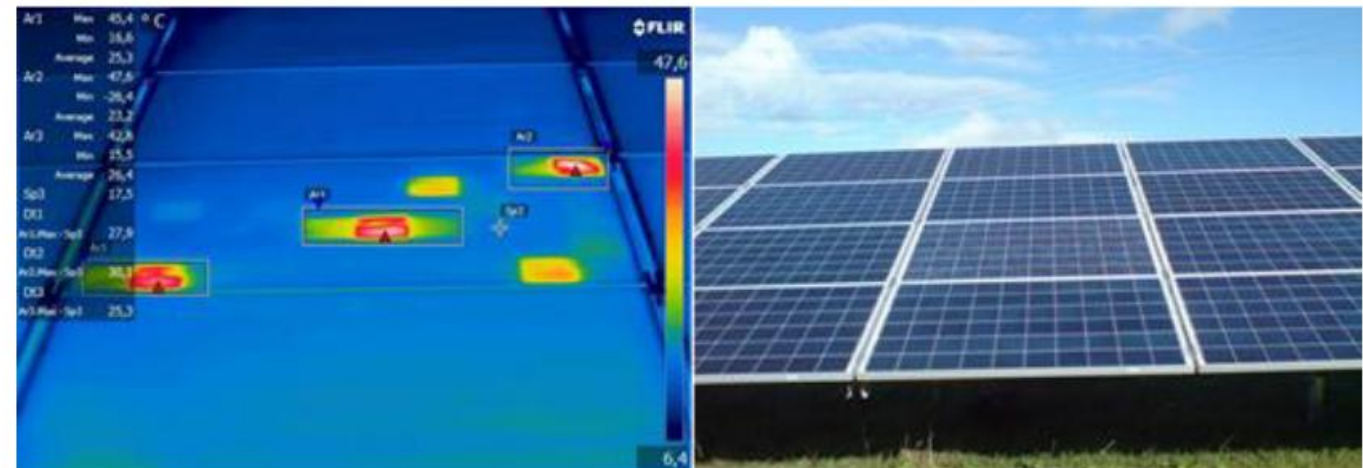
IEA-PVPS T13-10:2018

# What is the impact of Front Glass Cracks on IRT & RGB?
